# Whyte Island Rehabilitation Program - Year 1 Assessment

PBPL  
000885  
005  
02

28 August 2024

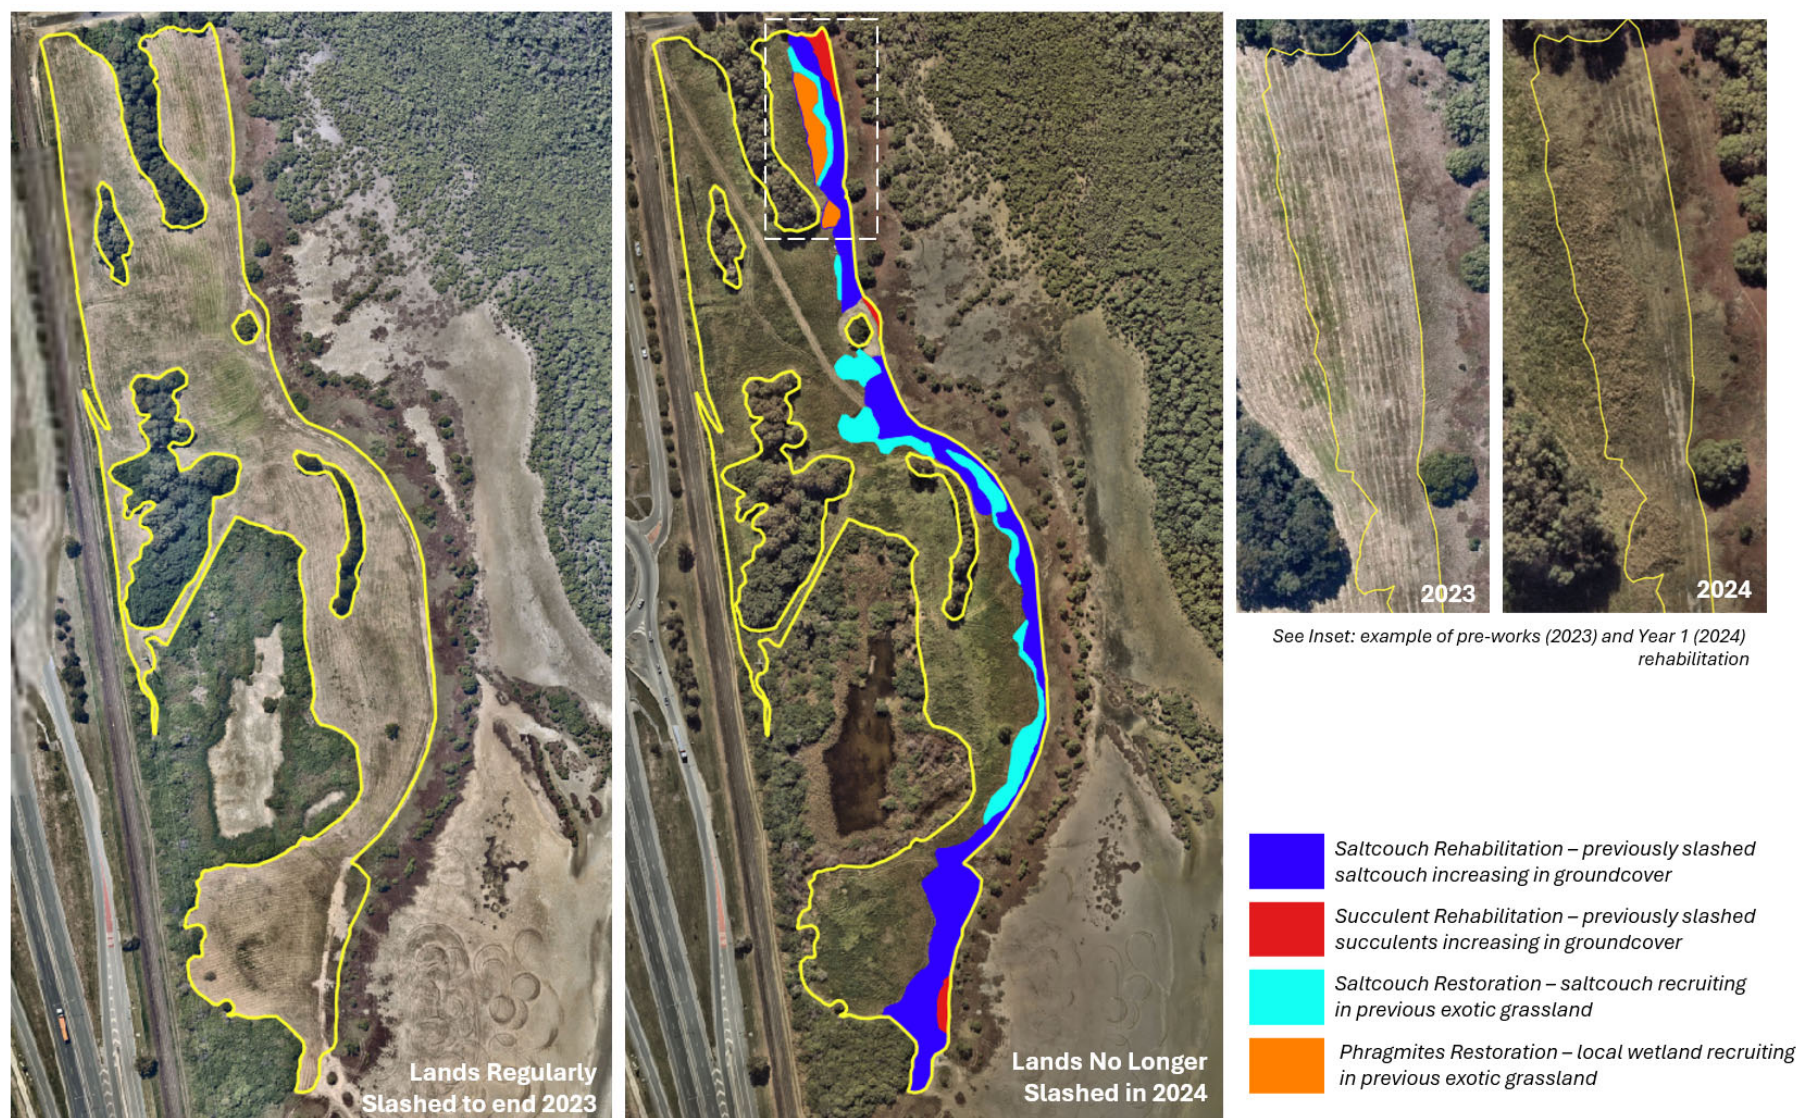
Figure 3.1 Year 1 – Outcomes of Removing Slashing

In late 2023, slashing in the project area was discontinued to allow natural vegetation regeneration. As a result of removing this practice, the previously disturbed saltcouch grassland increased in cover (averaging 80% groundcover outside the access tracks) (refer Appendix F). An area of 0.04 ha of previously slashed succulent saltmarsh also increased in cover from approx. 60% to 80% outside the access tracks. Saltcouch grasslands also expanded landward, resulting in a 0.2 ha gain of saltmarsh in the project area. In addition, 0.06 ha of *Phragmites australis* wetland regenerated in previously slashed habitat. Refer to Table 3.1 for changes in vegetation extent and condition following the removal of slashing.

Habitats adjacent to the upper tidal range are no longer regularly slashed. Removal of this practice has promoted the recruitment of native wetland taxa. An area of 0.5 ha of previously slashed saltcouch is increasing in cover from approximately 60-80% groundcover outside access tracks. An area of 0.04 ha of previously slashed succulent saltmarsh is also increasing in cover from approx. 60% cover to 80% groundcover outside the access tracks. There has also been a 0.2 ha gain of saltcouch and 0.06 ha gain of *Phragmites australis* wetland in previously slashed habitat. Remote sensing condition assessments also indicate poor saltcouch condition during the dry season, particularly in proximity to disturbed and degraded areas, which highlights the importance of protecting these communities from regular vehicle disturbance. Maintaining the condition of salt tolerant native taxa may also give marine plants a competitive advantage over more salt/drought sensitive exotic grasses. BioCondition plots and vegetation transects established at the terrestrial/intertidal interface will be used to monitor further changes in vegetation composition and extent associated with improved land management practices.

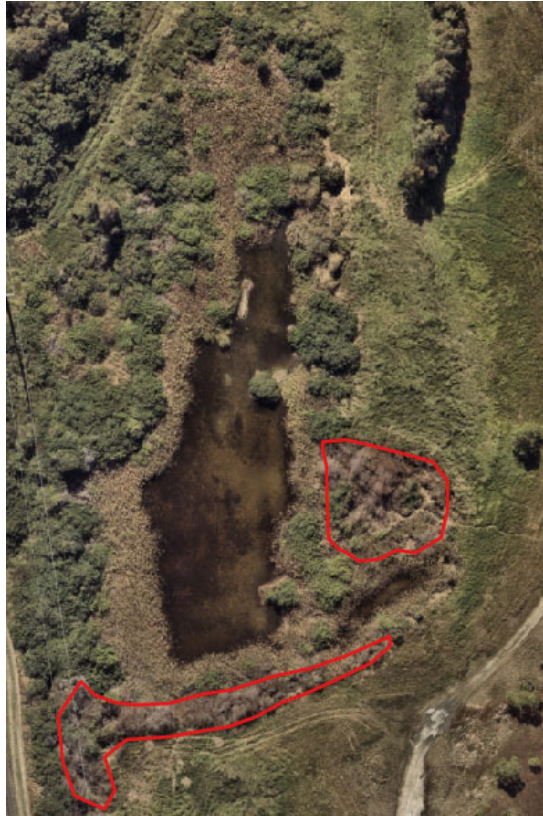
Figure 3.2 Targeted Schinus Control Mid-2024 (red polygons indicating successful treatment of Schinus, June 2024)

Selective weed control was undertaken in dense exotic *Schinus terebinthifolius* shrubland adjacent to the ephemeral wetland in mid-2024. The short timeframe between these on ground works and the first monitoring survey is not sufficient for substantive changes in habitat condition to occur. However, site observations indicate the weed control has had a high success rate (more than 80% successful weed kill) in at least 0.7 ha. This area will be progressively planted with native species.

An area of 2 ha of dense woody weed infestation surrounding the ephemeral wetland was treated just prior to the June 2024 inspection. Due to the recent treatment, it was not suitable to repeat the BioCondition assessment in June 2024. However, site observations indicate the weed control has had a high success rate (more than 80% successful weed kill) in at least 0.7 ha. This area will be progressively planted with native species. Follow up monitoring will be undertaken to re-measure BioCondition plots established in this area to quantify changes in habitat condition as a result of weed control and revegetation. All woody cover across the project area, including the exotic shrublands, display good vegetation health across all seasons highlighting the need for on-going weed control to target drought exotic taxa, such as *Schinus*, which can outcompete native species.

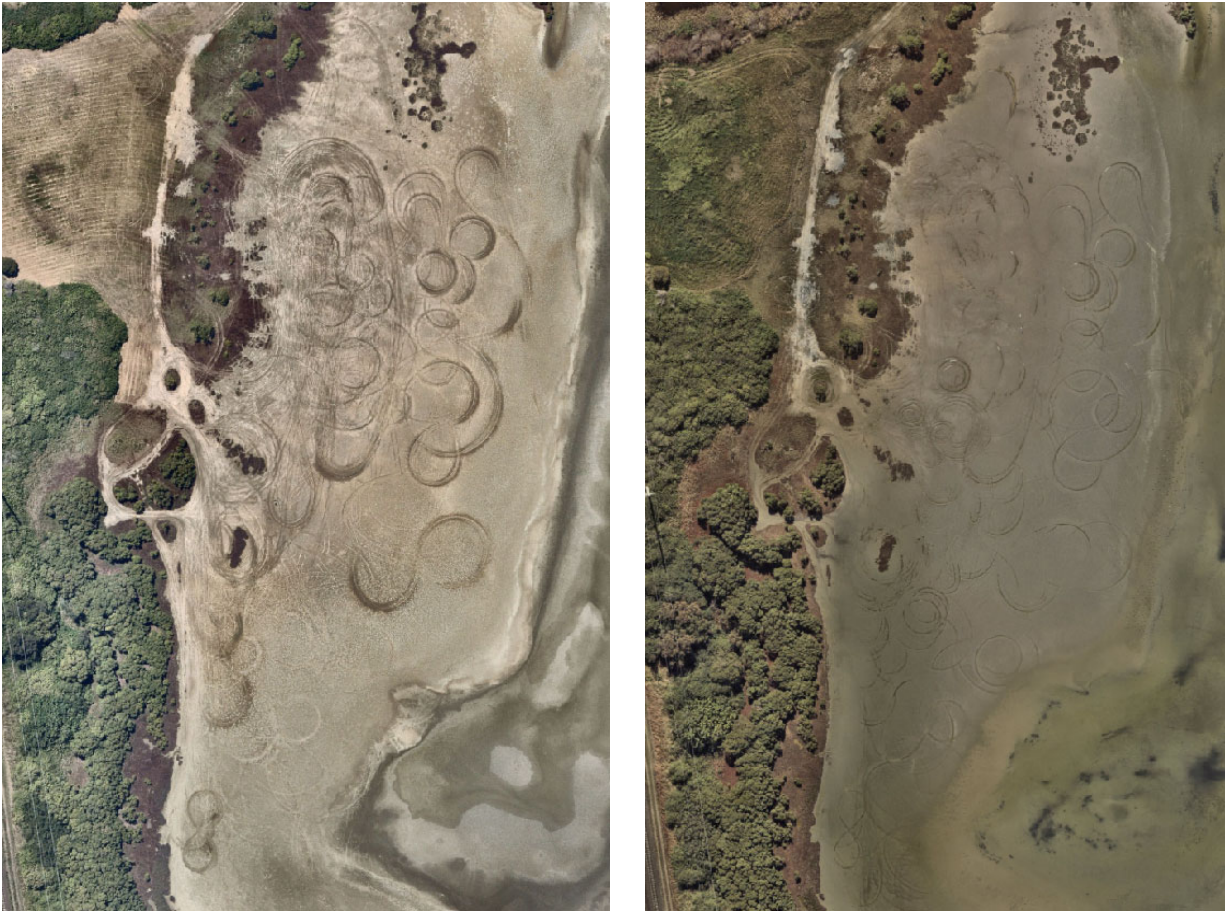
Figure 3.3 Claypan Disturbance Prior to Fence Establishment (left) and Post Fence Establishment (right)

The fence installed on the project area perimeter in early 2024 has successfully excluded illegal vehicle access and reduced disturbance to the claypan and adjacent saltmarsh. The short timeframe between these on ground works and the first monitoring survey is not sufficient for substantive changes in habitat condition to occur. However, site inspection and aerial photo analysis indicates 4.2 ha of wetlands were previously subject to direct vehicle disturbance and are presently undergoing natural recovery.

The fencing installed as part of the rehabilitation program has successfully removed illegal vehicle access to the project area. Whilst the short timeframe between these on ground works and the first monitoring survey is not sufficient for substantive changes in habitat condition to occur, site observations indicate the estuarine wetlands and claypan habitat are naturally recovering. Aerial photo analysis and the site survey confirms the 4.2 ha of wetlands are no longer subject to direct vehicle disturbance. Vehicle exclusion is likely to indirectly protected a further 15.6 ha of tidal wetlands and their shorebird assemblages from vehicle noise and visual disturbance. Results from future bird monitoring surveys, to be conducted during the optimal wader season, will be used to help confirm changes in wader habitat quality and/or extent as a result of removing vehicles from the estuarine wetlands.
