Assessment of the Health and Viability of the Mangrove Communities at Whyte Island

Prepared For: Port of Brisbane Corporation

Prepared By: WBM Oceanics Australia

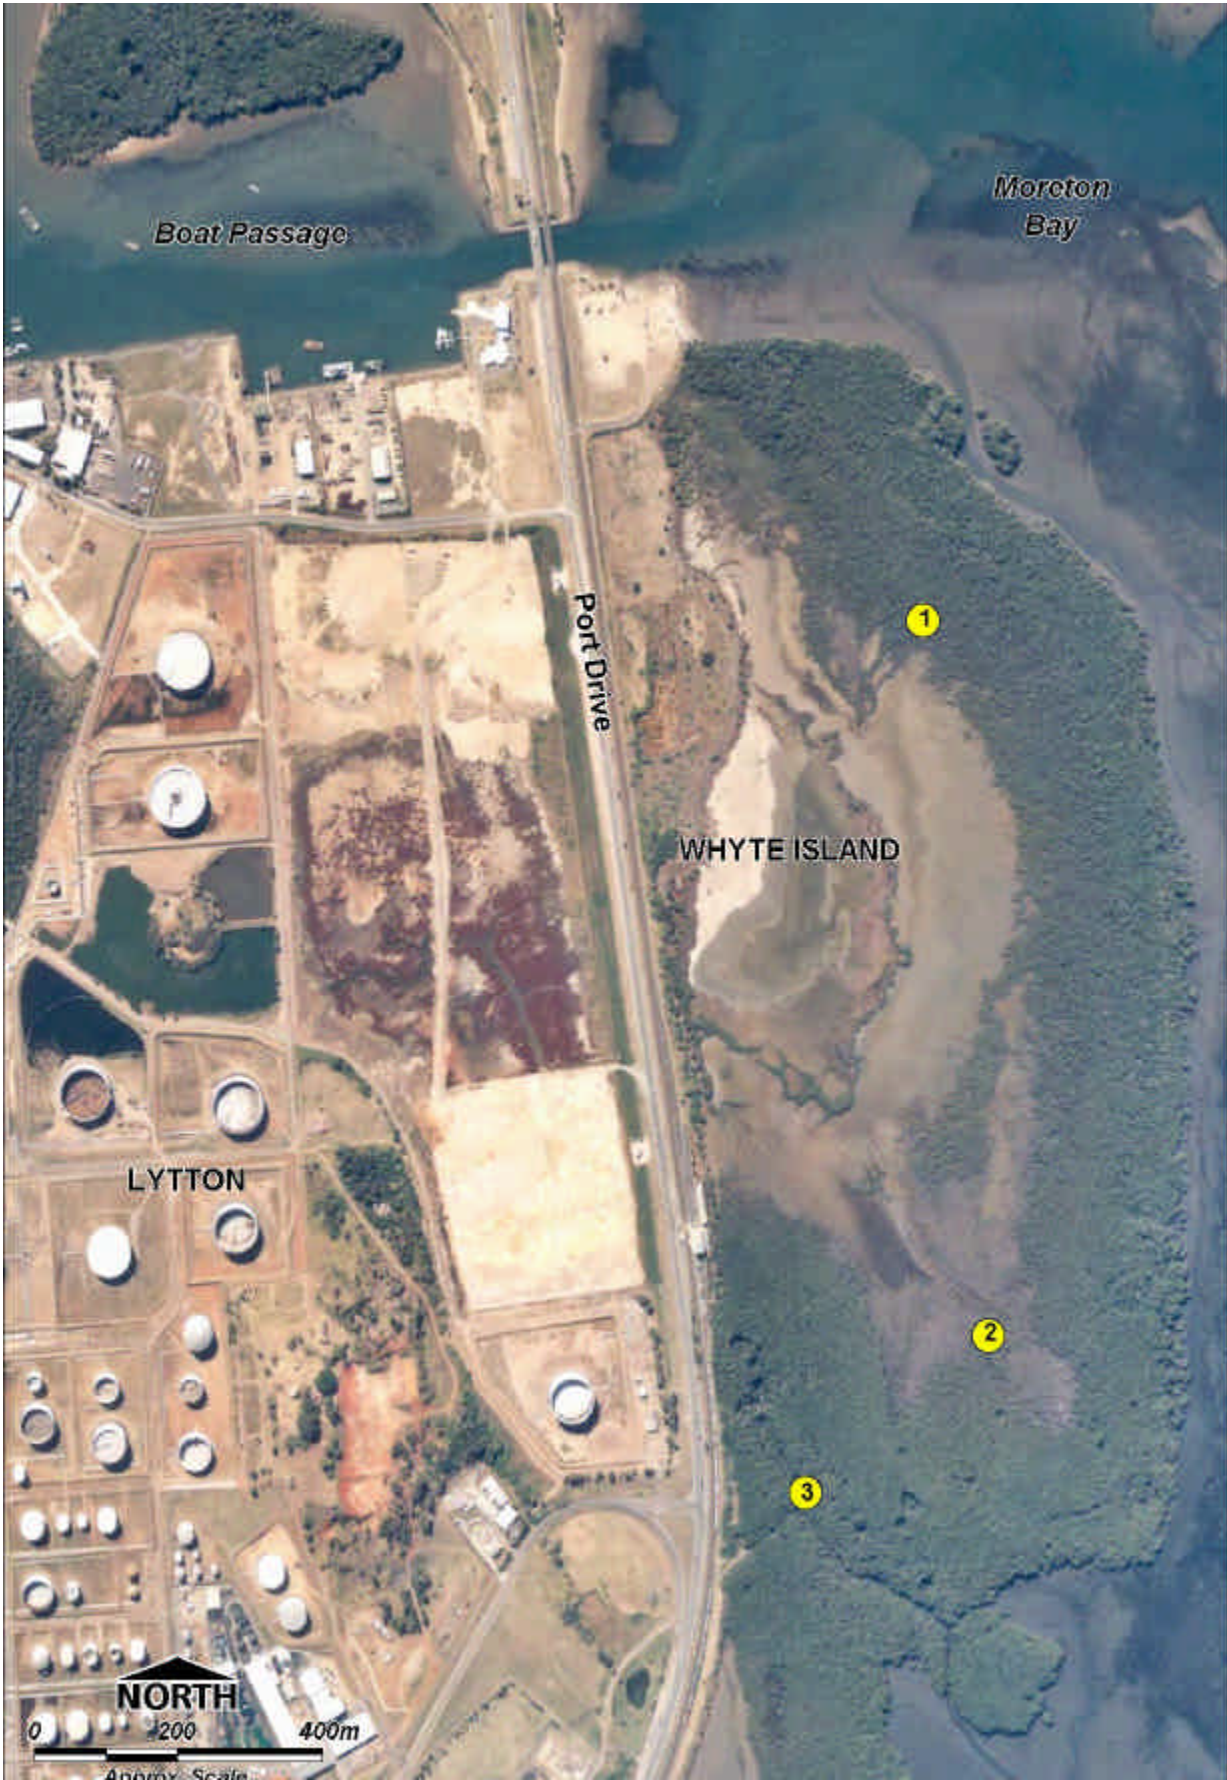
Figure 2.1 Location of Sediment Sampling Sites

Sediment samples were collected from three sites within the study area, near the Wynnum Waste Water Treatment Plant outfall, in an area of dead mangroves and in an area of stressed mangroves (Figure 2.1). All samples were analysed for the following parameters:

- Heavy metals;
- Organochlorines;
- BTEX/TPH; and
- Nutrients.

Samples were collected from the upper 10cm of the sediment profile and retained in approved containers before delivery to a NATA registered laboratory within accepted holding periods

Heavy metal concentrations (Table 3.1) at Sites 1 and 2 were within acceptable levels for all elements except Mercury, which was found in concentrations more than 1.5 times the Maximum Level listed in National Ocean Disposal Guidelines for Dredged Material (Environment Australia 2002). These guidelines give effect-based levels for heavy metals in sediments. Values below the Screening Level are considered safe, concentrations above the Screening Level but below the Maximum Level require further investigation on a case-by-case basis and concentrations above the Maximum Level are considered to be detrimental to biological processes.

Compared to Sites 1 and 2, Site 3 had elevated levels of Copper, Nickel, Lead and Zinc. Concentrations of Copper, Mercury, Nickel and Zinc at Site 3 were above EA (2002) screening levels. Furthermore, mercury concentration at all three sites was above the maximum level outlined in the guidelines. The elevated heavy metal concentrations at Site 3 may be linked to the sewage outfall, however additional investigations would be required to confirm this and to identify reasons for the elevated Mercury levels at all three sites at Whyte Island.

Nutrient levels (Table 3.2) at all three sites were similar to those recorded at Fisherman Islands (WBM 2000a) and Bulwer Island (Mackey *et al* 1992). Elevated concentrations are expected given the high levels of organic matter present in the sediments. Additionally, Site 3 (closest to the Wynnum WWTP outfall) had higher levels of Nitrite, Nitrate and Phosphorous than Sites 1 and 2.

Organochlorine pesticide (Table 3.3) and BTEX concentrations (Table 3.4) were low at all three sites however elevated levels of Petroleum Hydrocarbons were recorded at Sites 2 and 3.

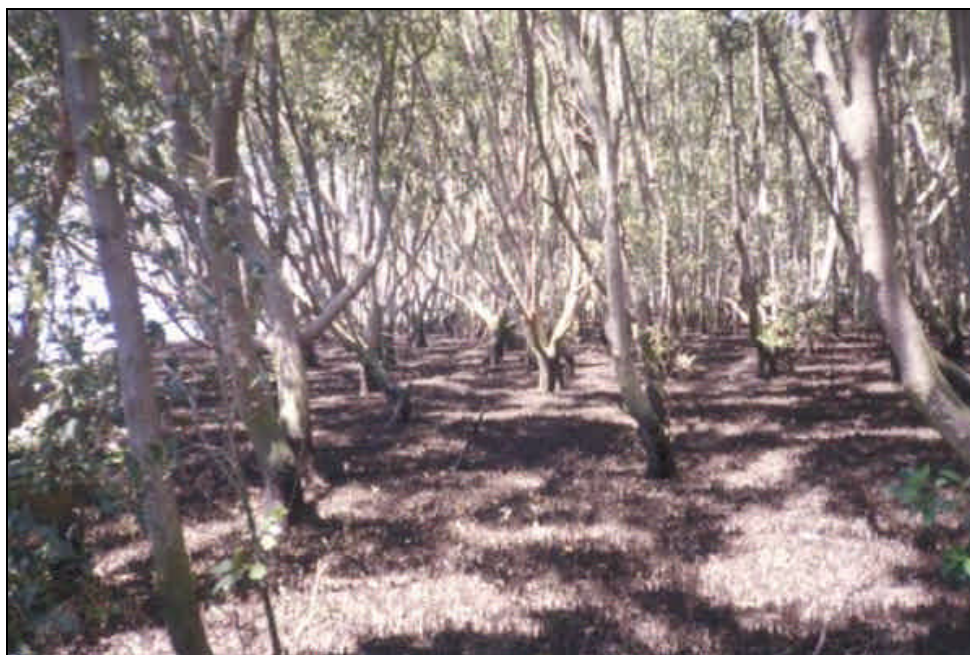
**Figure 2.2 Mangrove Health Category - GOOD**

Mangrove Health - along the survey transect, a visual assessment of the health of the mangroves was made at each site based on criteria developed in conjunction with the PBC for the 1999/2000 survey. Criteria for each category are listed in Table 2.1 and examples of each category are shown in Figure 2.2 to Figure 2.6.

Category	Condition	Description
1	Good	Leaves green. No abnormal leaf loss evident. No epicormic growth. No leaf curling.
2	Fair	Leaves green. Some yellowing of leaves and/or curling, but <20% of canopy affected. Some epicormic growth apparent.
3	Poor	Many leaves yellow, brown and/or curled. Substantial reduction in canopy. Abundant leaf curling and/or epicormic growth apparent.
4	Dead	Leaves brown or absent. Little or no canopy remaining.
5	Regrowth	Canopy reduced but regrowth evident in the form of new trees. Disturbance event generally evident (ie. constructed bund).

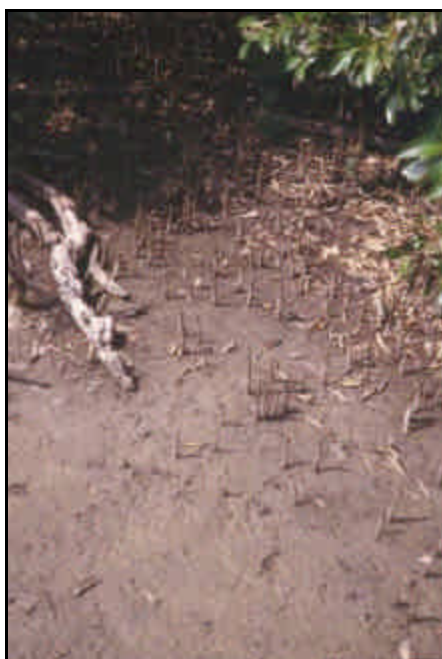
Figure 2.7 Macroalgae Category - RARE

At each of the sampling stations along the survey transect, a visual estimation of the coverage of macroalgae was recorded. This estimation was based on the four categories listed in Table 2.2. Examples of each of the categories are shown in Figure 2.7 to Figure 2.10.

Category	Condition	Description
1	Very Abundant	>75% coverage of pneumatophores and/or sediments, heavy coating/carpet
2	Abundant	50-75% coverage, most surfaces coated, easily visible
3	Common	10-50% coverage some macroalgae visible
4	Rare	<10% coverage, no macroalgae

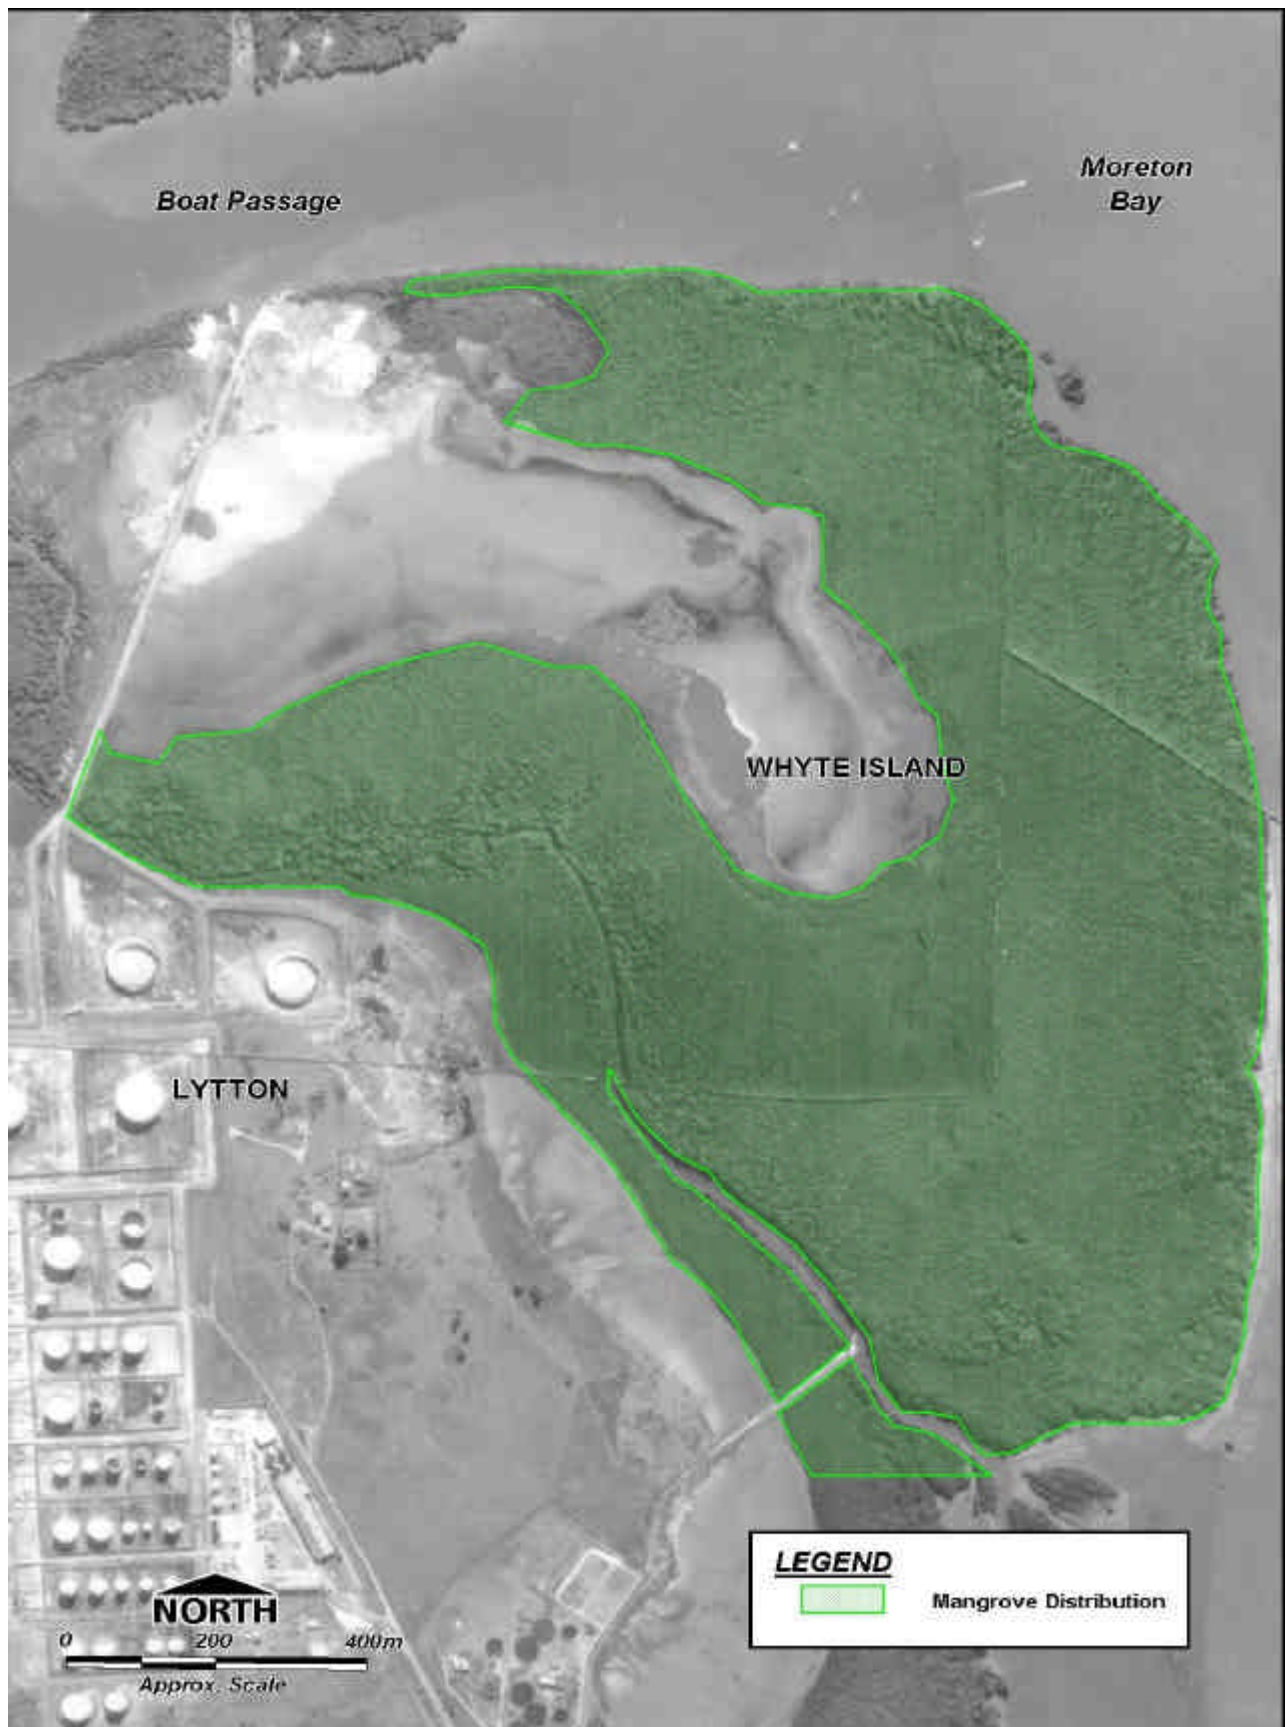
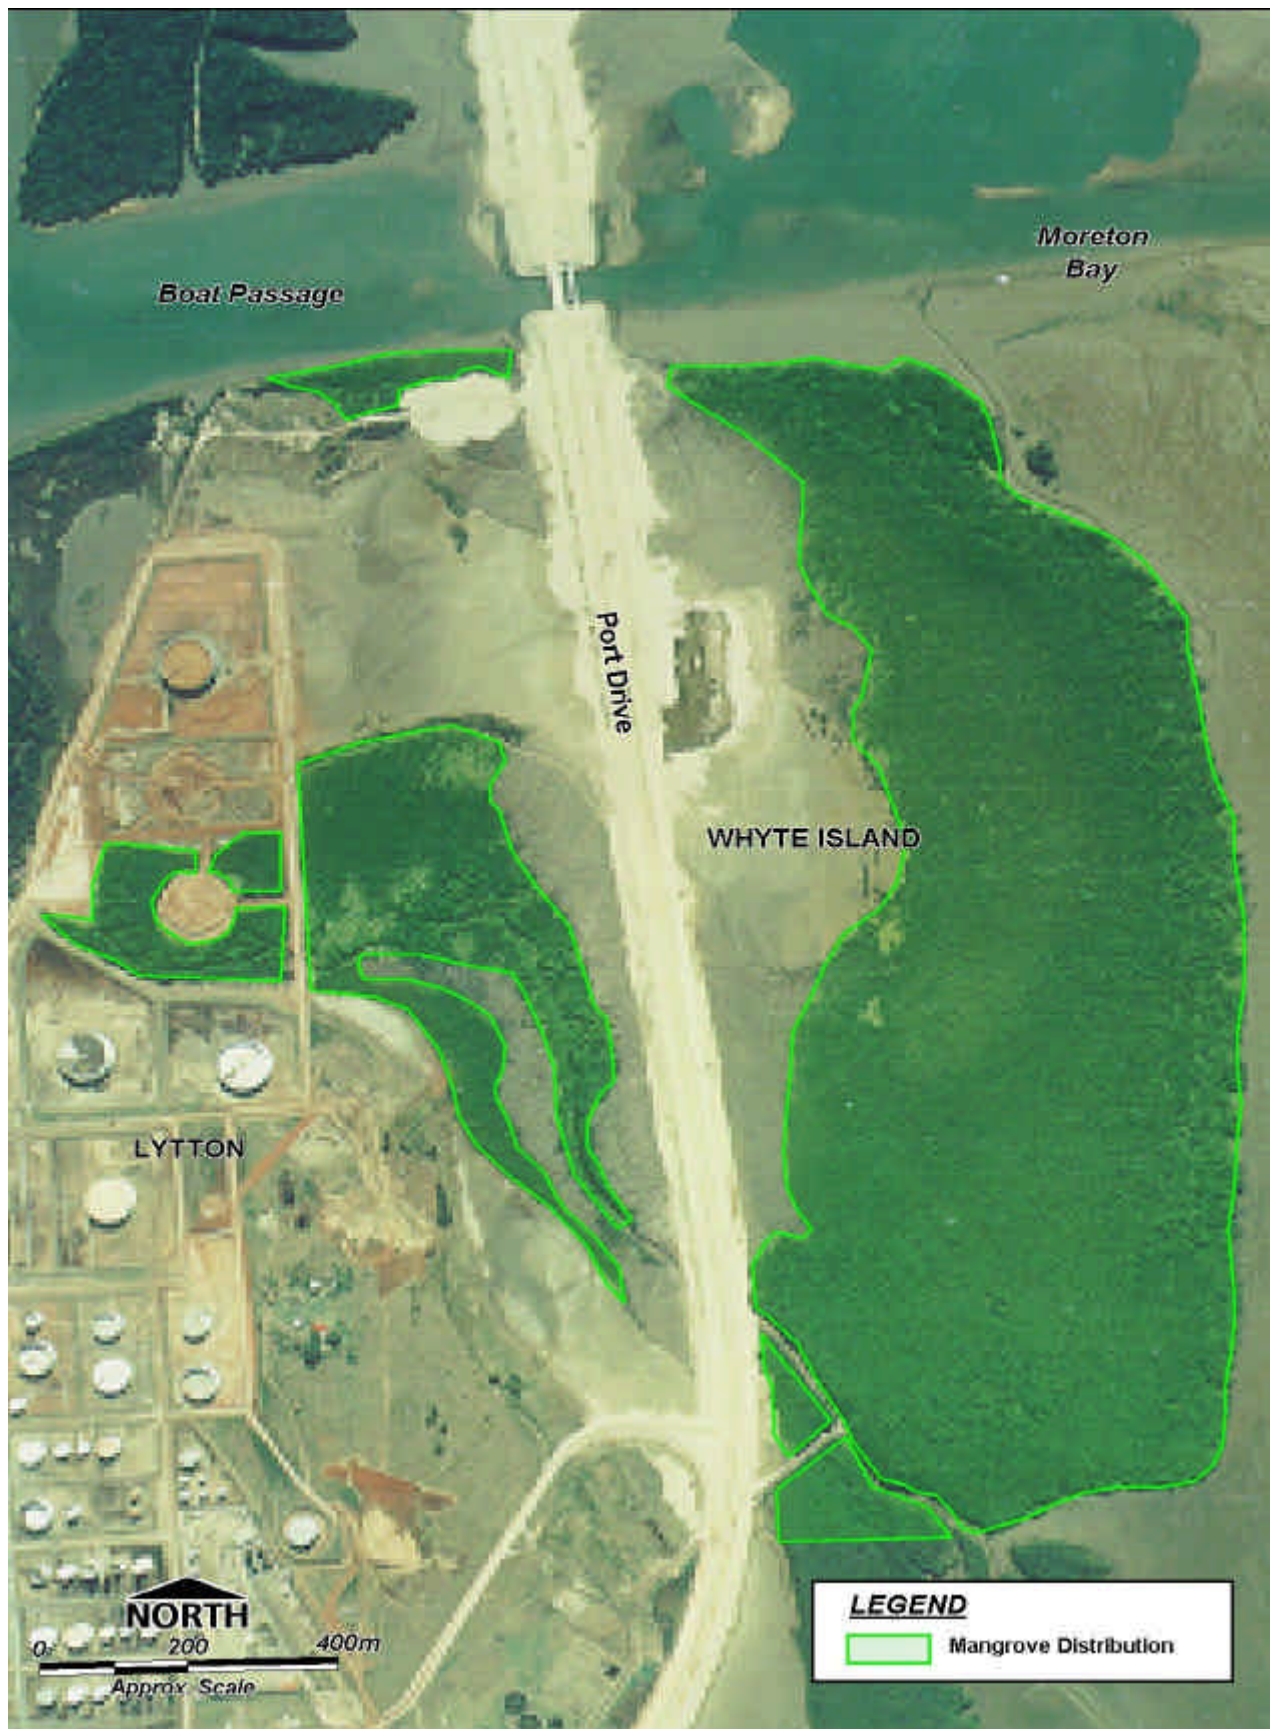
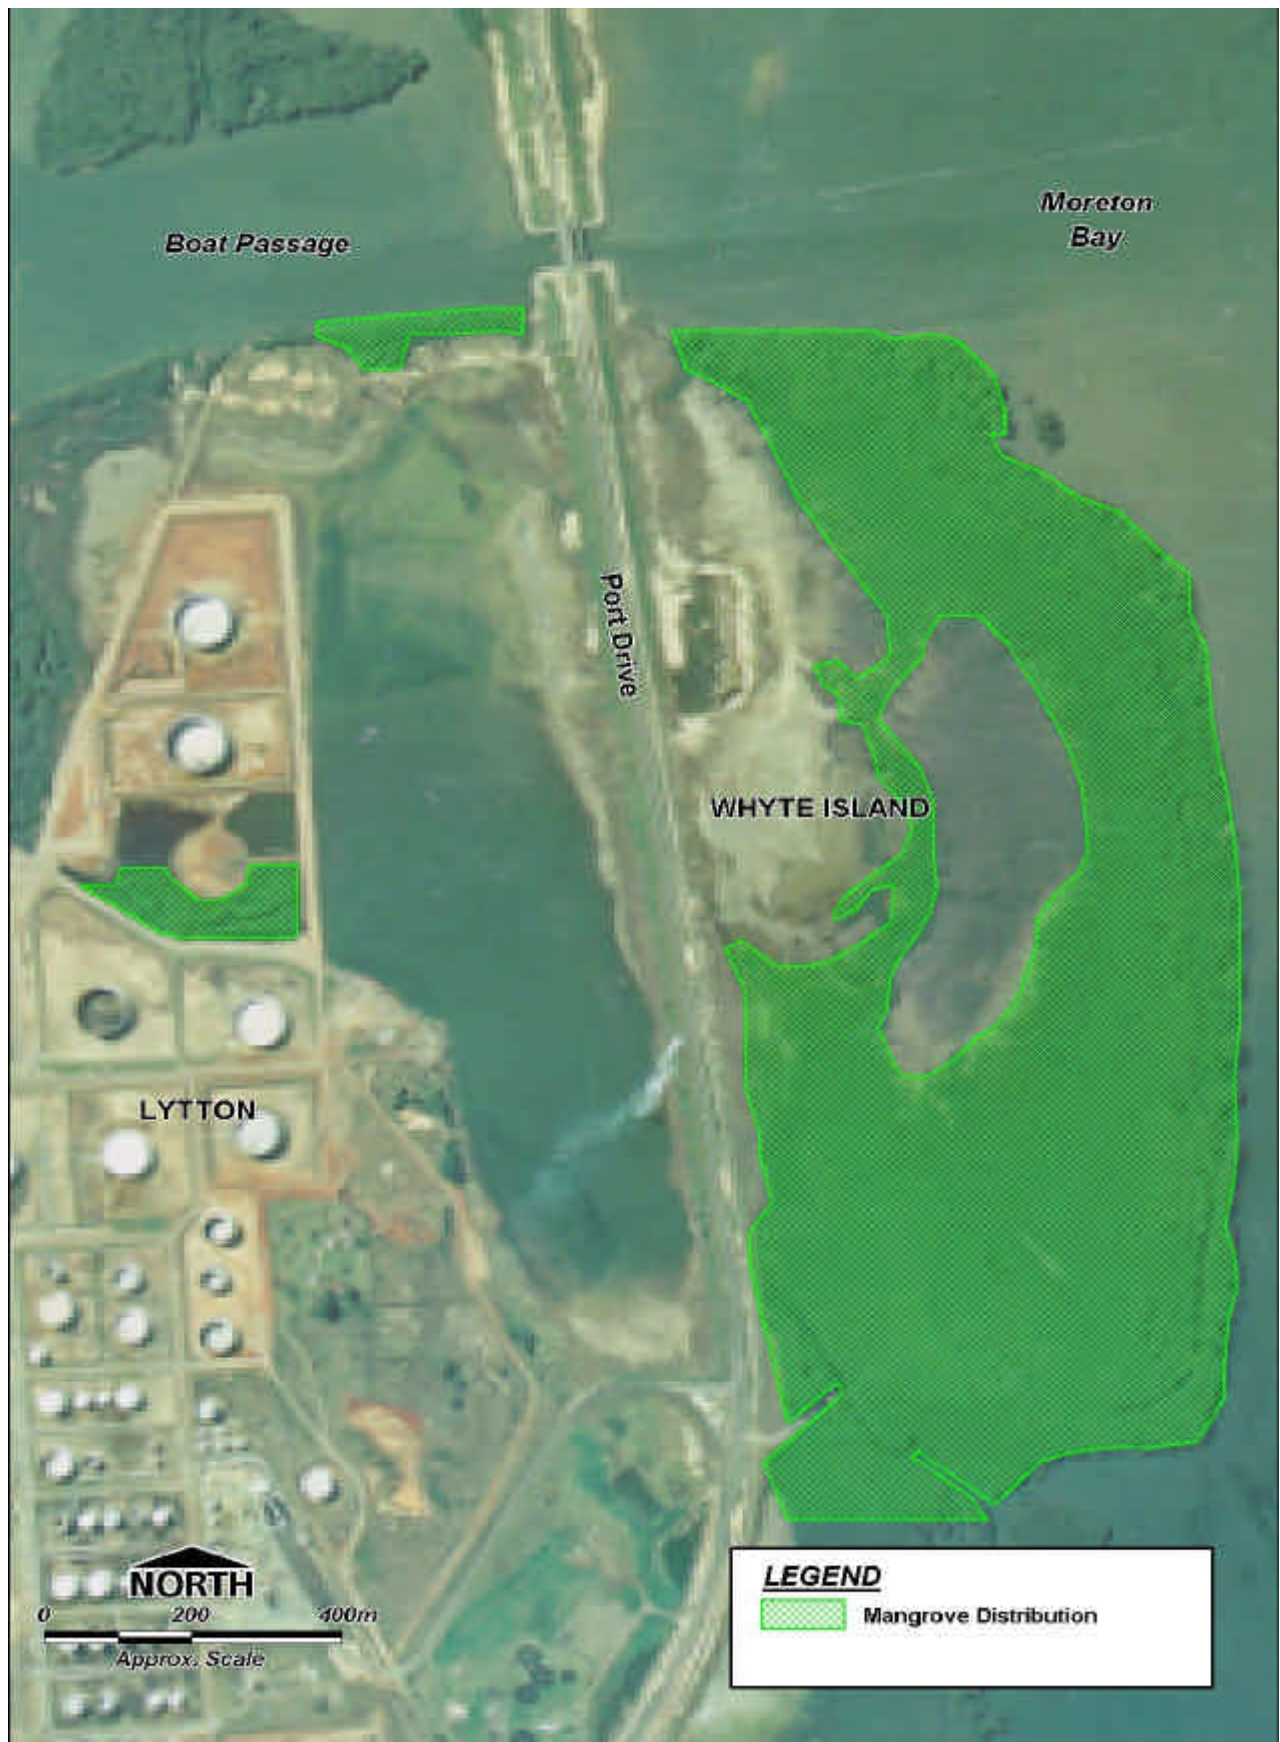
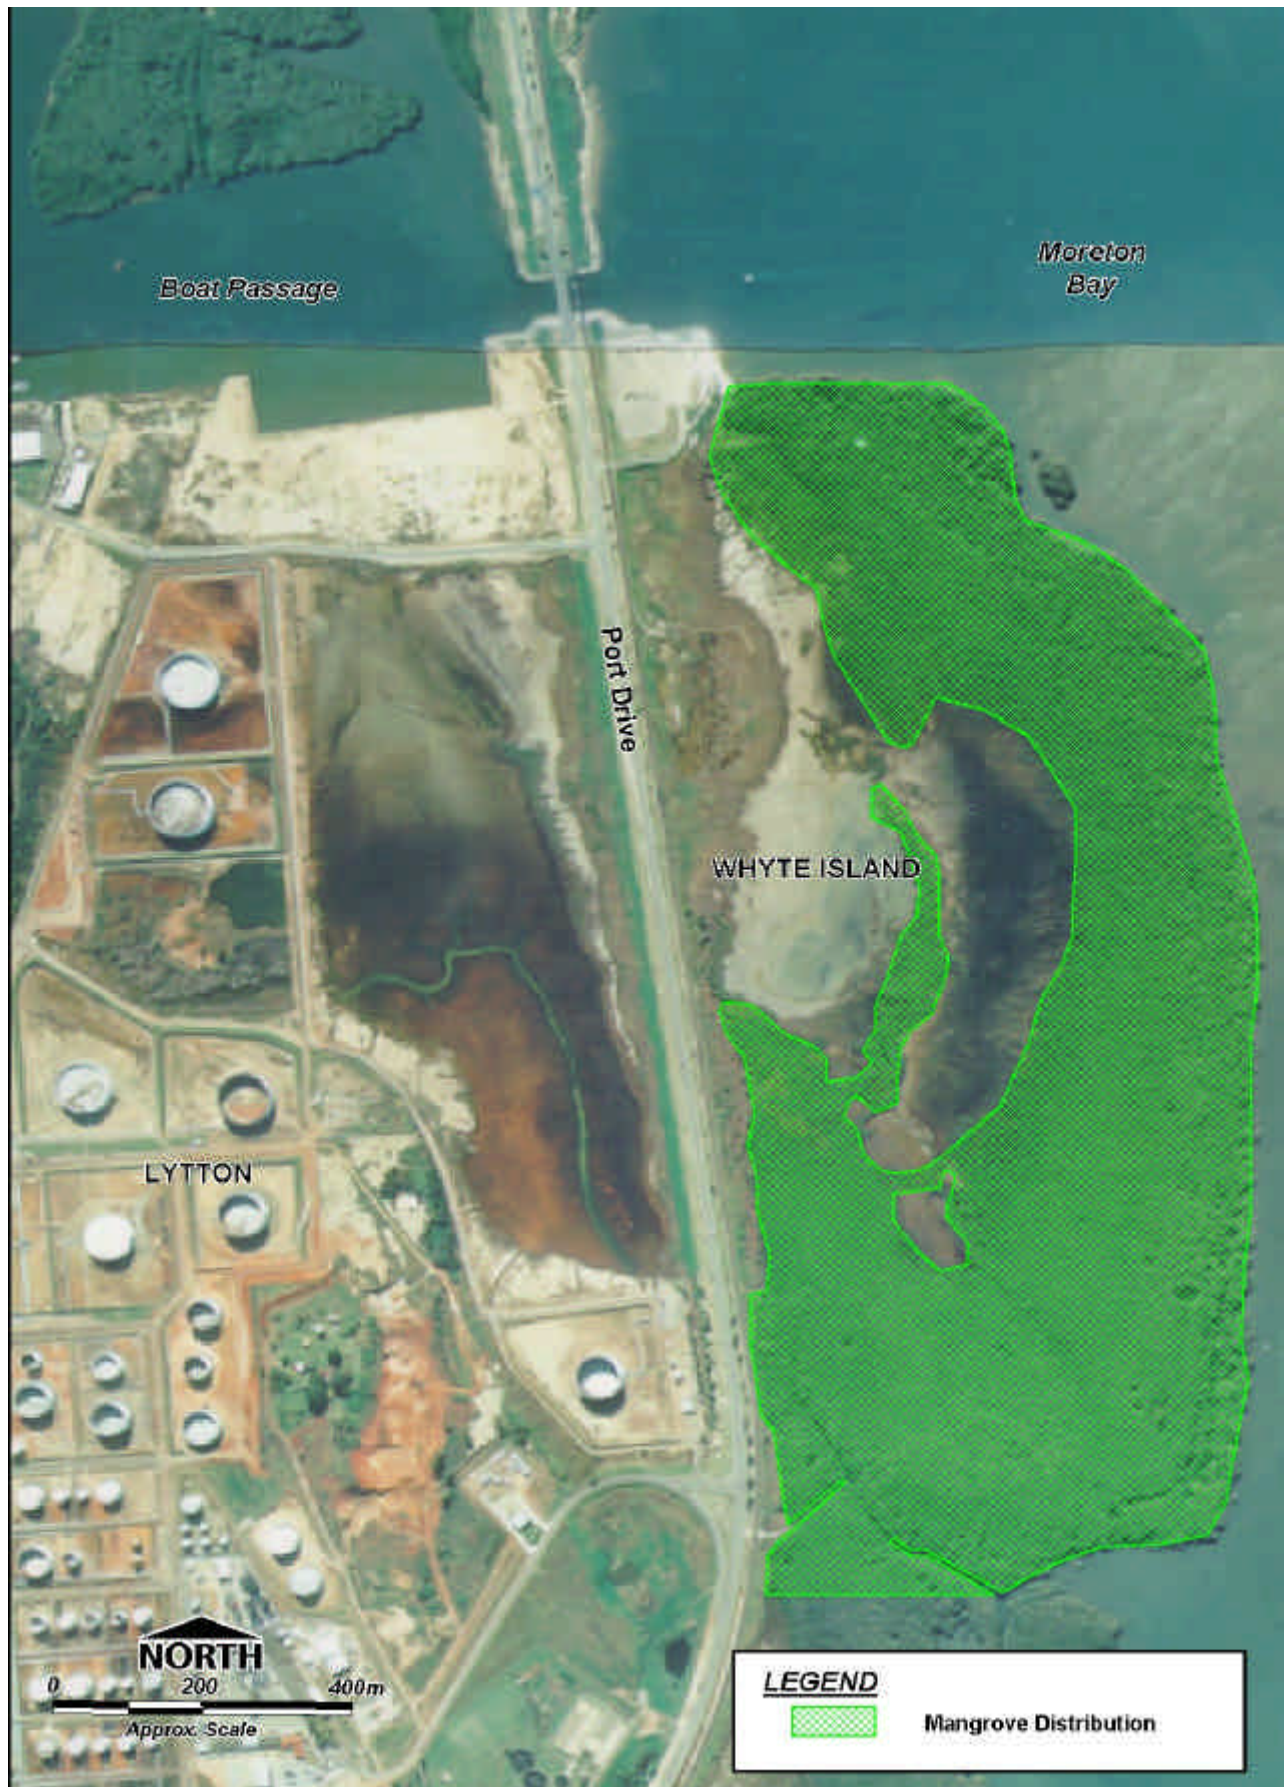
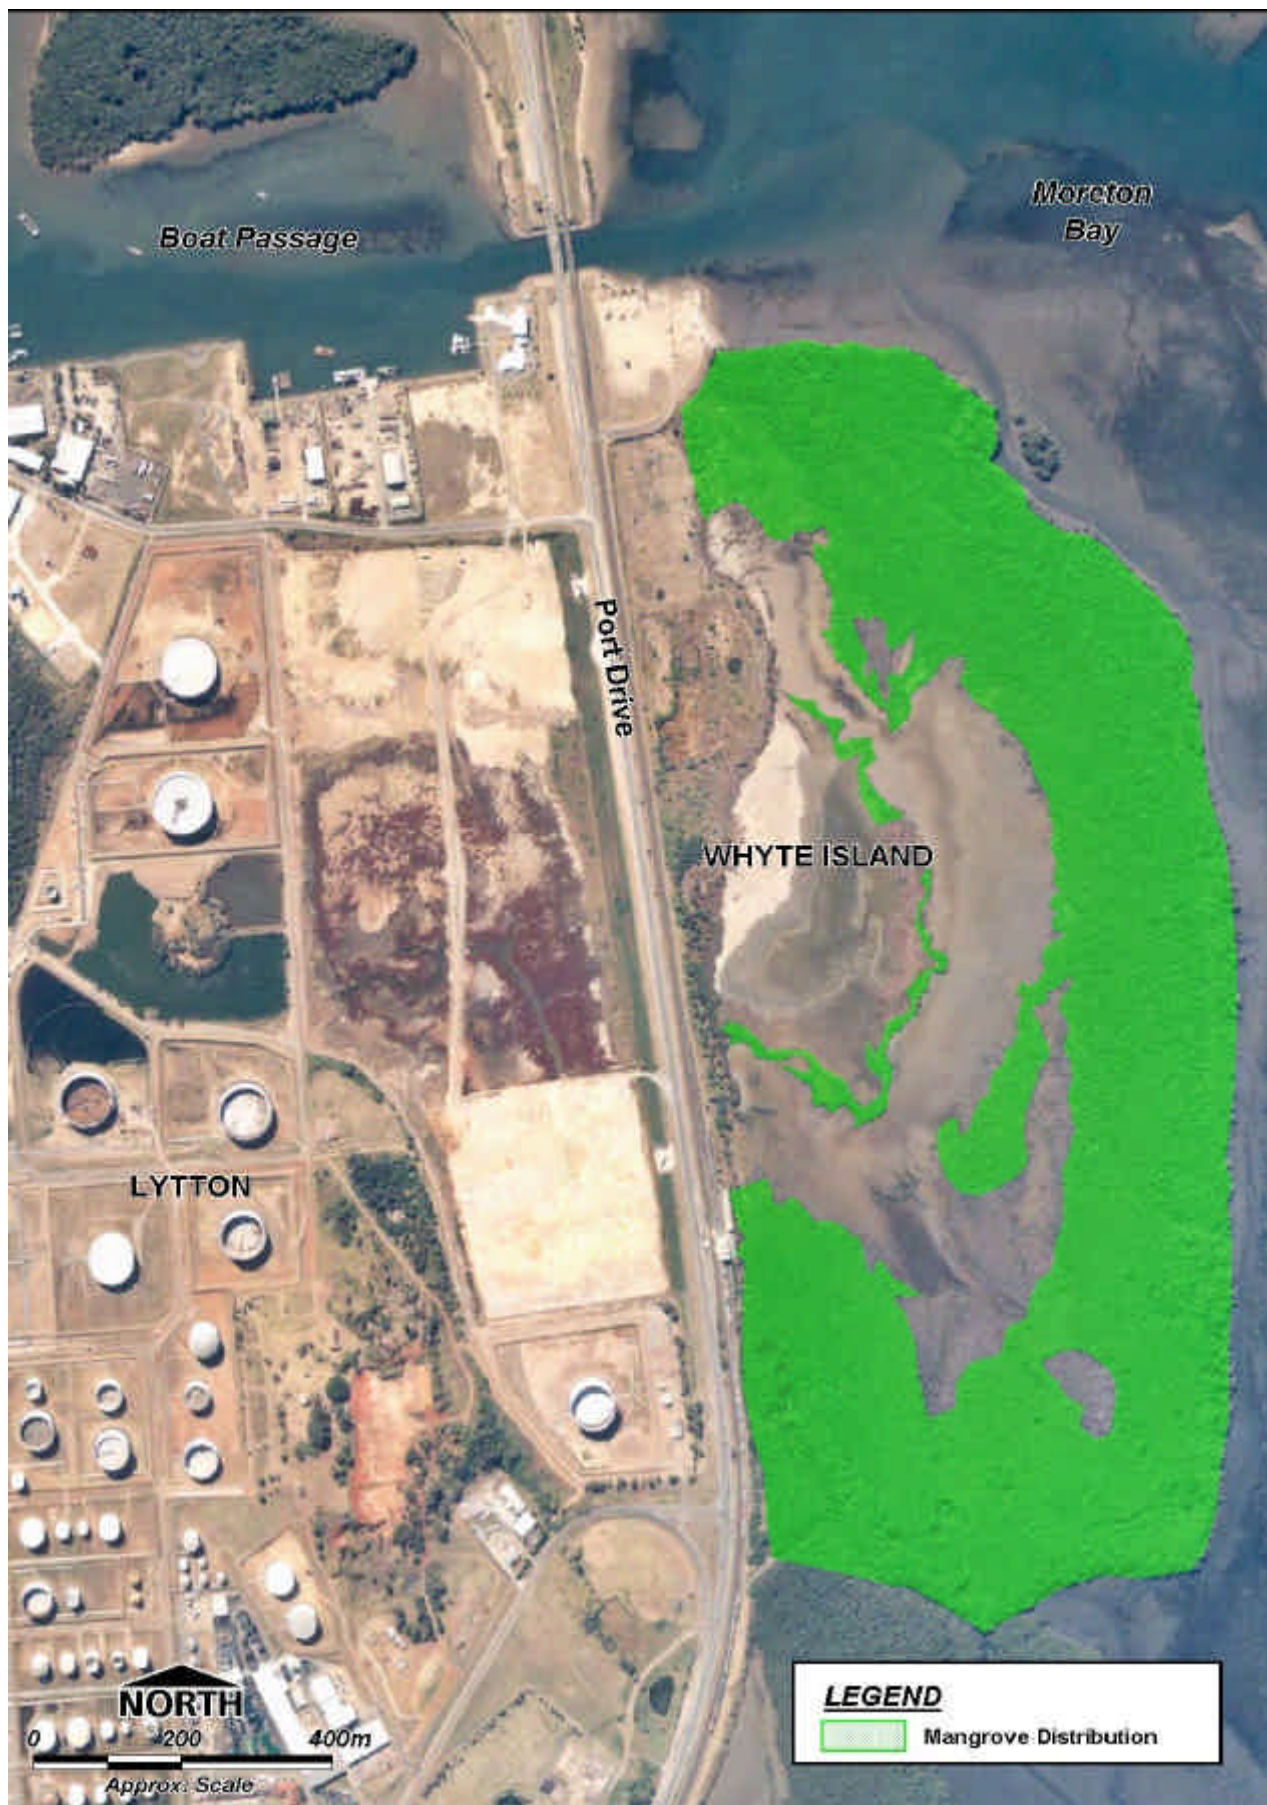
The Whyte Island area has undergone significant changes as a result of the development of Port Drive, the major access to the Port of Brisbane facility as evident in the series of photographs shown in Figure 3.2 to Figure 3.6.

Between 1972 and 1978 Port Drive was constructed linking Whyte Island and Fisherman Islands via a bridge across the Boat Passage. Expansion of the Oil Refinery to the west of Port Drive also occurred during this period. By 1991 major changes had occurred at the north-western end of Whyte Island for the construction of facilities such as the Port of Brisbane Operations Base, tug berths and the Water Police base. The 2002 photo shows the completed Queensland Rail Refuelling Depot at the southern end of Whyte Island and the ongoing development of the land immediately west of Port Drive.

Figure 3.2 Whyte Island mangrove distribution - 1972

Figure 3.3 Whyte Island mangrove distribution – 1978

Figure 3.4 Whyte Island mangrove distribution – 1983

Figure 3.5 Whyte Island mangrove distribution – 1991

Figure 3.6 Whyte Island mangrove distribution – 2002

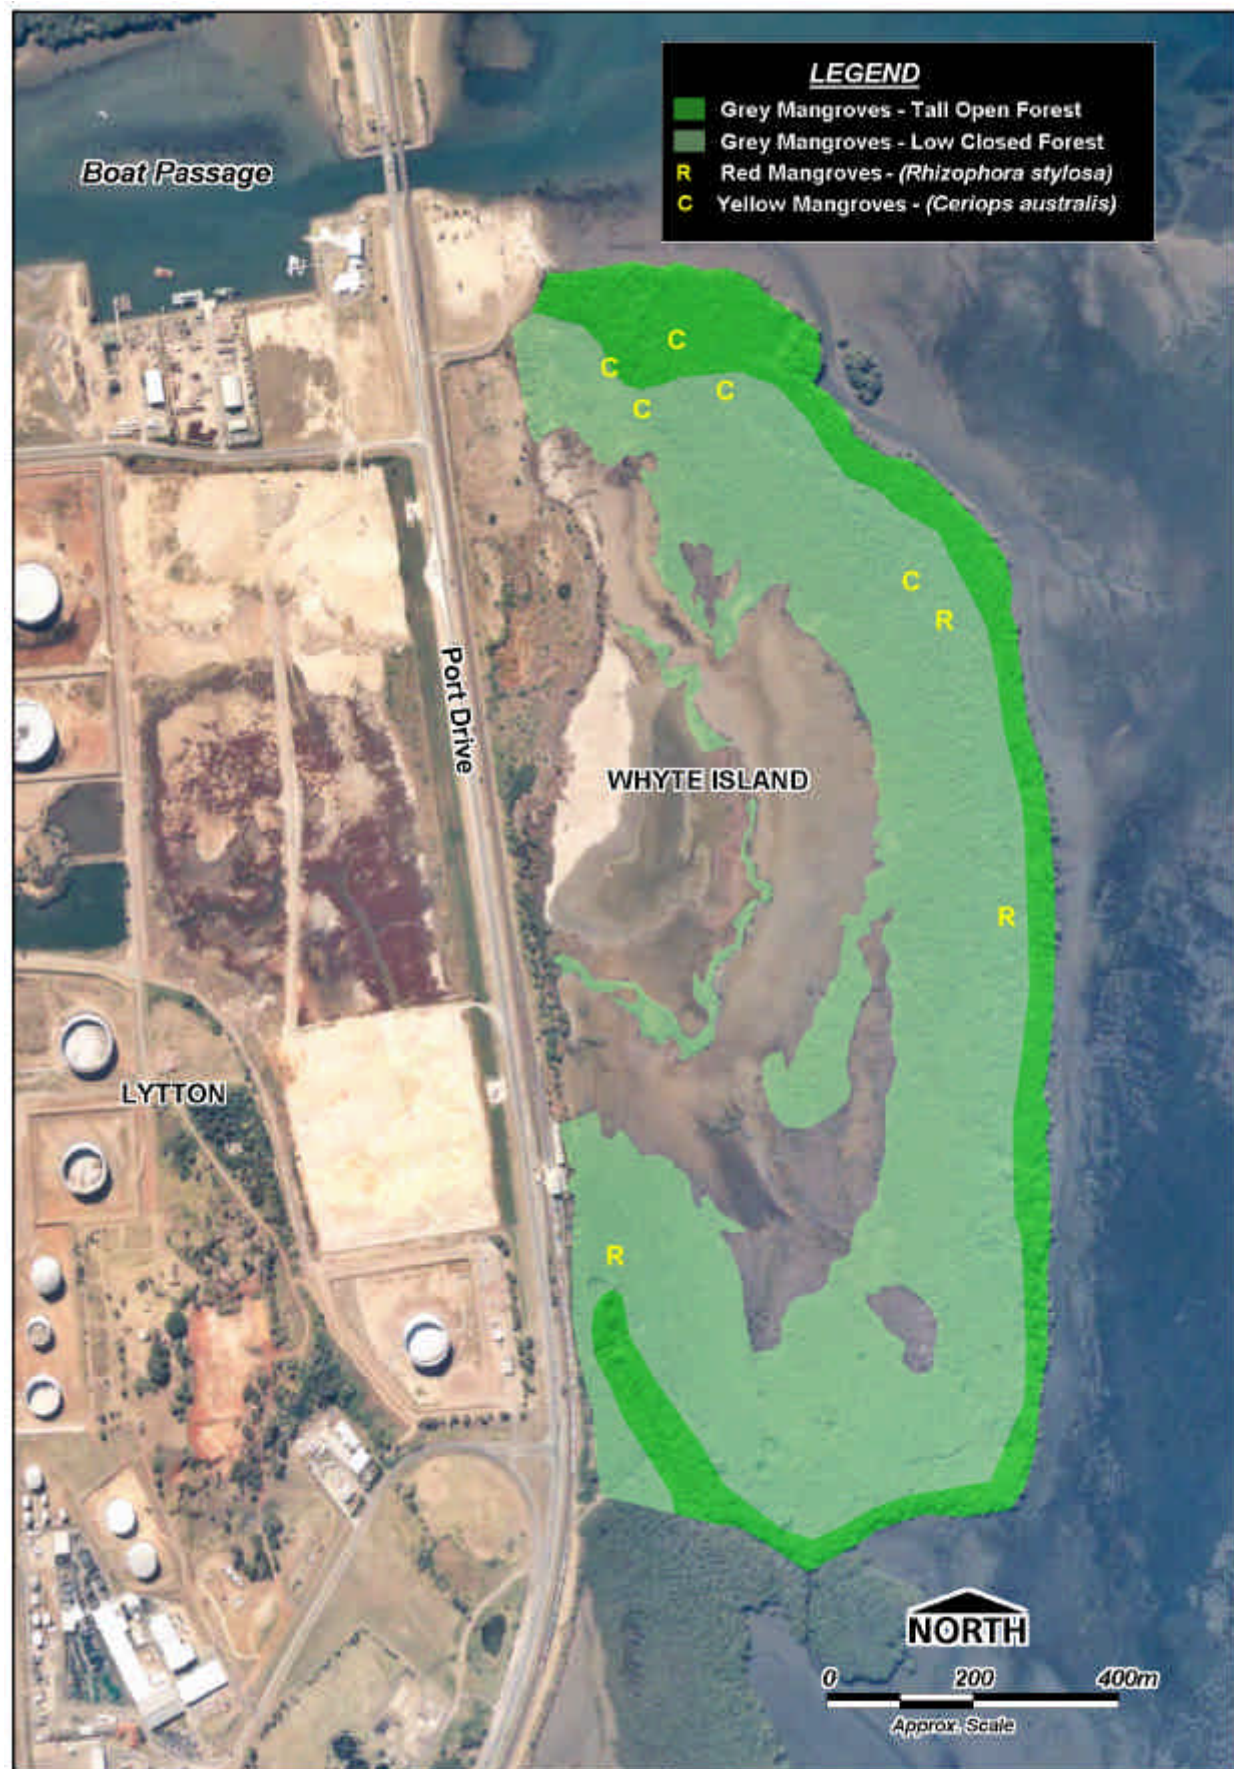
Figure 3.7 Species Distribution of Mangroves at Whyte Island – 200

Figure 3.7 shows the distribution of mangrove species throughout the study area. *A. marina* was the most abundant species at Whyte Island, both in terms of areal extent and number of individuals. *C. australis* was found at the northern end of the study area and isolated patches of *R. stylosa* occurred mainly on the seaward fringe of the mangroves, primarily along small creeks and drainage lines.

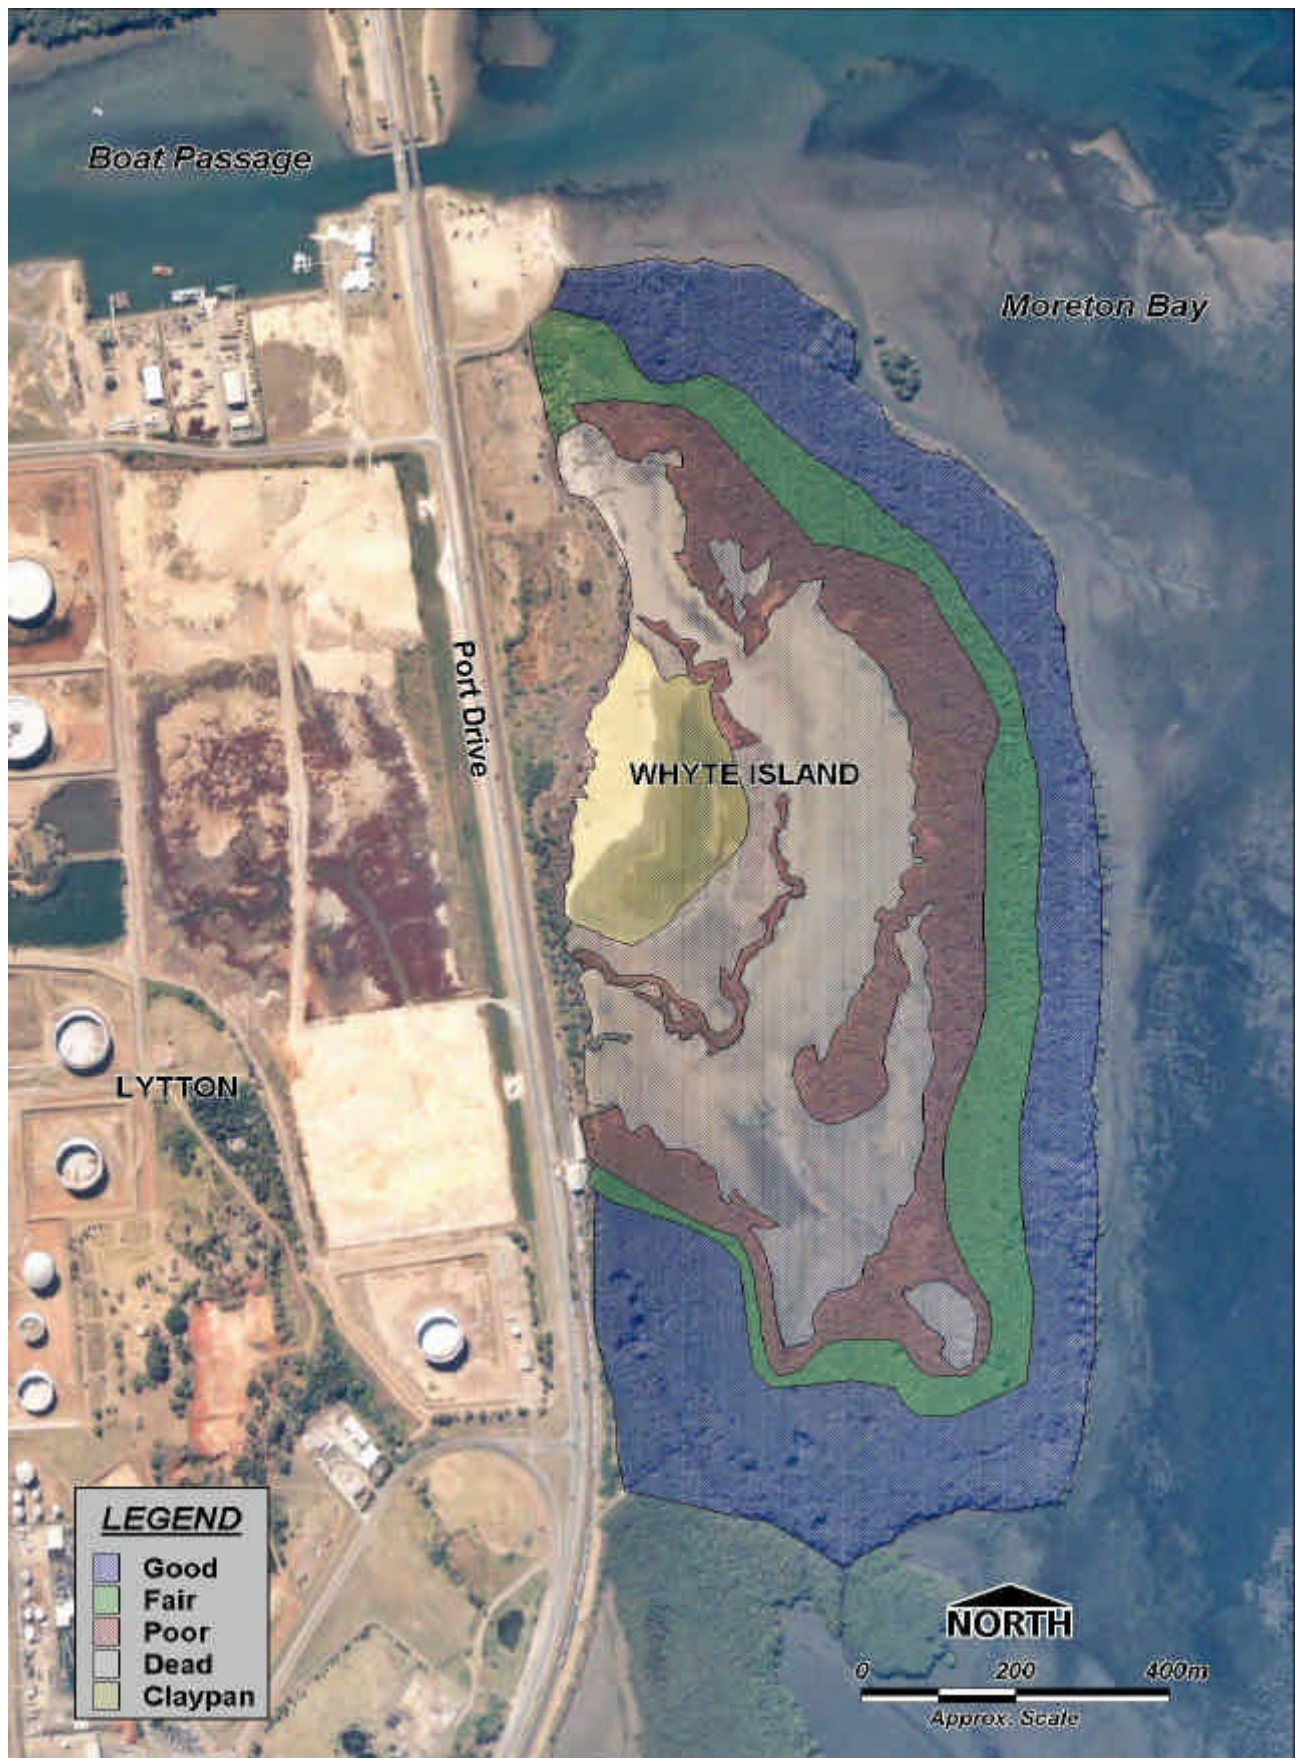
Figure 3.8 Mangrove Health at Whyte Island - 2002

Figure 3.8 shows the distribution of mangrove health classifications at Whyte Island in 2002. The area of mangroves within each classification is presented in Table 3.5.

CATEGORY	Area in ha (proportion of total study area)
Good	31.6 (32.6%)
Fair	13.7 (14.2%)
Poor	18.5 (19.2%)
Dead	26.6 (27.5%)
Bare/claypan	6.3 (6.5%)
TOTAL	96.7 ha

There was a distinct zonation evident in the health classification of the mangroves of Whyte Island. Mangroves around the perimeter of the community were in good condition, while in the middle of the island a large area of dead mangroves was mapped. This dieback had occurred over a prolonged period, and the existence of a zone of stressed mangroves adjacent to the dead area indicates that the impacting process/es is ongoing. Approximately 50% of the remaining mangroves are exhibiting signs of stress.

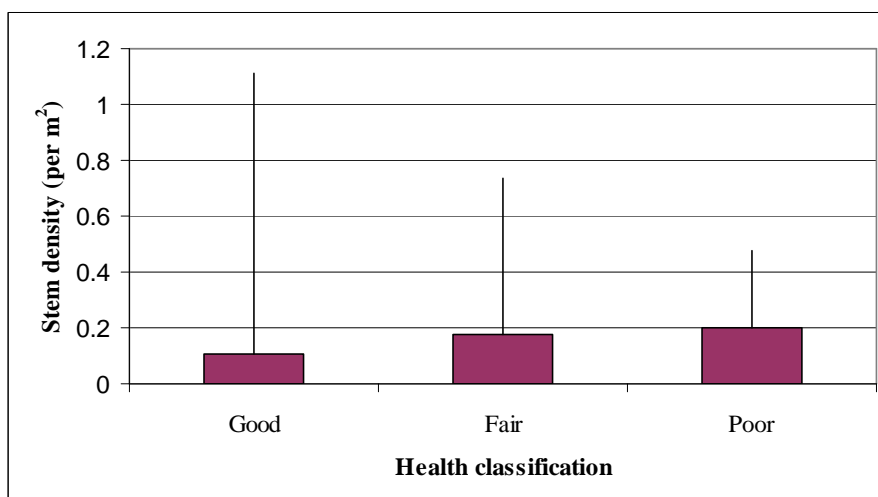
Figure 3.9 Average Mangrove Stem Density for Each Health Classification

Figure 3.9 shows the average stem density for each health classification. Mean stem density appears to be highest in mangroves classified as Poor, however no statistically significant difference between categories is evident due to the high degree of variability.

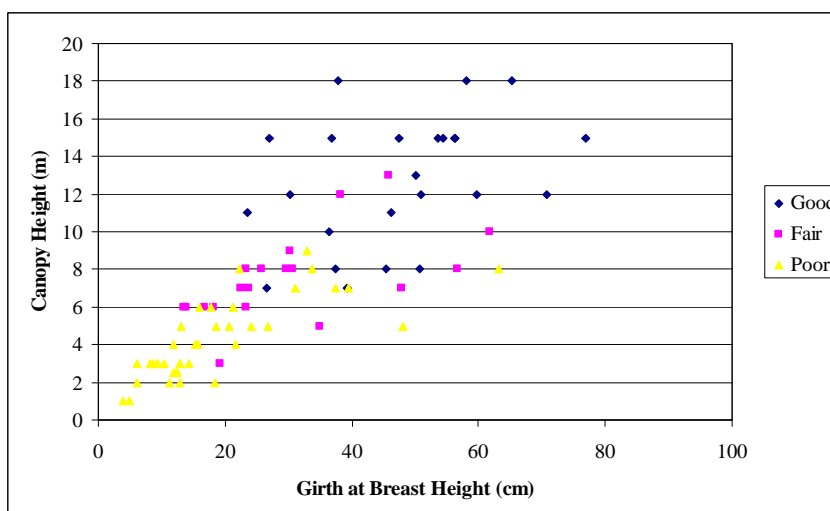
Figure 3.10 Average Girth at Breast Height and Canopy Height of Mangroves at Whyte Island

Figure 3.10 shows the relationship between Girth at Breast Height (BGH) and canopy height for mangroves within each health classification. The trend of canopy height increasing approximately linearly with GBH up to a GBH of 65 cm is consistent with that reported for other mangrove communities in the region (Mackey and Monsur 1994; WBM 2002).

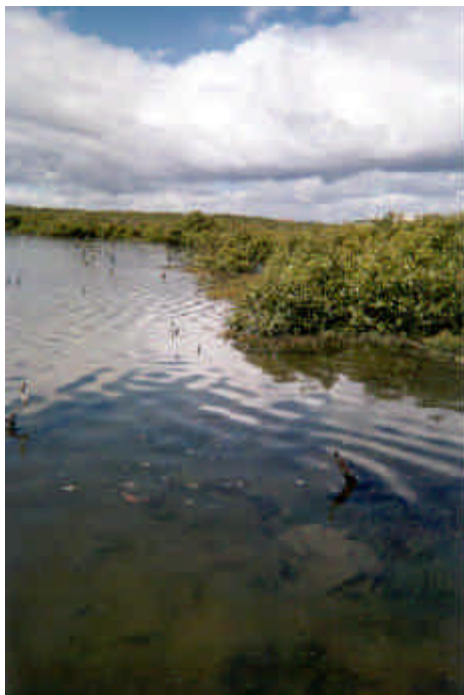
At Whyte Island, effluent from the Wynnum Waste Water Treatment Plant (WWWTP), which began operations in the mid 1960's, flows into the creek that originally separated the island from the mainland. In the construction of Port Drive, this creek was filled in along almost its entire length with only a 50m stretch remaining at the southern (downstream) end. This infilling reduced the tidal prism of the creek and hence decreased flushing and tidal exchange at the point where the outfall flows into the creek. This would have resulted in the concentration of nutrients within the creek with tidal flushing reduced but nutrient inputs maintained (or possibly increased as a result of the increasing population).

Algal blooms are likely to have occurred under these conditions (high nutrients and reduced tidal exchange) resulting in the same impacting process evident at Luggage Point. That is, ponded areas developing as a result of drainage lines being blocked by algal mats. In this process, mangrove dieback would not necessarily commence close to the outfall. Decaying algal mats are likely to have been washed into the centre of Whyte Island on large tides and gradually accumulated around mangrove roots and in drainage lines, eventually resulting in areas becoming separated from the normal flow paths with water unable to drain away during each tidal cycle. Thick algal mats were observed in the degraded areas at Whyte Island (Figure 4.1 and Figure 4.2).

Figure 4.1 Loose algal mat

Rehabilitation works are unlikely to be successful, in this or any other case, unless existing impacting processes are removed. For example, the Luggage Point Rehabilitation works were not undertaken until nutrient inputs were reduced as a result of upgrades to the Luggage Point Treatment Plant and improved solid waste management. It is recommended that investigations into reducing nutrient outputs from Wynnum WWTP be carried out prior to undertaking any rehabilitation works.

Advantages: Reinstatement of tidal flushing to degraded areas is likely to bring about a rapid increase in mangrove health. The area contains an abundant supply of parent stock material and adequate recruitment is likely. By draining the ponded areas, the areas of suitable mosquito breeding habitat would also be reduced.
