Assessment of the Health and Viability of the Mangrove Communities at Whyte Island

Prepared For: Port of Brisbane Corporation

Prepared By: WBM Oceanics Australia

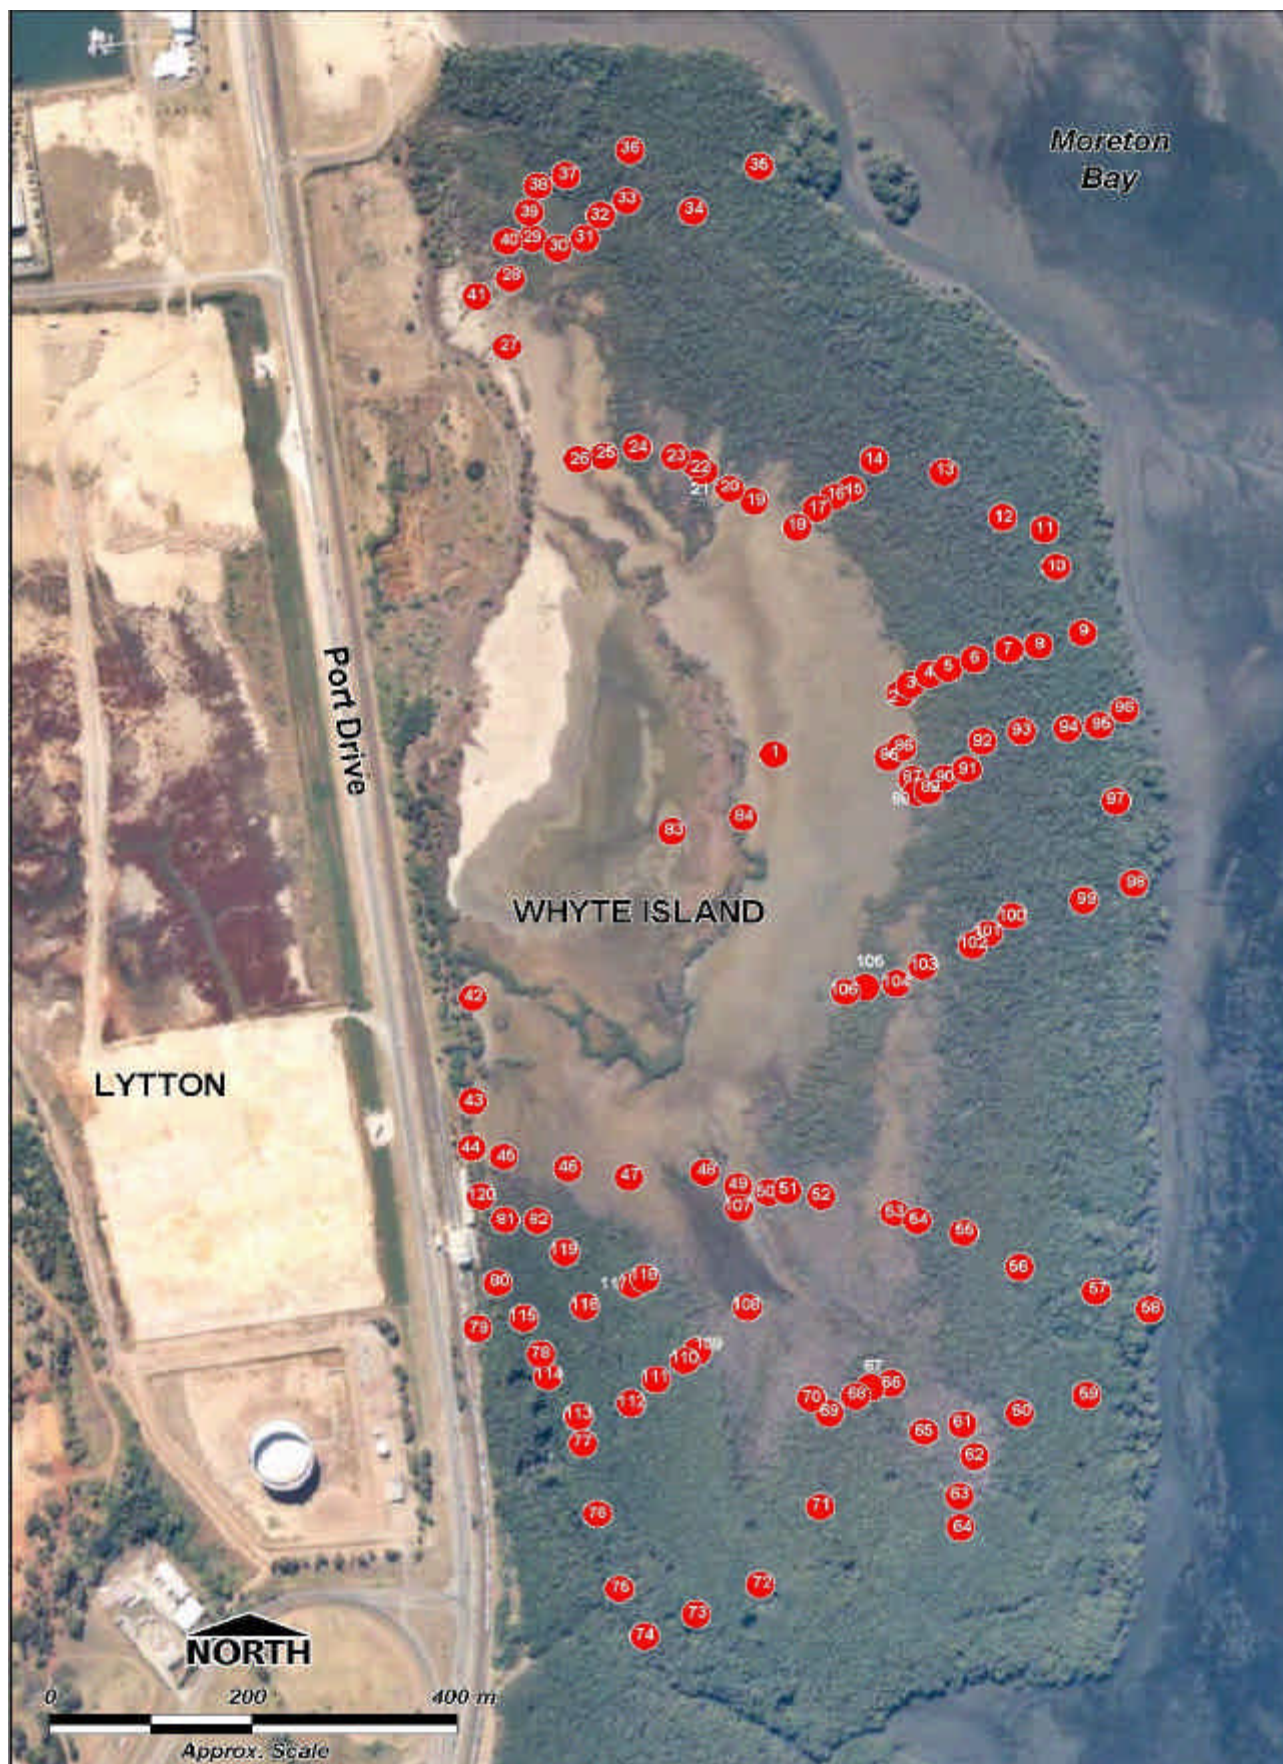
Figure A-1 Whyte Island Survey Points

A survey of the study area was undertaken between March and May 2002, over a total of 13 days. The study area was traversed on foot notionally following eight transects running perpendicular to Port Drive (that is, approximately north-east). Assessments were made at approximately 50m intervals, with more frequent observations made in dense areas and/or those containing changes in

The location of the measurements was recorded using a differentially corrected GPS, providing a horizontal accuracy of $\pm 1\text{m}$. The GPS was also used to navigate along each transect. Deviations were made from the predetermined route in response to field conditions (such as especially soft sediments) and/or the presence of features of interest. The boundaries of vegetation communities along each transect were also recorded to ground truth the vegetation maps produced from the aerial photographs. The coordinates of each assessment site are listed in APPENDIX A:, which also shows a map of the points overlayed on the 2002 aerial photograph.
