# **Turbidity Monitoring of Bed Levelling Operations – Brisbane River**

Prepared For: Port of Brisbane Corporation

Prepared By: WBM Oceanics Australia

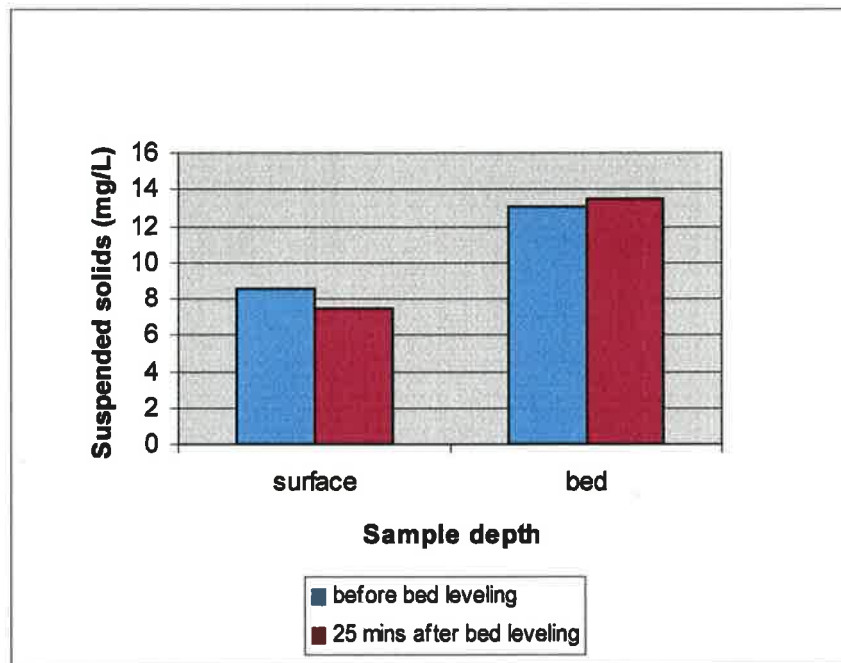
**Figure 3.4 Concentrations of Suspended Solids Before and After bed levelling operations**

Aerial photography (refer to Plate 2) taken prior to bed levelling did not indicate any significant visible turbid water plumes offshore from the face of the wharf at the surface. The analysis of water samples yielded a corresponding low range of suspended solids. The suspended solids were 7 to 10 mg/L near the water surface (1 m depth) and 12-14 mg/L adjacent to the bed (9 m depth).

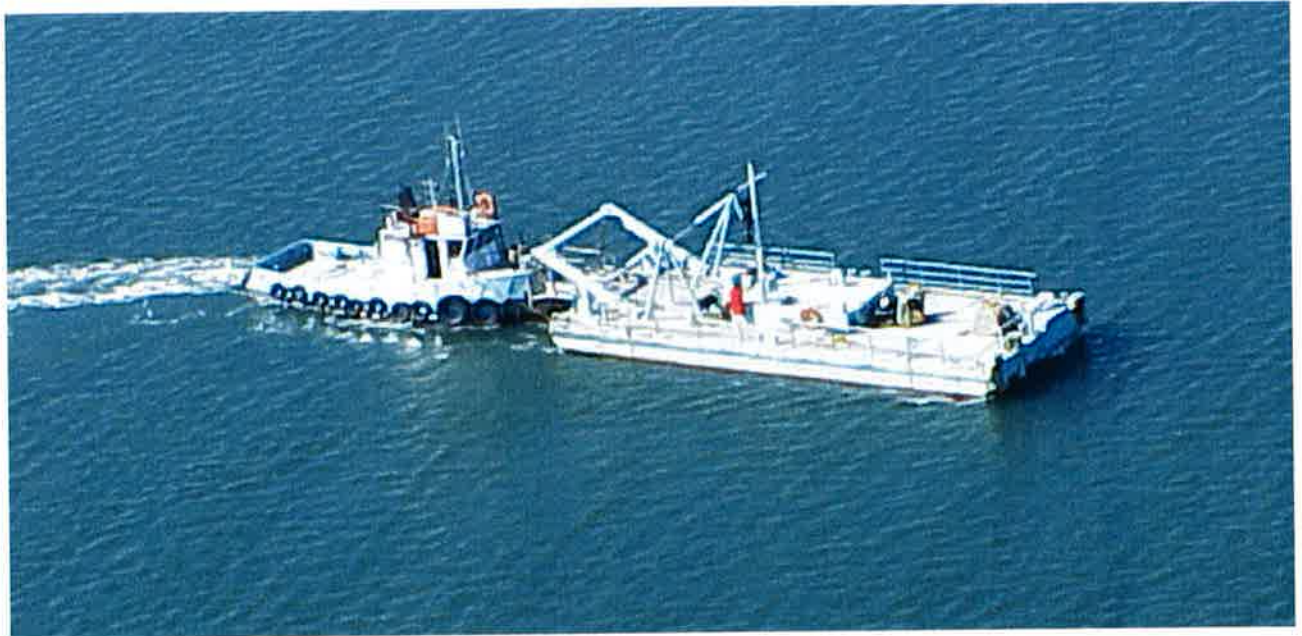
**Plate 1: Tug *Seahorse* and bed levelling barge. The bed-levelling blade is deployed from the gantry at the stern of the barge.**

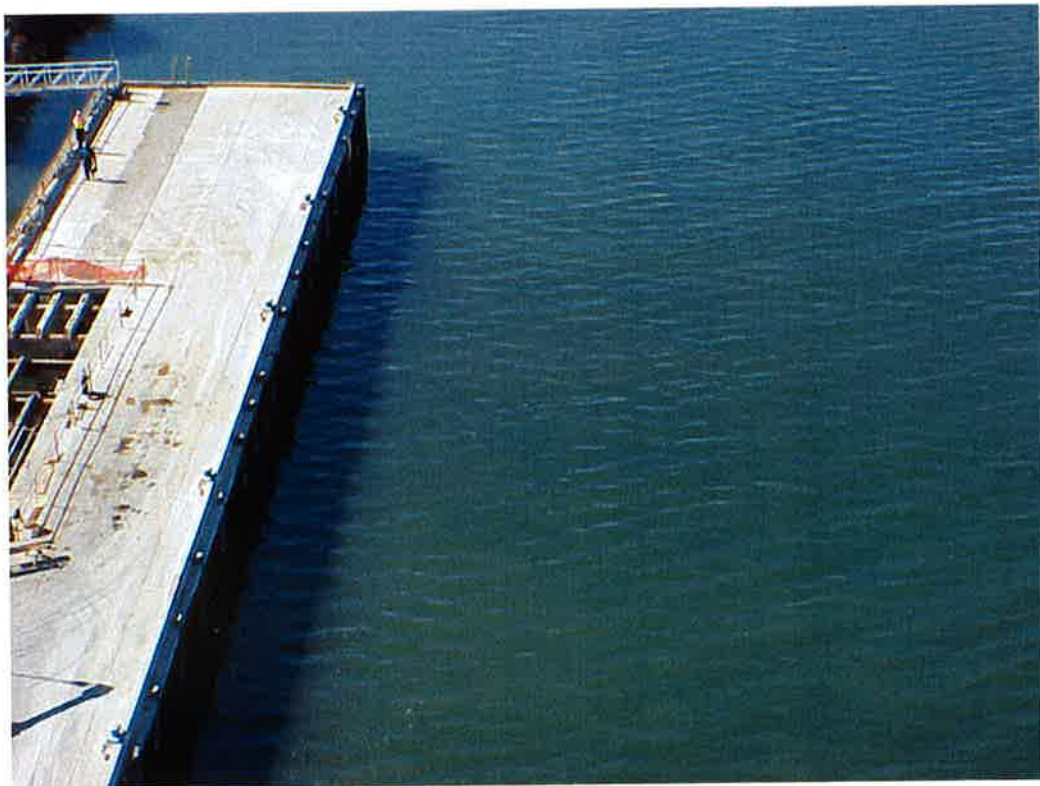
**Plate 2: Baseline turbidity conditions adjoining the Incitec North Wharf prior to bed levelling operations.**

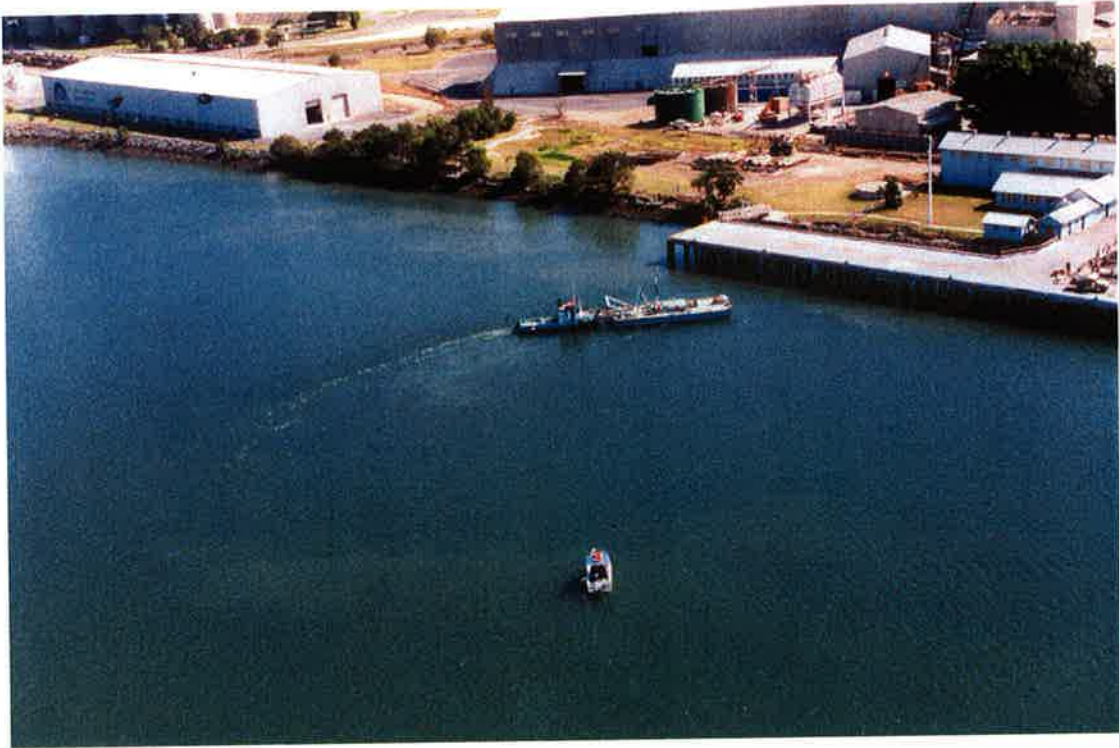
**Plate 3: Bed levelling equipment in operation at the Incitec North Wharf. The bed leveller is preparing to start another pass (the 6<sup>th</sup>) along the face of the wharf, heading into the flood tide current. Note that the spatial extent of the plume created by previous bed levelling passes is relatively small (approximately 4 vessel lengths long).**

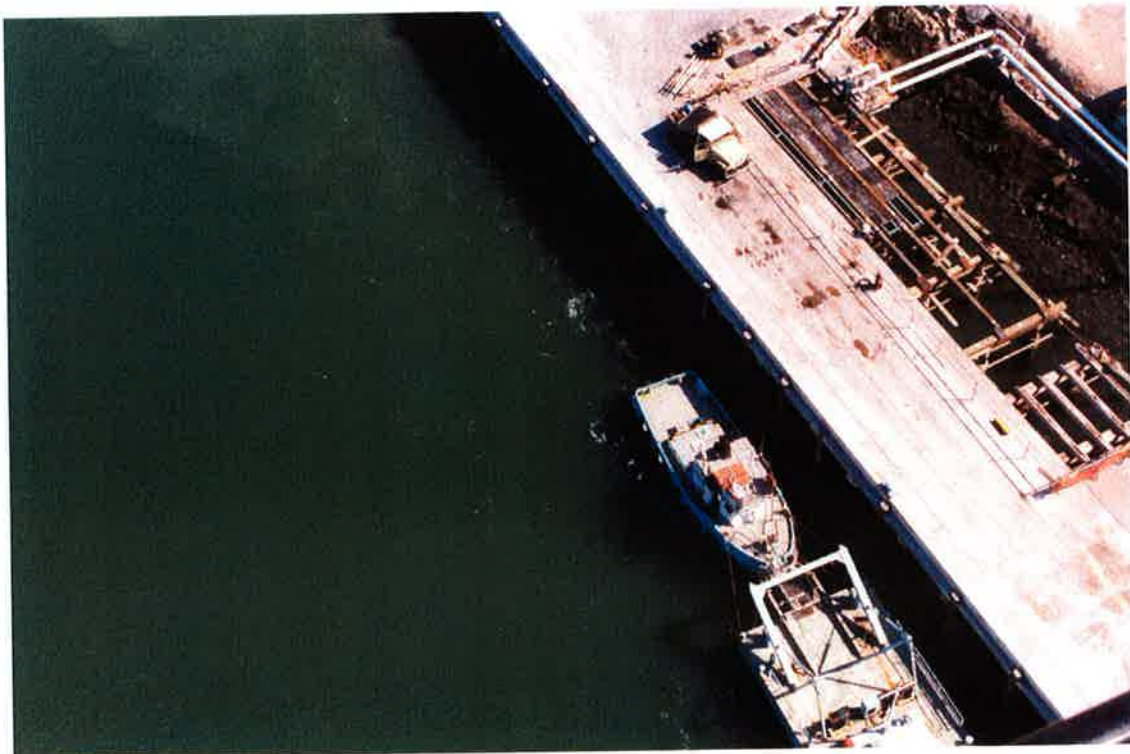
**Plate 4: Overhead view of the bed leveller in operation along the wharf face. Visible surface plume appears approximately 20m astern of the *Seahorse*.**

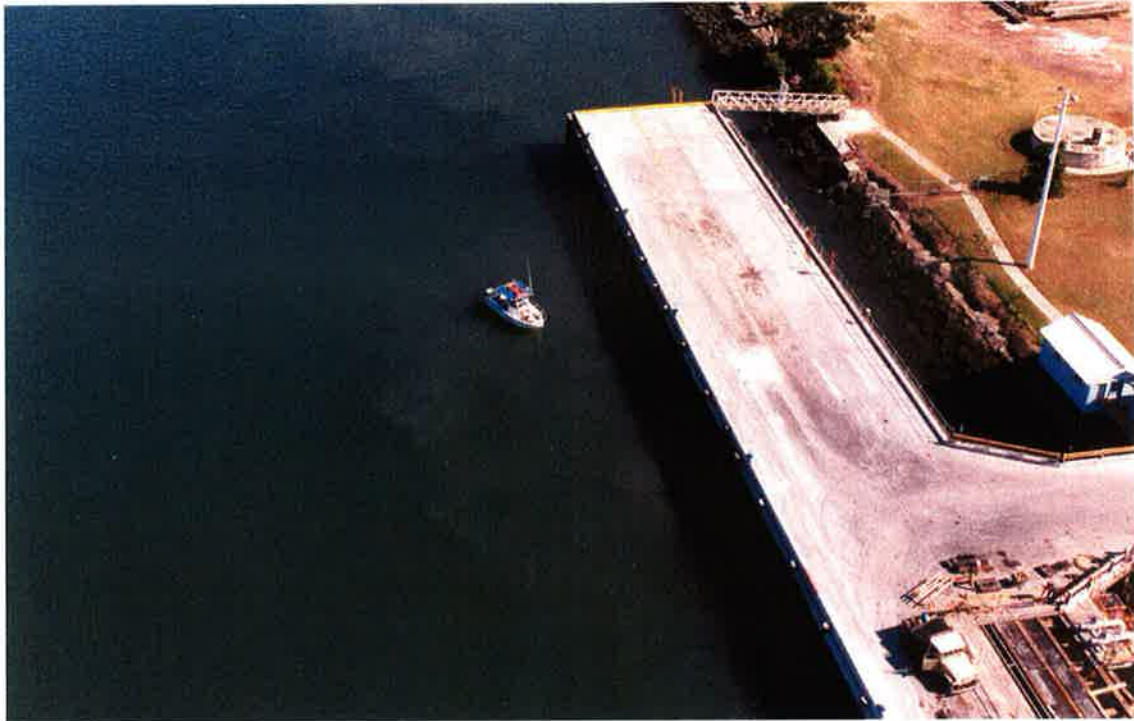
**Plate 5: Survey vessel traversing through turbid plume created by bed levelling operations.**

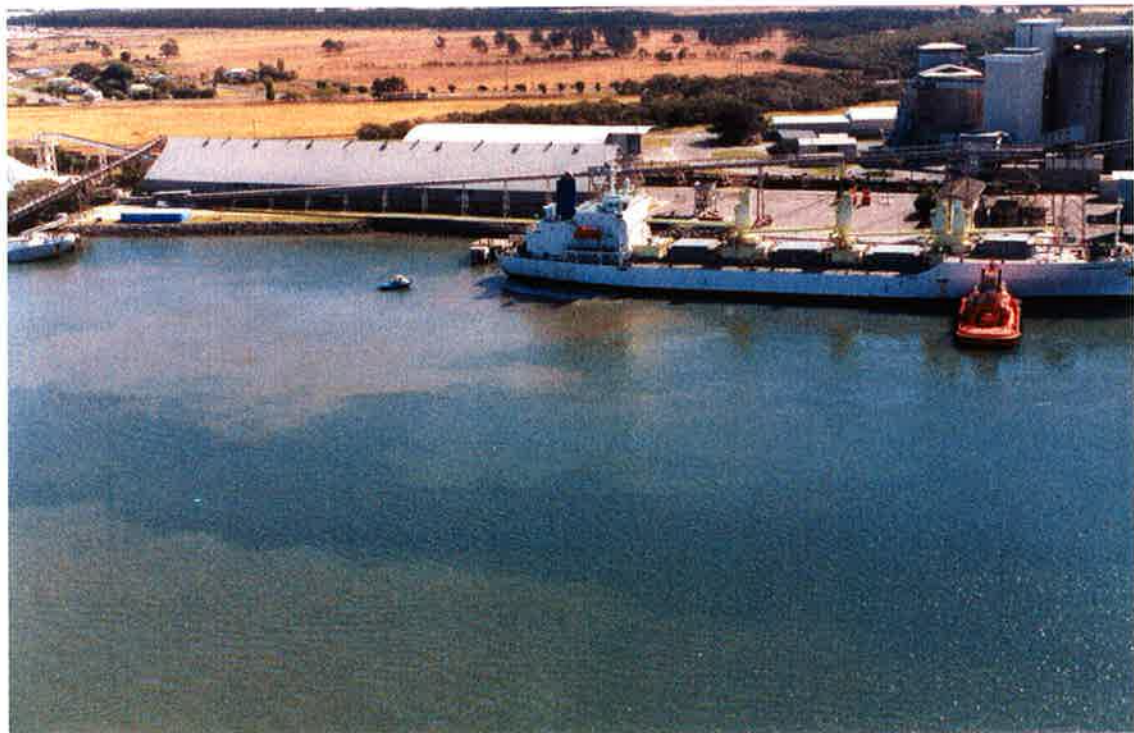
**Plate 6: Shown for comparative purposes, the turbid plume created by ship berthing operations at the Pinkenba Bulk Wharf, just upstream of the Incitec North Wharf. Note the turbidity and the extent of the plume were much greater than that associated with bed levelling operations. Plume in foreground of photo was associated with the turning of the ship head to sea, prior to berthing.**

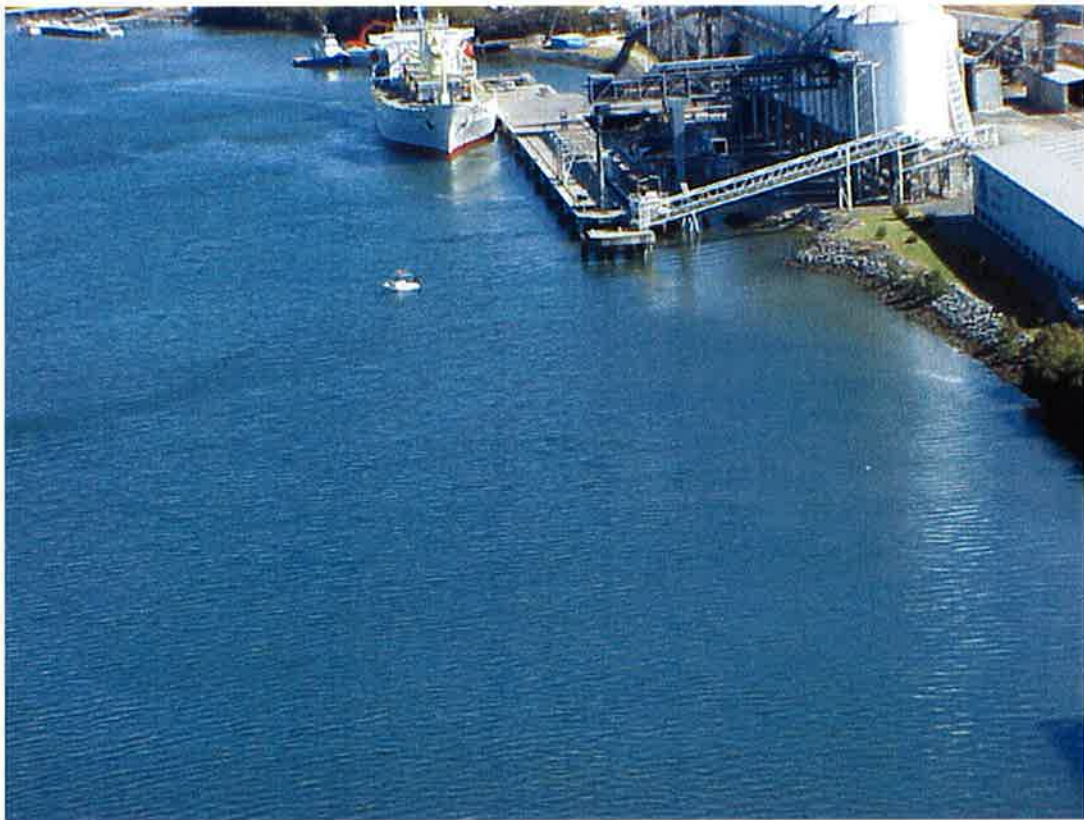
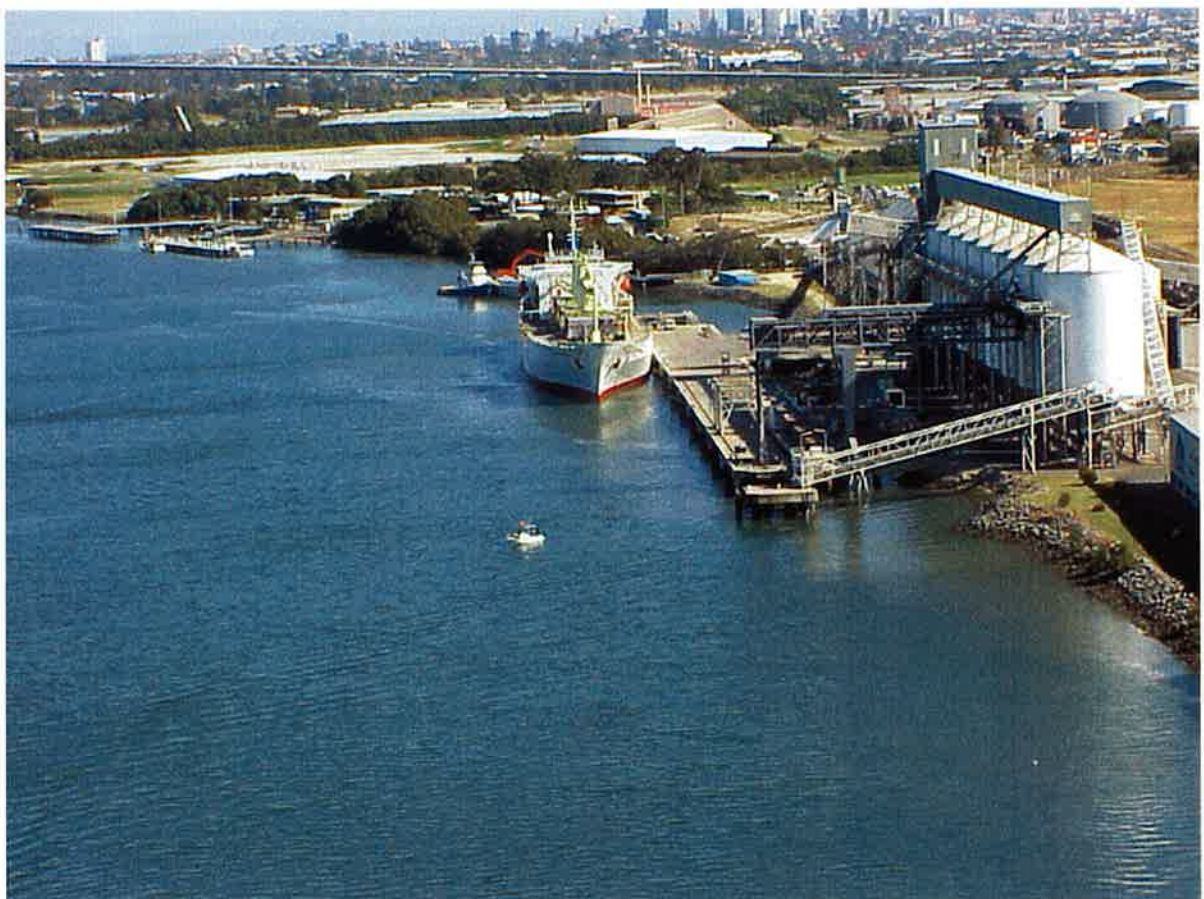
**Plate 7 and Plate 8: Looking upstream to survey vessel, just after removal of the plume-indicating drogue. Photos were taken approximately 25 minutes after the**

conclusion of bed levelling operations. Drogue was removed from the water column close to the Pinkenba bulk wharf. Note the general absence of visible surface plumes. The plume evident in shoal water adjoining the wharf was not due to the bed leveller but to an outflow of sediment-laden water from the drain located between the wharfs (Refer to Plate 9).

As illustrated in Plate 7 to Plate 9, a visible plume of turbid water was evident in shoal water close to shore just downstream of the Pinkenba Bulk wharf. This plume was not related to the operation of the bed leveller, but was due to a drain discharge located approximately 100 m downstream of the Pinkenba Bulk Wharf.

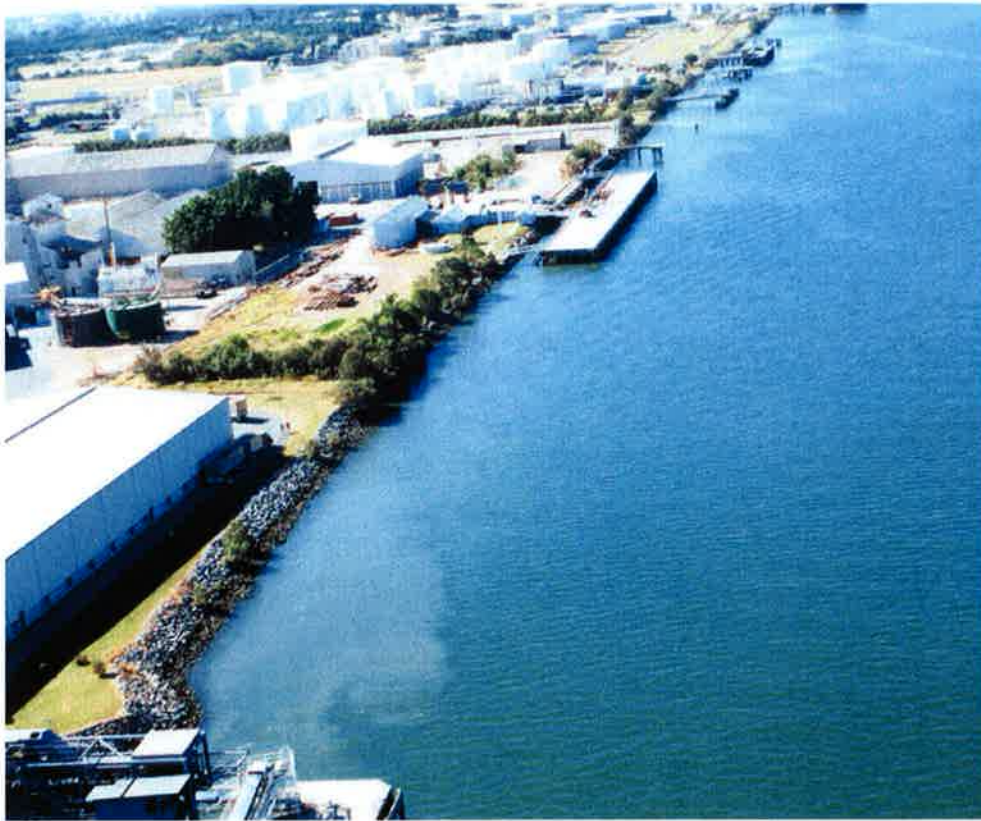
**Plate 9: Photo looking downstream from the Pinkenba Bulk Wharf. Turbid plume in shoal water close to shore, downstream of the Pinkenba Bulk Wharf, is associated with a drain discharge and not the bed levelling operations. Drain is located at the mangrove line shown in centre of photo.**

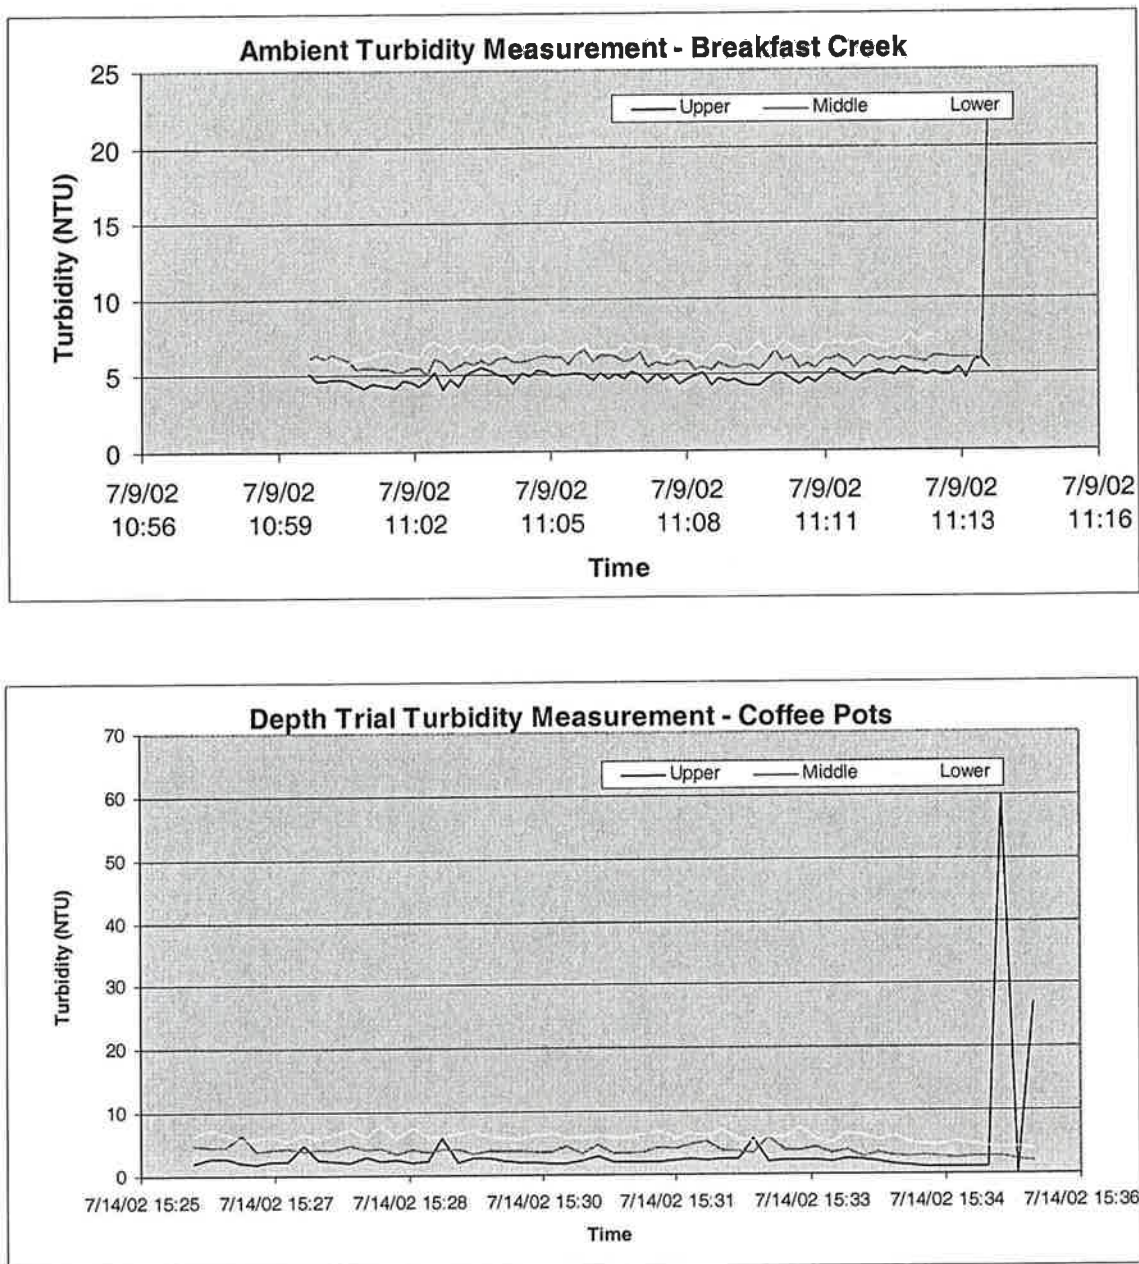
Once configured as towfish on the weighted line, the sensors were field tested to check their orientation and operation during slow speed towing at the depths required for the project. This trial was conducted in Moreton Bay within the Port of Brisbane entrance channel adjoining the Coffee Pots. The results from each field test are shown below in **Error! Reference source not found.**

Figure B. 1 Field Test Results for the Turbidity Sensors.
