Mangrove Health Assessment: 2014 Monitoring Results

Reference: R.B20259.007.01.MangroveHealth2014.docx

Prepared for: Port of Brisbane Pty Ltd

Prepared by: BMT WBM Pty Ltd (Member of the BMT group of companies)

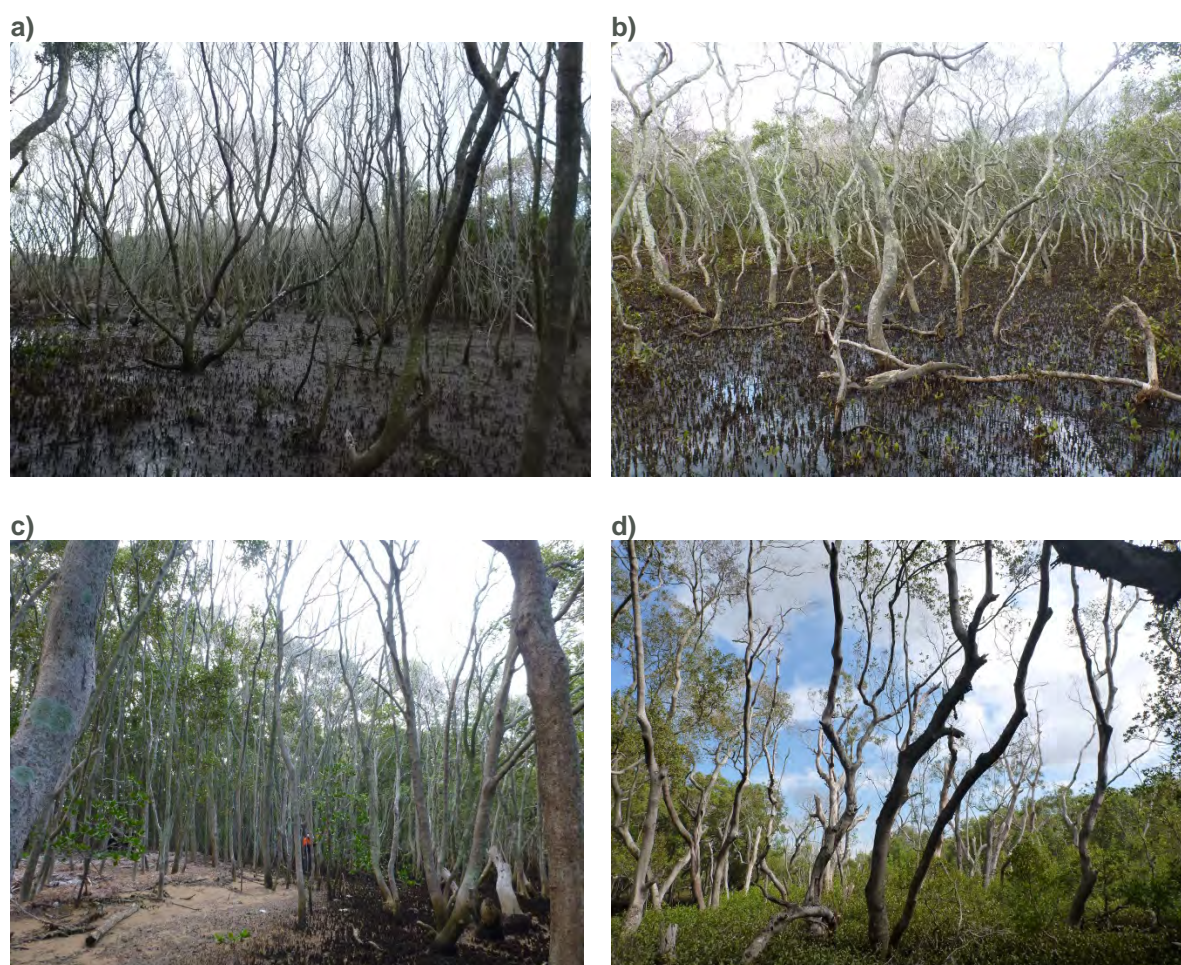
New areas of mangroves in poor condition were observed on both the outer eastern (Figure 3-6) and western boundaries of the Coal Loading Area, totalling an approximate area of 0.8 ha. New recent dieback was also recorded towards the south-western part where a high degree of sand deposition has occurred, burying pneumatophores. Mangrove condition throughout the rest of this section was comparable with that of the previous survey.

A new large patch of dead mangroves was recorded in the south-western corner of Whyte Island (Figure 3-6). No surface water pooling or other visually obvious stressors were observed here at the time of the surveys. A smaller patch of dead mangroves was also recorded towards the south-eastern corner. Both these areas of dead mangroves were entirely surrounded by mangroves in good condition, suggesting that the controlling process/es were resulting in highly localised effects (see Discussion section for potential causes).

Figure 3-6 Photographs of recent dieback and poor health recorded at a) Fisherman Islands northern section, b) Fisherman Islands eastern section, c) Coal Loading Area, d) Whyte Island, 2014

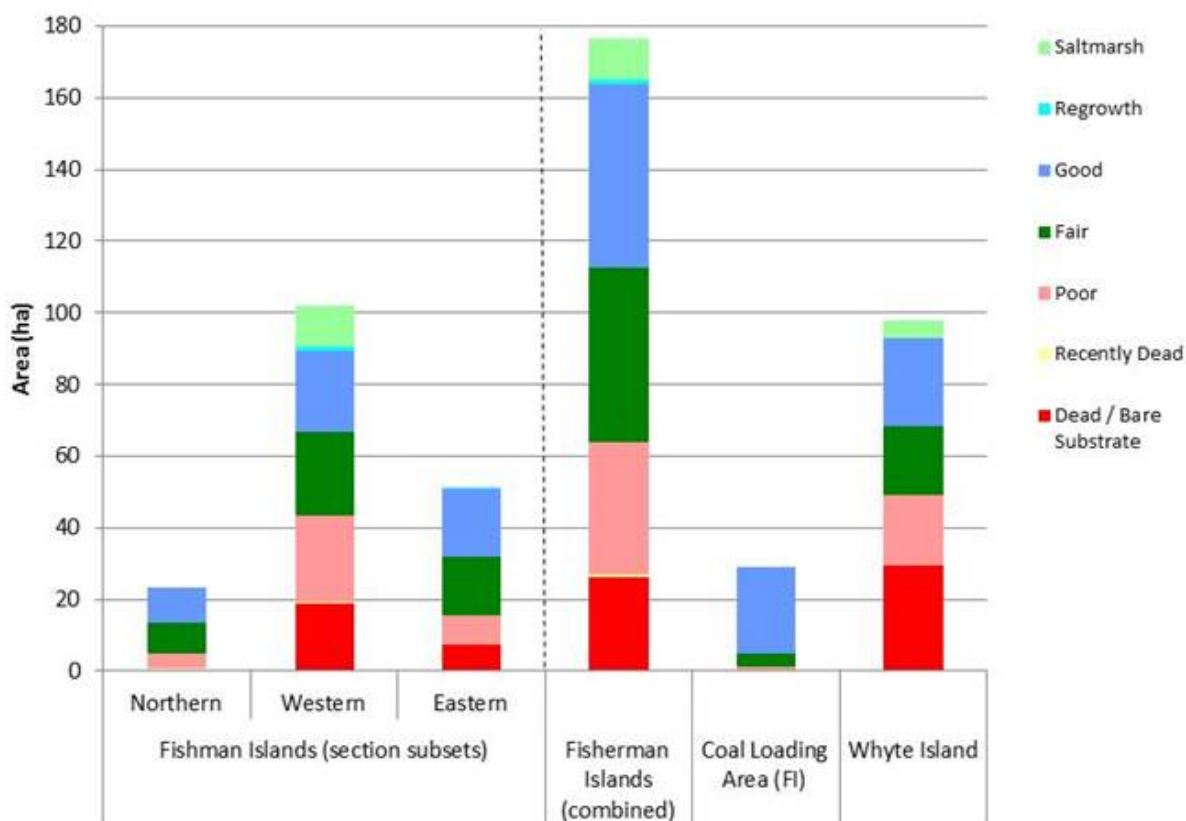
Figure 3-8 provides a comparison of the proportion of each mangrove health category, by area, contributing to each of the five locations. Proportional to size, the Coal Loading Area was in the best condition, while Whyte Island and the western and eastern sections of Fisherman Islands contained high proportions of both dead and poor condition mangroves (contributing up to 50% of the total area at Whyte Island).

Figure 3-8 Mangrove health categories contributing to the total area mapped for each study area section

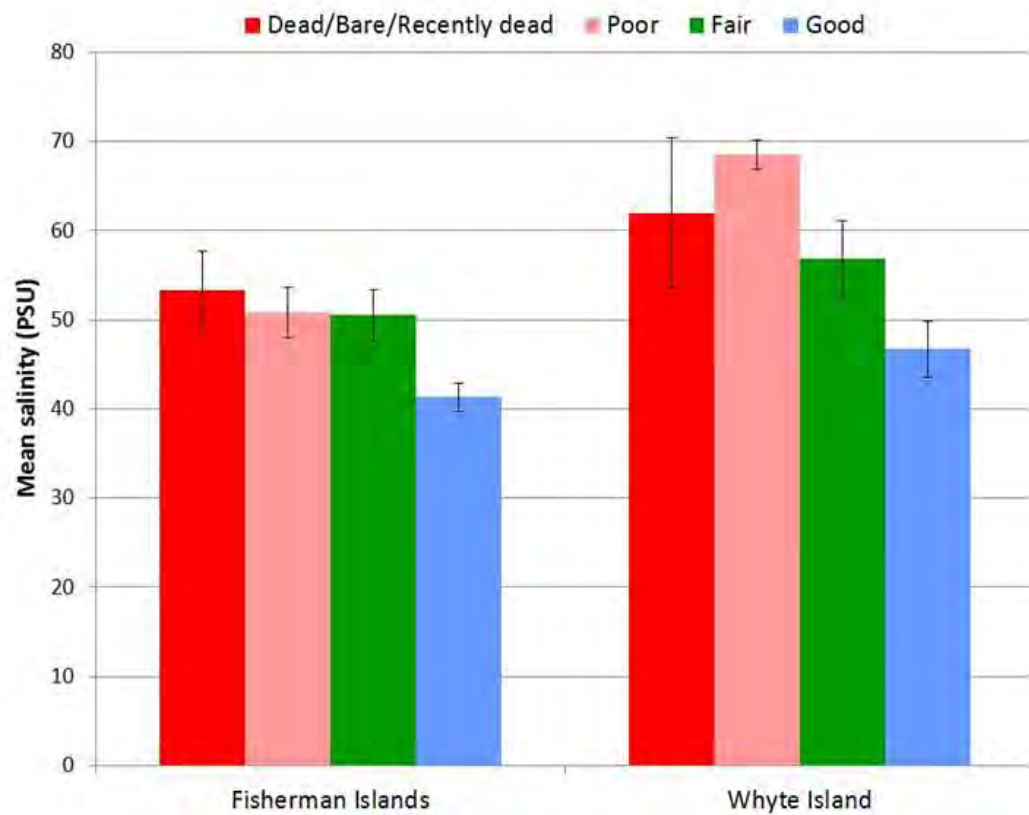
It is hypothesised that the lower salinity concentrations in sediments from mangrove areas in good health may be partly due to differences in the local elevation and drainage patterns. Areas of dead mangroves and mangroves in poor condition were typically associated with ponded surface water. Ponded surface water usually indicates inadequate drainage and poor tidal flushing, which can lead to degraded water quality over time. This is particularly the case during periods of low rainfall and/or increased evaporation.

The trends observed in pore water salinity (i.e. between locations and mangrove health categories) during the present survey were similar to those reported for the previous survey (see Figure 3-15, FRC Environmental 2012). However, salinity was slightly lower at both Fisherman Islands and Whyte Island during the previous survey (mean salinity ranging from approximately 25 – 48 PSU), on account of rainfall prior to sampling. While the recent salinity values were more reflective of those recorded during the earlier 2008 and 2010 surveys, particularly at Whyte Island, they did not display the marked and consistent trend between mangrove health categories. For instance, in 2008 and 2010, at both Fisherman Islands and Whyte Island salinity concentrations clearly increased with increasing mangrove degradation (i.e. salinity increased across each mangrove health category, from good to fair, then poor and dead).

Figure 3-14 Mean (\pm S.E) salinity of pore water across the study area during 2014

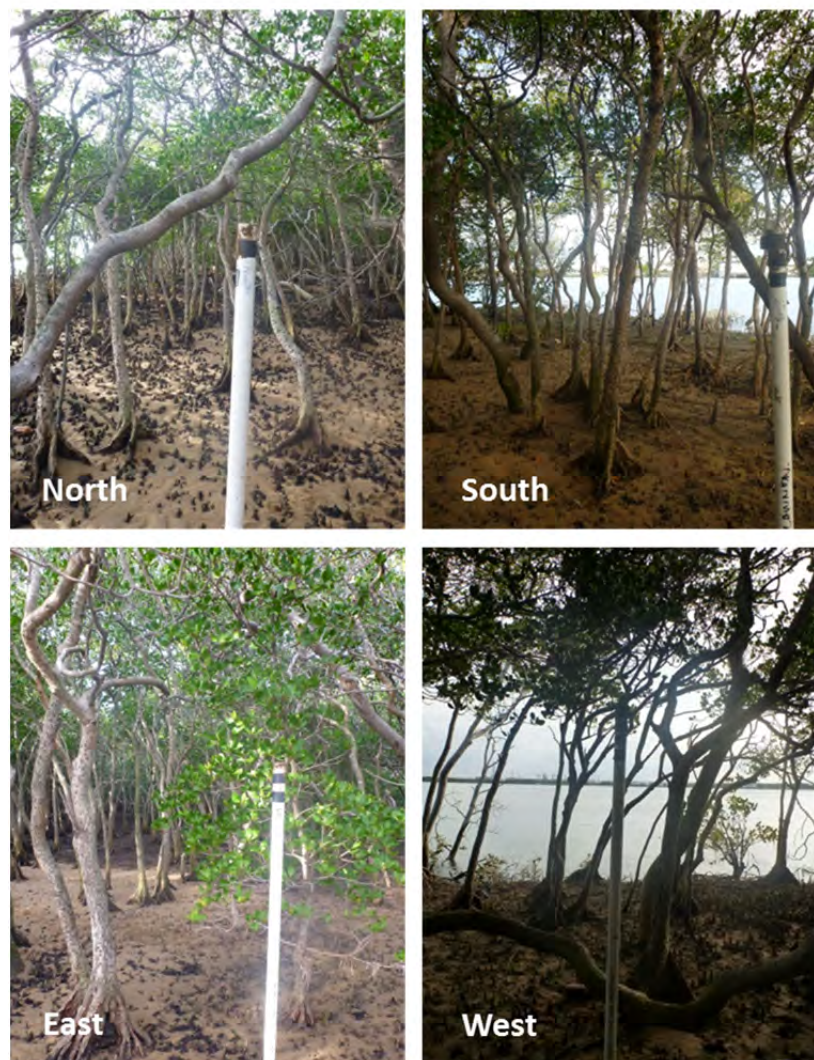
| Site | Existing Description (2012) ¹ | Notable changes observed in 2014 |
|---|---|---|
| 1 | Open <i>Ceriops tagal</i> forest with <i>Avicennia marina</i> understory in fair condition, substrate dominated by sands | A slight increase in macroalgae on roots in some places |

Figure A-1 Site 1 Photographic Monitoring, 2014

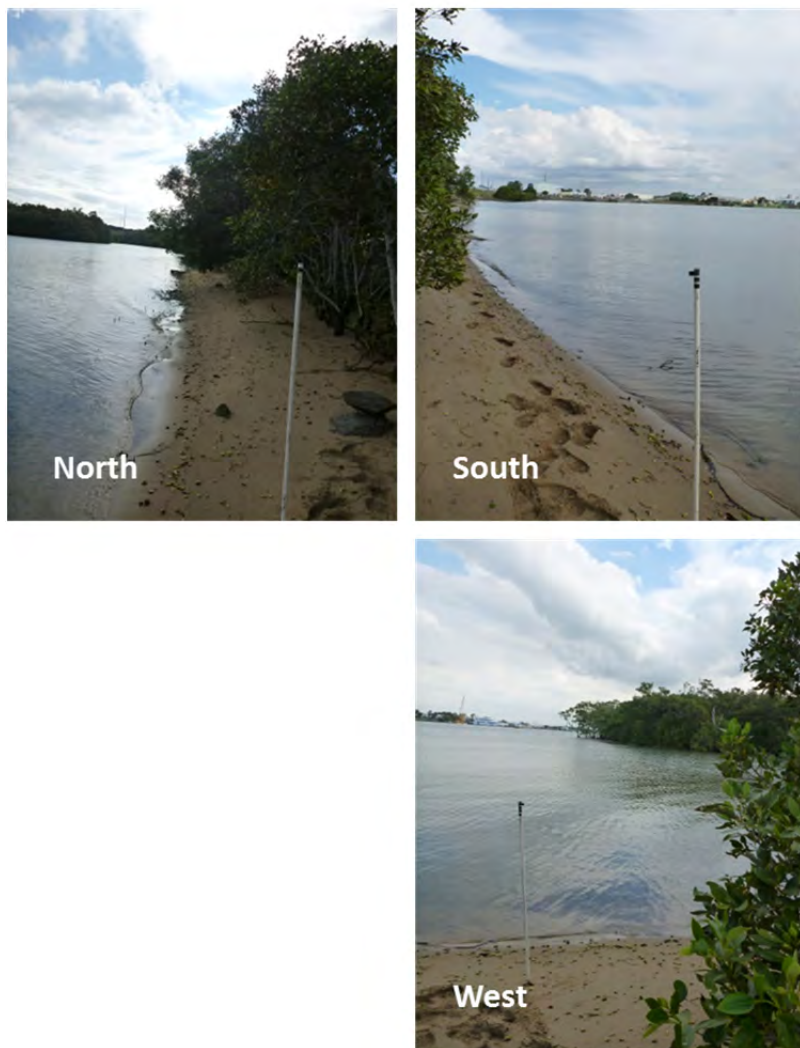
| Site | Existing Description (2012) ¹ | Notable changes observed in 2014 |
|---|---|---|
| 5 | Thin fringe of <i>A. marina</i> shrubs along sandy shore, of fair health; sandy substrate, reduce pneumatophore density likely from deposition or erosion | No notable change, though appears in good condition overall (as opposed to previous 'fair') |

Figure A-5 Site 5 Photographic Monitoring, 2014

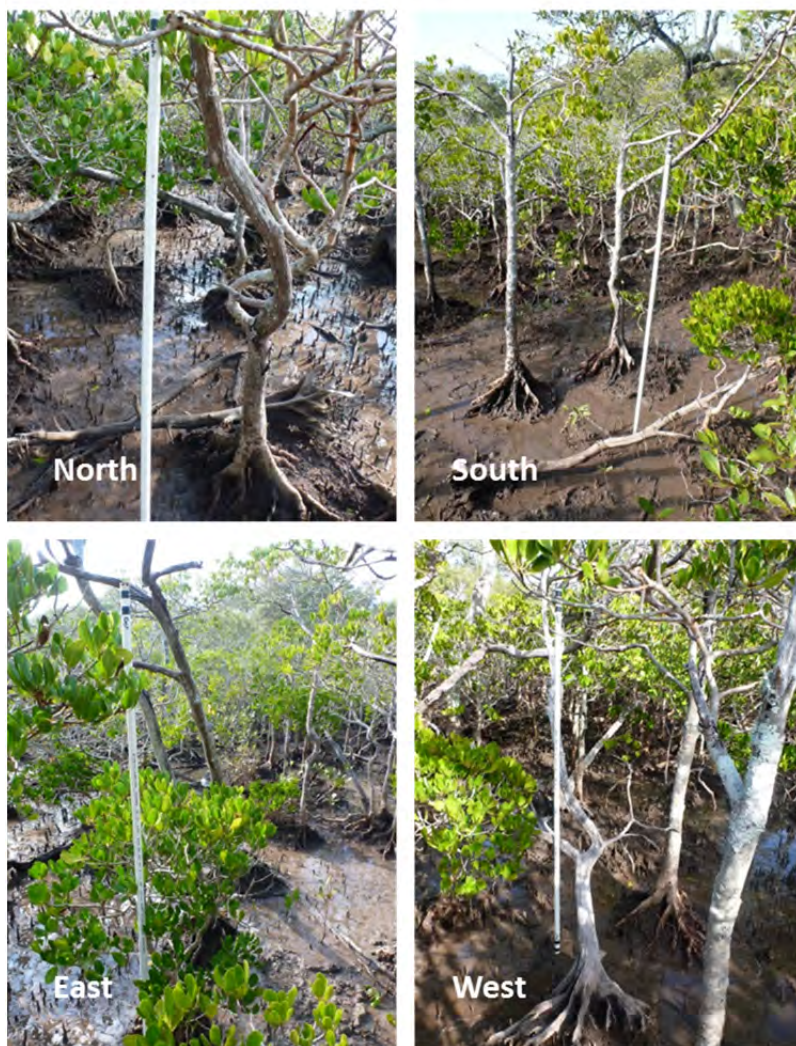
| Site | Existing Description (2012) ¹ | Notable changes observed in 2014 |
|---|---|---|
| 11 | Low, closed <i>C. tagal</i> forest with scattered <i>A. marina</i> of fair health; areas of pooling water observed | A few fallen trees; low seedling density and surface water remains; approaching poor condition |

Figure A-9 Site 11 Photographic Monitoring, 2014

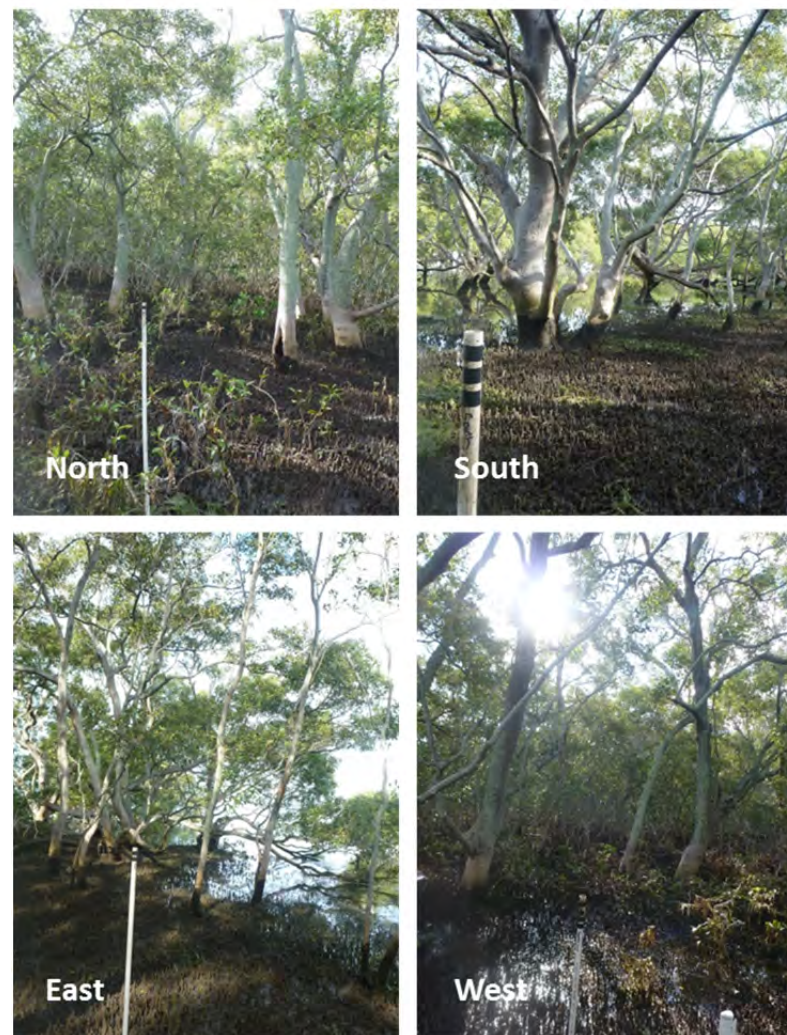
| Site | Existing Description (2012) ¹ | Notable changes observed in 2014 |
|---|---|---|
| 17 | Mature, tall and open <i>A. marina</i> forest in good health; general decline in seedling/sapling health due to leaf loss and smothering by seagrass wrack | Condition as per previous; saplings becoming established |

Figure A-12 Site 17 Photographic Monitoring, 2014

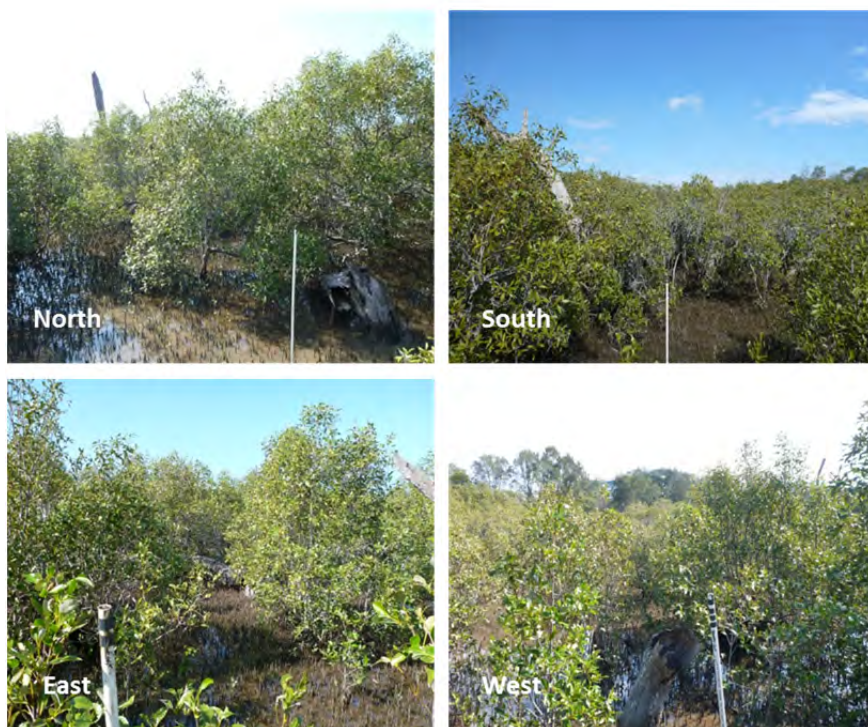
| Site | Existing Description (2012) ¹ | Notable changes observed in 2014 |
|---|---|---|
| 15 | Low, open <i>A. marina</i> forest in poor health due to epicormic growth and leaf damage by insects; forest represents an area of regrowth with saplings continuing to increase in height | Regrowth now well established, taller and in good to fair condition |

Figure A-18 Site 15 Photographic Monitoring, 2014
