Port of Brisbane Mangrove Monitoring Program - 2020 Final Report

Reference: R.B23621.007.01.Mangroves 2020.docx
Date: November 2020
Confidential

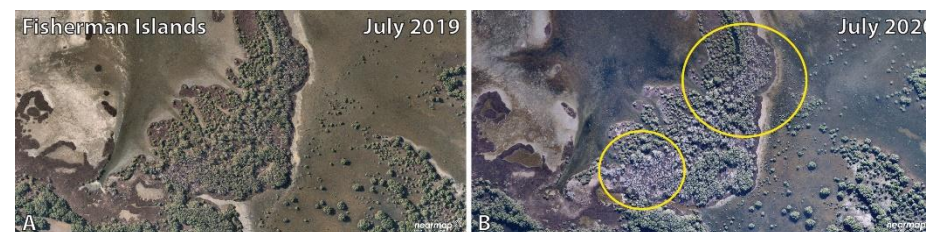
- The three condition indicators declined between 2019 and 2020 at all test (Fisherman Island, Whyte Island, Bulwer Island) and control sites. Inspections of aerial photography confirmed that areas of poor mangrove condition had canopy thinning (leaf loss) and/or tree mortality (Figure 1).

Figure 1 Leaf loss and tree mortality of Fisherman Islands inland mangrove communities between July 2019 (A) and July 2020 (B)

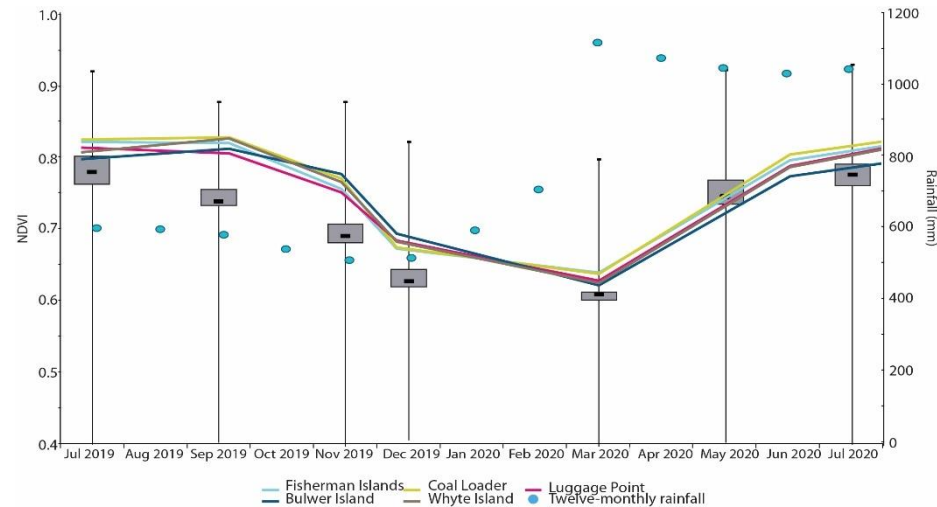
- NDVI was lowest in March 2020 during the 2019-2020 monitoring period (Figure 2). This was the fourth lowest NDVI value on record in the period 2016-2020.
- In addition to seasonal cycles described below, there were long term cyclic changes in mangrove health during the 2016-20 monitoring period. Peaks in NDVI values occurred one to three months following rainfall peaks, and there was a significant correlation between the ranks of rainfall and NDVI within seasons for summer ($p = 0.98$, $p < .05$) and winter ($p = 0.90$, $p < .05$). However, the relationship between rainfall and NDVI was not linear ($r < 0.7$, $p > 0.1$). This was most likely due to confounding influences of seasonality

Figure 2 Temporal changes in NDVI and twelve-month cumulative rainfall at test and control (box plot) sites - July 2018 to July 2019

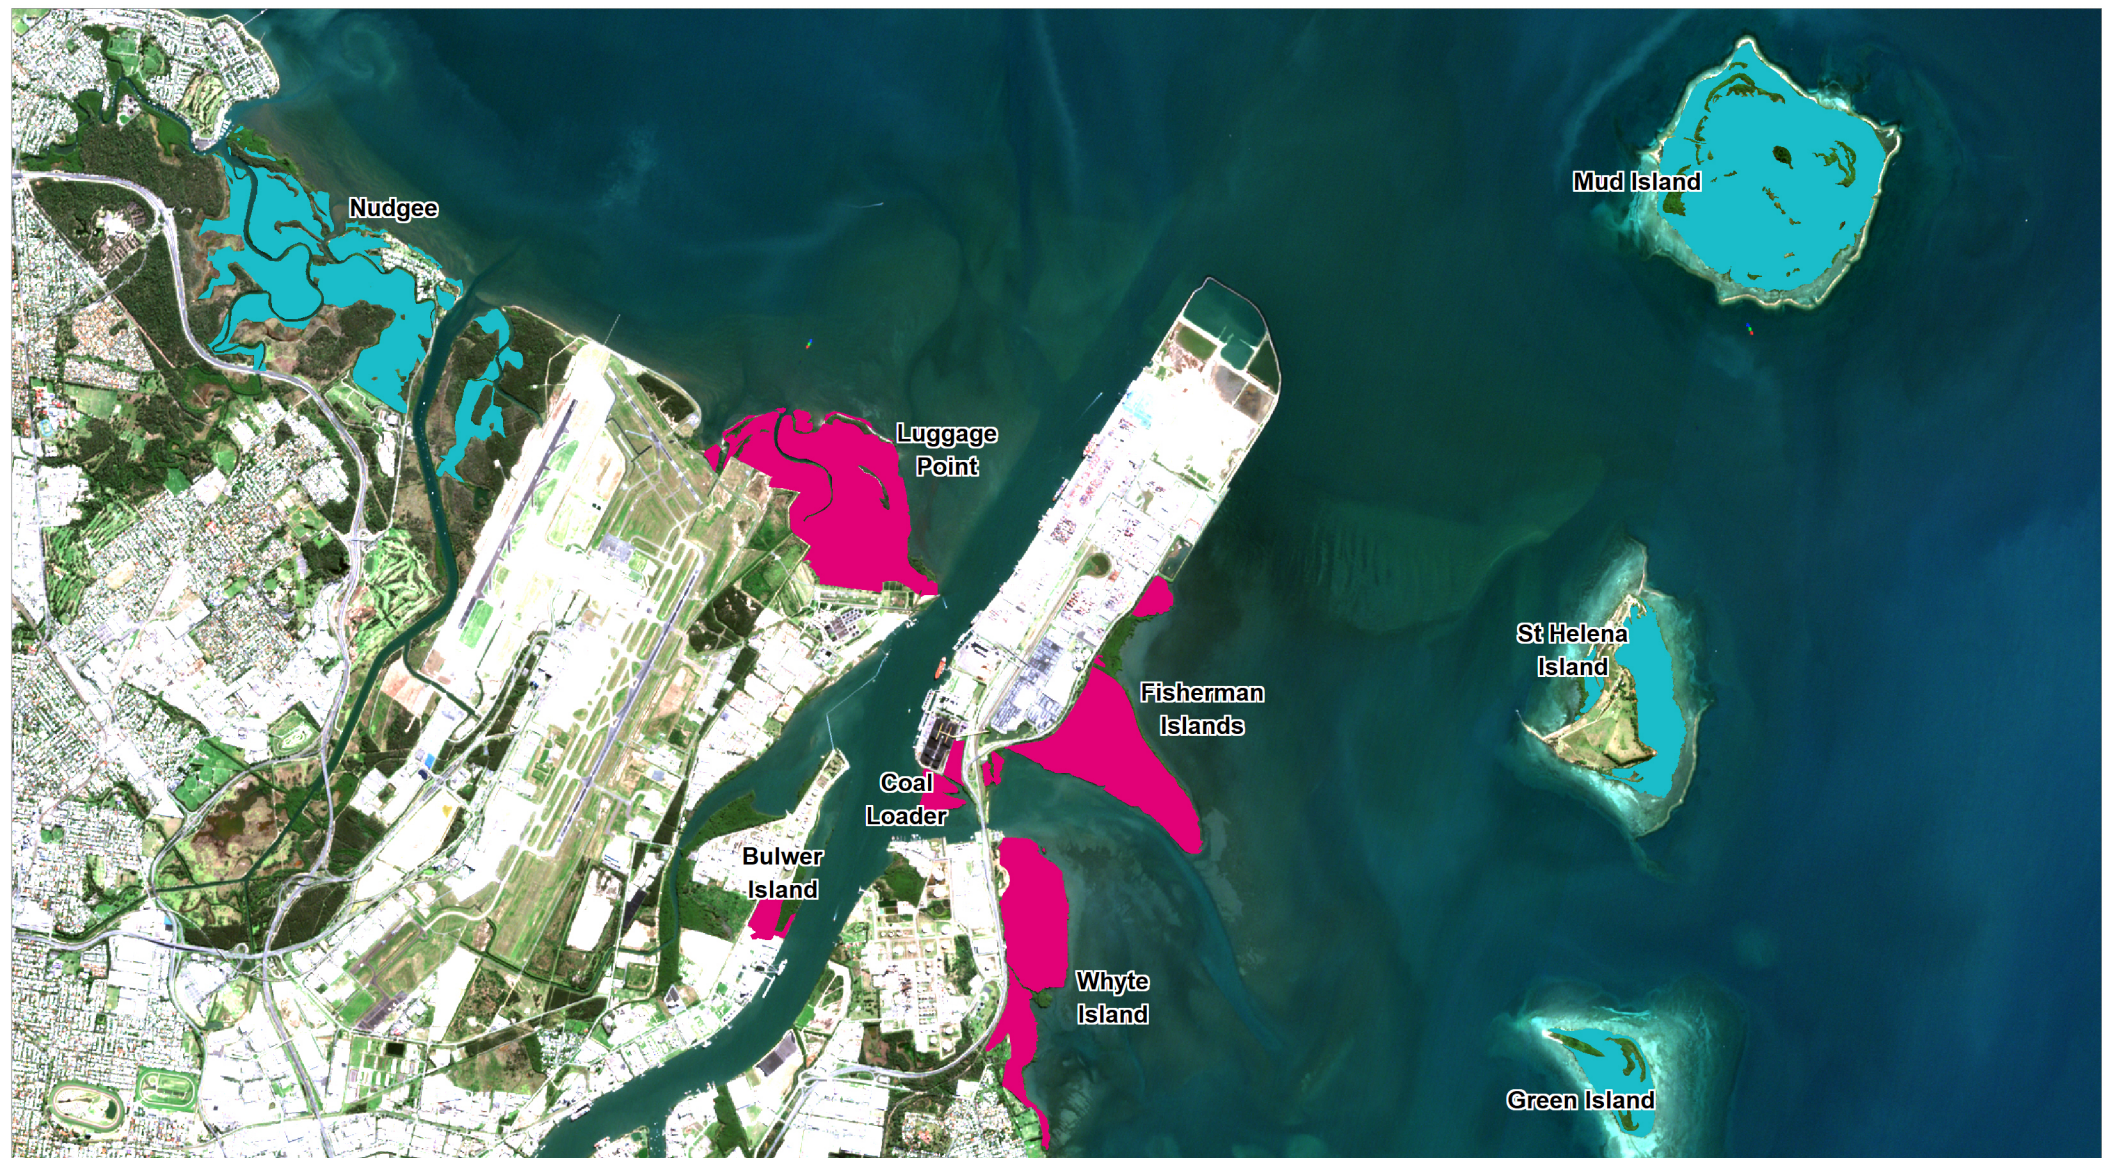
2-1

The area (hectares) and pixel counts for mangrove forests in each investigation areas are presented in Table 2-1, and the extent of these areas are shown in Figure 2-1. Sentinel-2 images provided between 2,293 and 44,460 pixels per investigation area (depending on size of the investigation areas), which provided sufficient resolution to assess broad temporal trends in the vegetation health indices.

Mangrove health assessment test and control sites

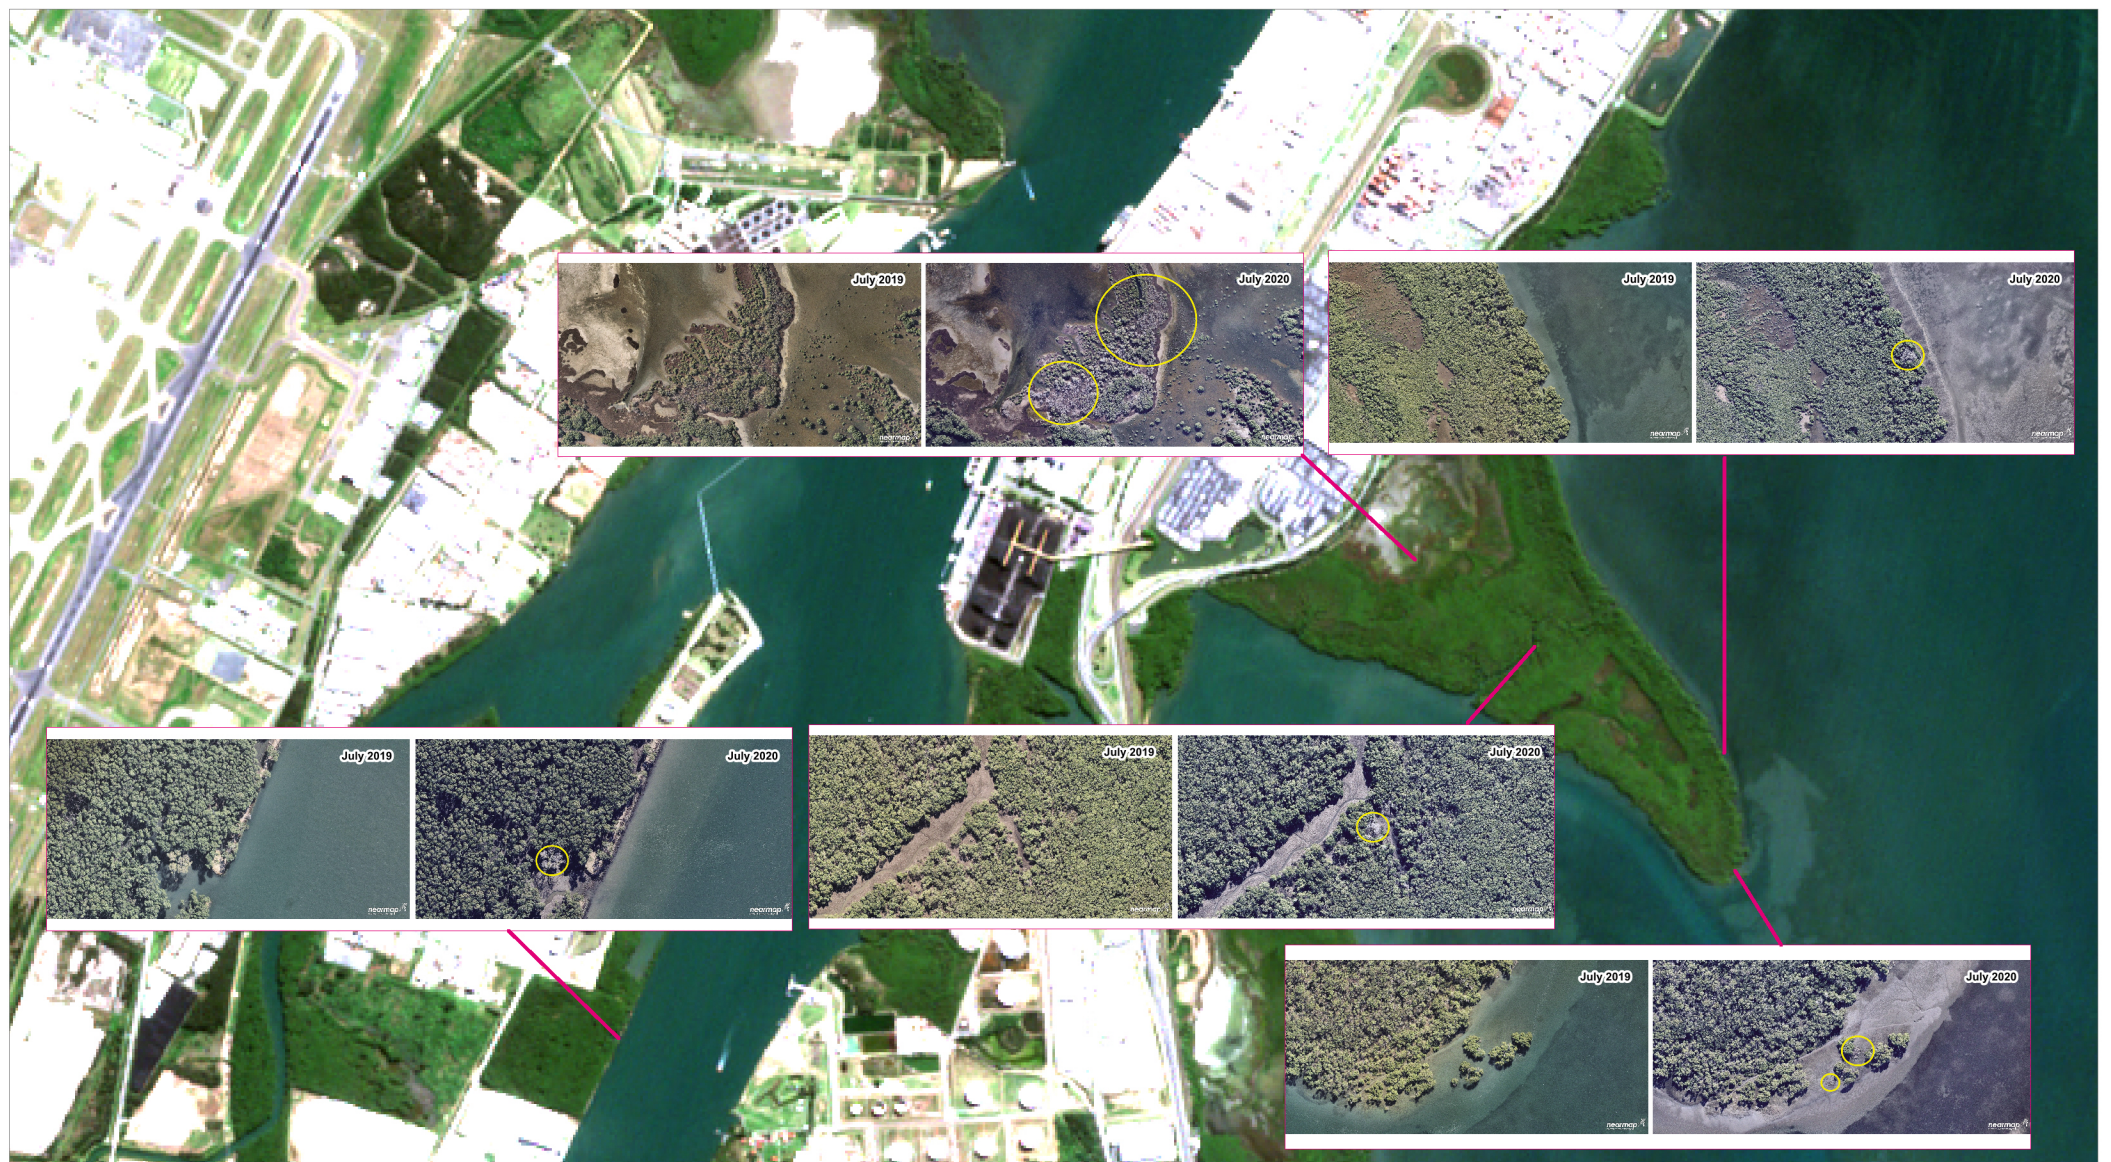
Vegetation community metrics slightly decreased in July 2020 compared to July 2019 across all investigation areas. However, there were a few areas of increased vegetation along the seaward margins and localised interior areas. Key areas of mangrove loss around the port area are shown in Figure C-1 and include:

Changes in mangrove health between 2019 and 2020 on Nearmap Imagery

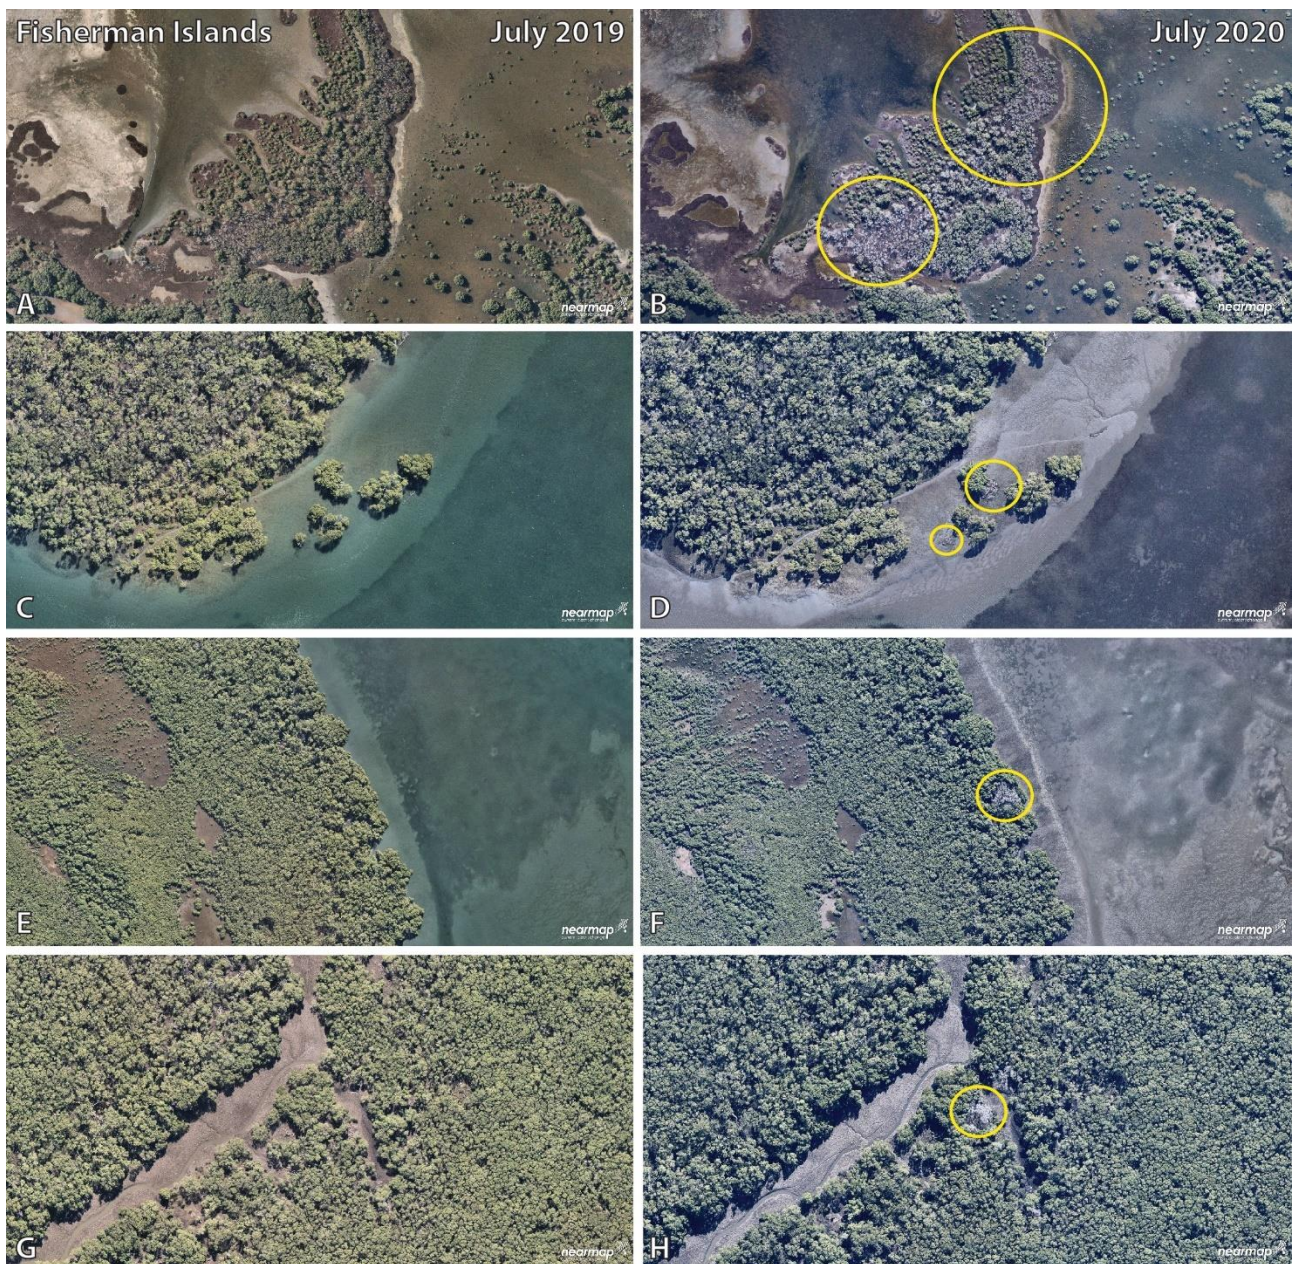
- There were numerous instances of tree deaths within inland saltmarsh regions at all test and control sites (see Figure C-2 images A/B and G/H for examples). This is likely due to drought conditions and salt stress.

- South-east tip of Fisherman Islands – death of one tree between July 2019 and July 2020, verified by inspection of aerial imagery (Figure C-2 images C/D).

- Eastern seaward edge of Fisherman Islands - death of one tree between July 2019 and July 2020, verified by inspection of aerial imagery (Figure C-2 images E/F). This large dead tree is located 450 m north of the tip of Fisherman Islands.

- Tidal channel bisecting Fisherman Island - Tree death confirmed by inspection of aerial imagery, and some vegetation in poor condition nearby.
- Adjacent to constructed fishway at Bulwer Island - Death of a large tree that was previously displaying leaf loss (see Figure C-3 image I/J). Aerial imagery indicates leaf loss on several other trees nearby.

The areas of loss of Fisherman Island are shown in Figure C-2 and the areas of Bulwer Island, Whyte Island and a Nudgee example are shown in Figure C-3.

Figure C-2 Aerial imagery of Fisherman Islands July 2019 and July 2020. Bank erosion causing tree loss (A, B); tree death at the tip of Fisherman Island (C, D); tree death on the eastern fringe (E, F); and tree death in the middle of Fisherman Island (G, H).
