Port of Brisbane Mangrove Health Monitoring Program 2019 – Final Report

Reference: R.B23621.002.01.Mangrove_2019.docx
Date: February 2020
Confidential

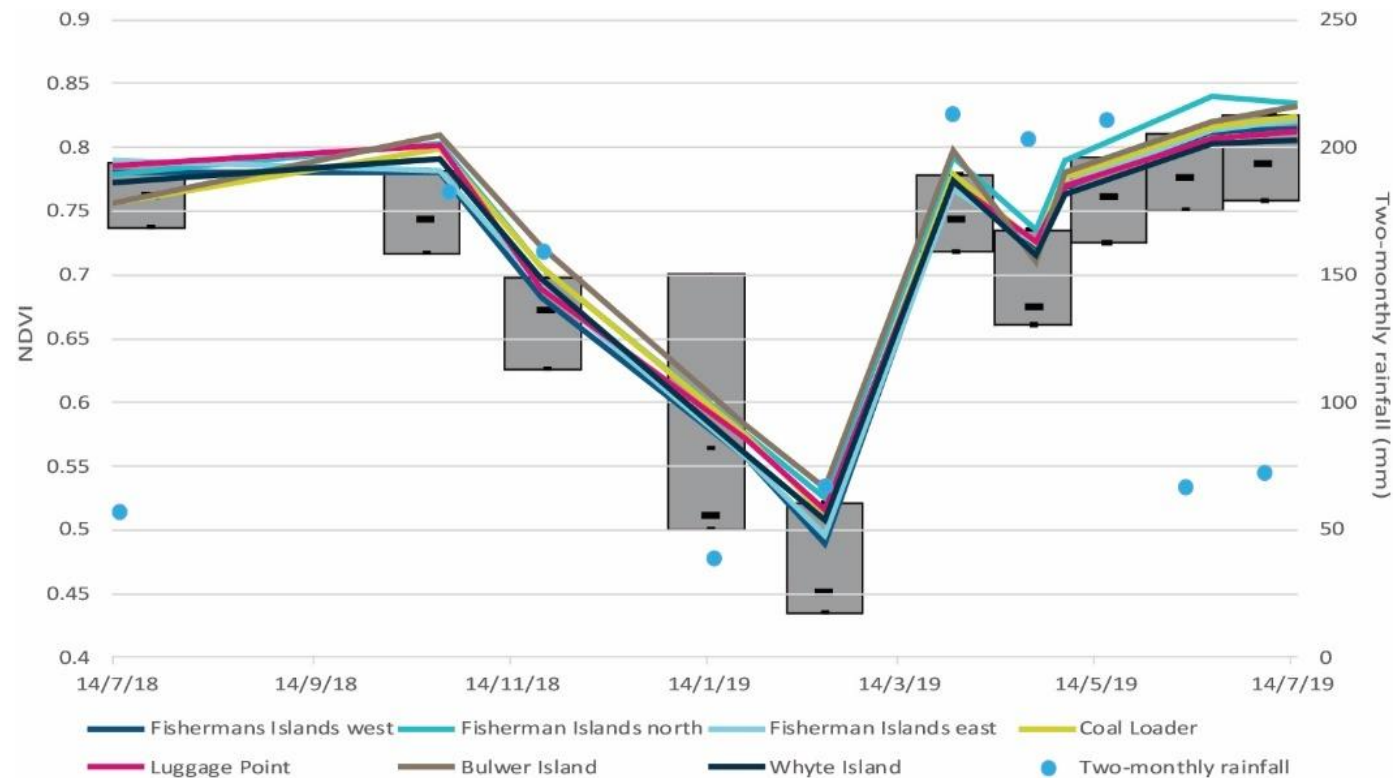
Figure 1 Temporal changes in NDVI and two-month cumulative rainfall at test and control (box plot) sites - July 2018 to July 2019

Consistent with previous years, seasonal changes in vegetation indices were observed within the 2018-19 monitoring period. NDVI (Figure 1), SAVI and LAI declined over late spring/summer 2018, but rapidly improved in autumn 2019, coincident with an increase in two-month cumulative rainfall. Past sampling carried out by BMT found that mangrove condition tracked long-term trends in rainfall, consistent with these results.

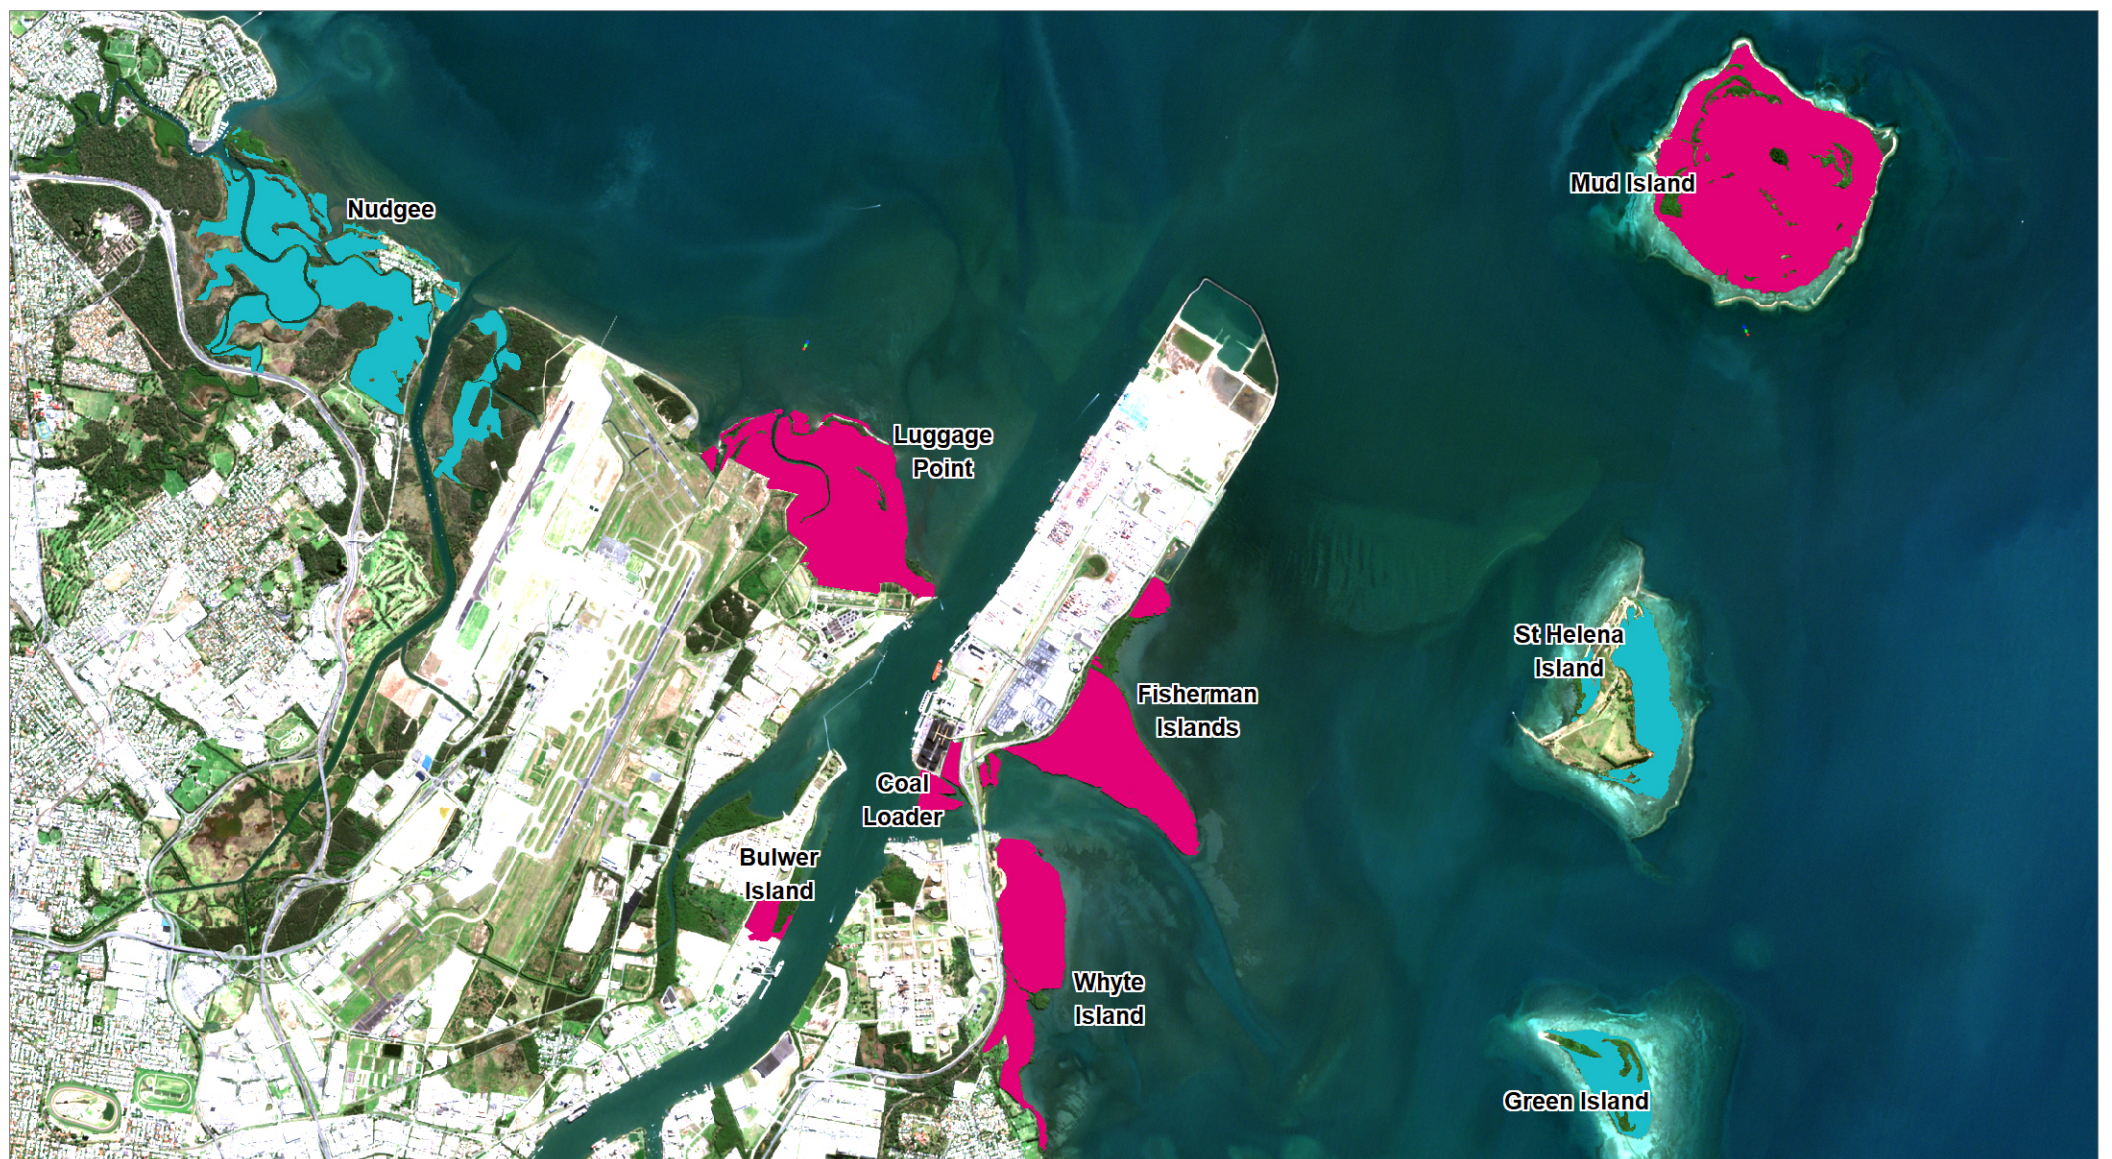
The area (hectares) and pixel counts for mangrove forests in each investigation areas are presented in Table 2-1, and the extent of these areas are shown in Figure 2-1. Sentinel-2 images provided between 2,293 and 44,460 pixels per investigation area (depending on size of the investigation areas), which provided sufficient resolution to assess broad temporal trends in the vegetation health indices.

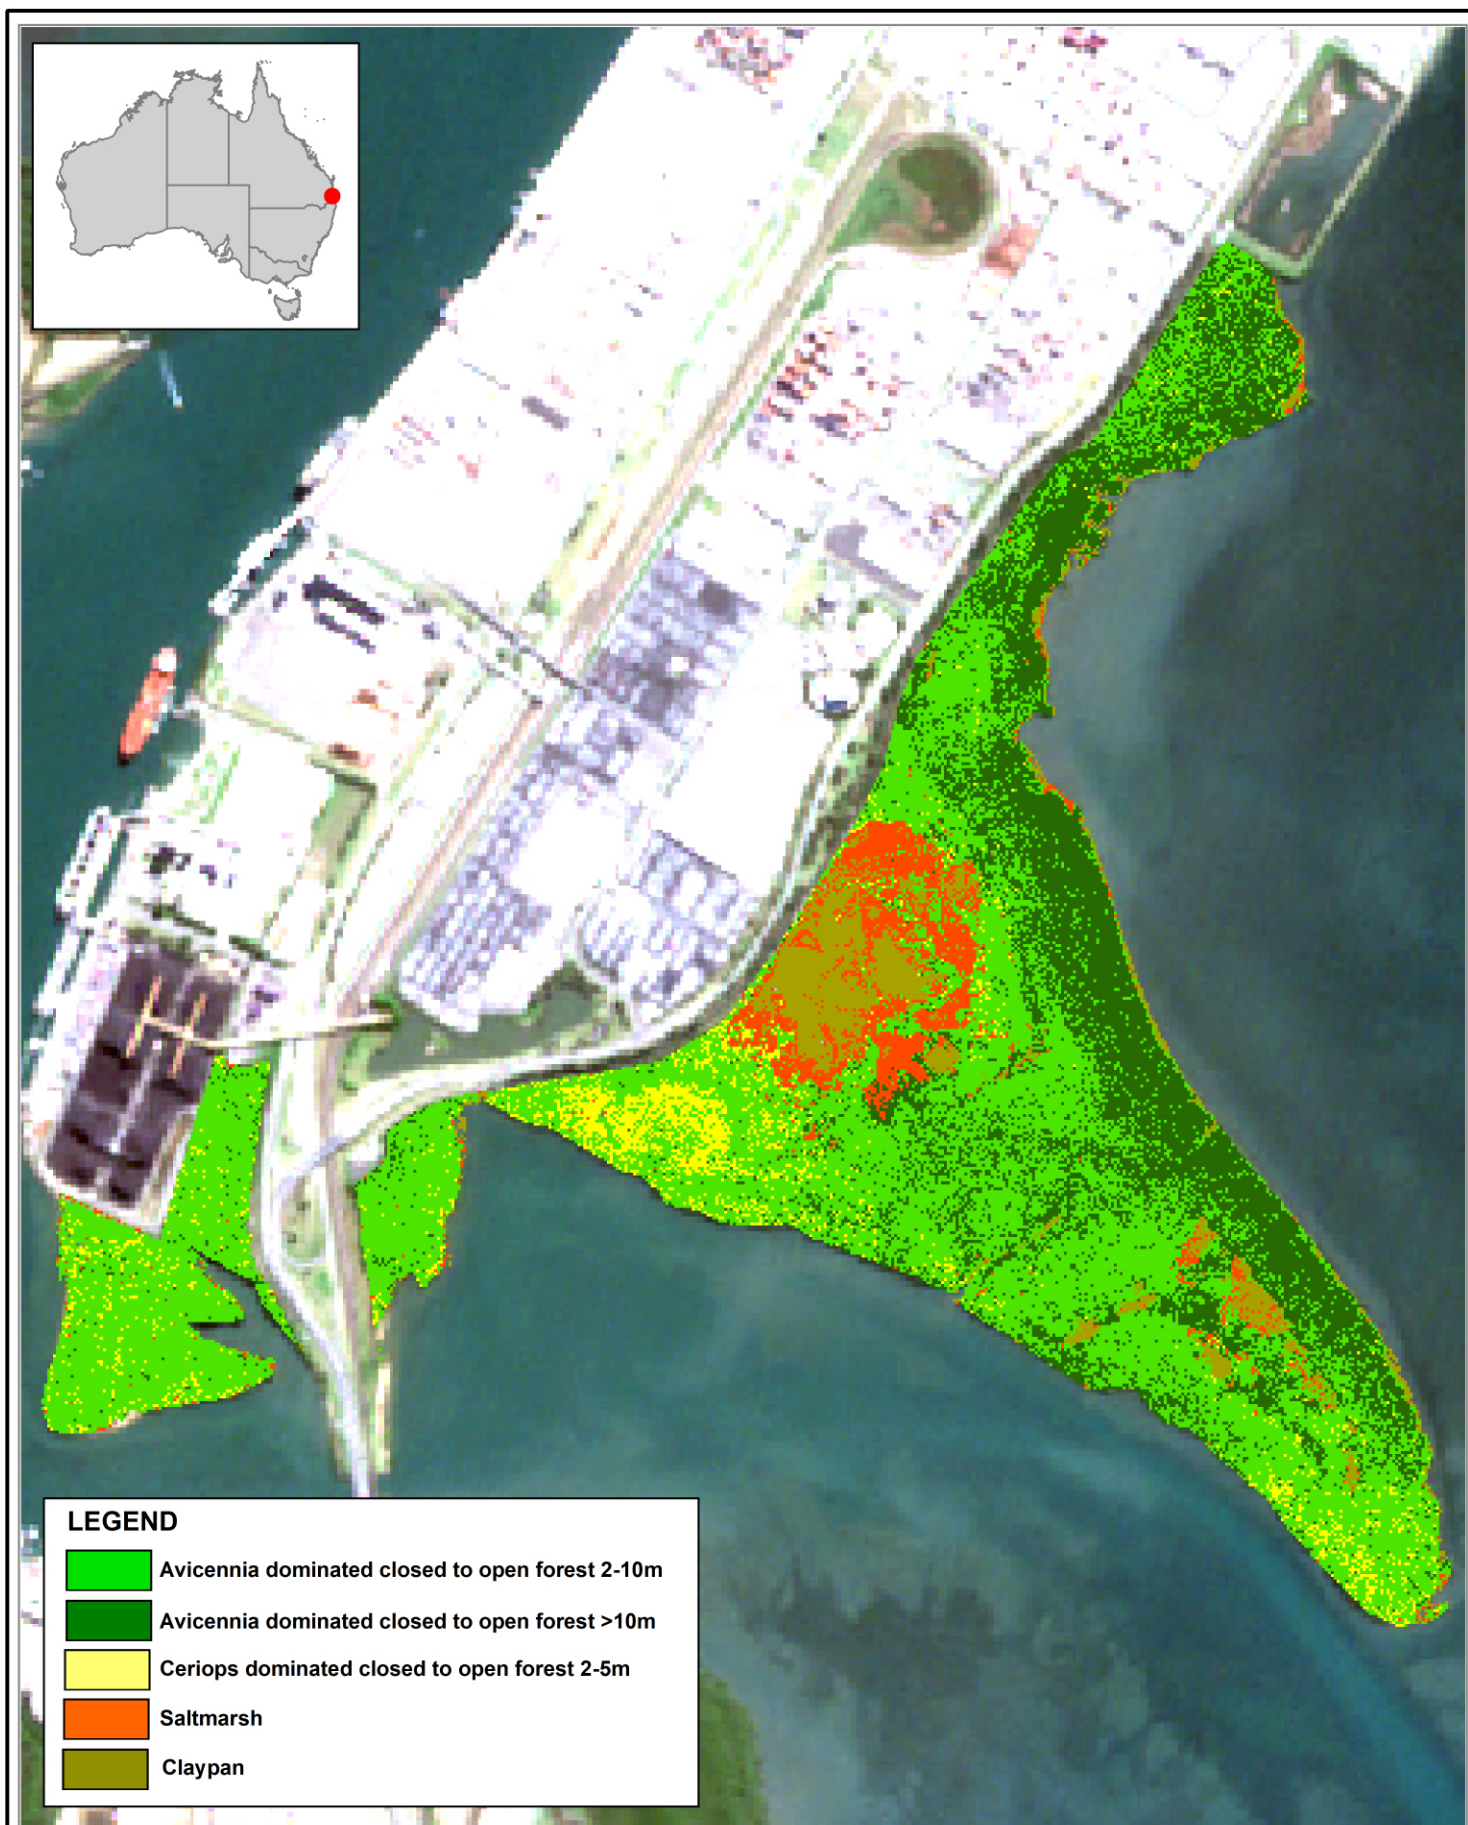
Figure:
3-1

Title:
Mangrove species Fisherman Islands 2019

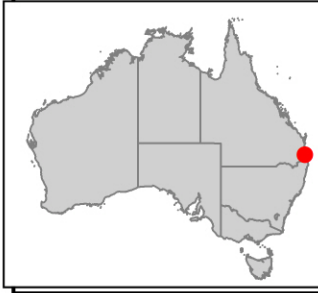
<p>Title:</p> <p>NDVI at investigation sites in July 2018, November 2018, February 2019, and July 2019</p> <p>BMT WBM endeavours to ensure that the information provided in this map is correct at the time of publication. BMT WBM does not warrant, guarantee or make representations regarding the currency and accuracy of information contained in this map.</p>		<p>Figure:</p> <p>3-4</p>	<p>Rev:</p> <p>A</p>
<p>Filepath: \\BMT-BNE-FS01\drafting\B20259_I_BRH Port of Brisbane DLR\DRG\Mangrove_2018\ECO_004_190725_NDVI_4_plot.WOR</p>		<p>Approx. Scale</p>

Spatial patterns in NDVI, SAVI and LAI are mapped for all investigation areas in Figure 3-4, Figure 3-6 and Figure 3-7, respectively. The three metrics had broadly consistent spatial patterns. The main exception was that SAVI and LAI resolved finer scale differences in mangrove condition than NDVI, most notably between the northern and southern shorelines of Fisherman Islands. The northern side of Fisherman Islands supported taller (BMT WBM 2016) and healthier mangrove forests than the southern shoreline.

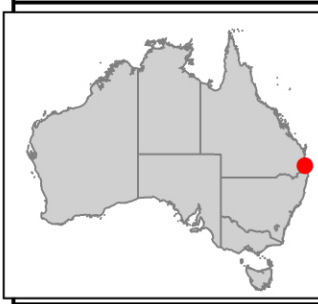
Title: SAVI at investigation sites in July 2018, November 2018, February 2019, and July 2019		Figure: 3-6	Rev: A
<small>BMT WBM endeavours to ensure that the information provided in this map is correct at the time of publication. BMT WBM does not warrant, guarantee or make representations regarding the currency and accuracy of information contained in this map.</small>

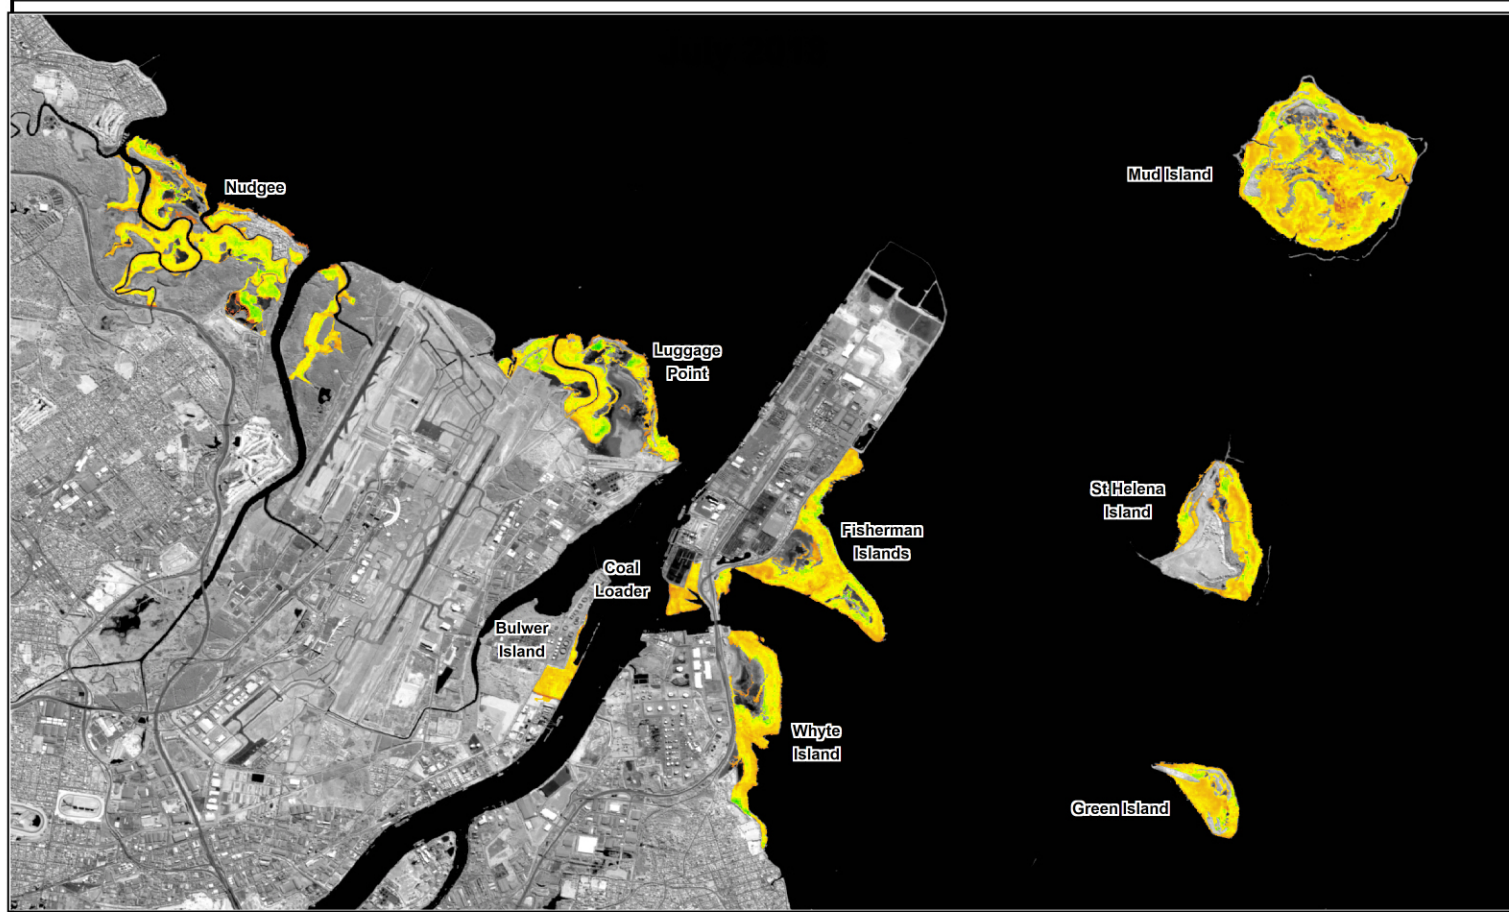
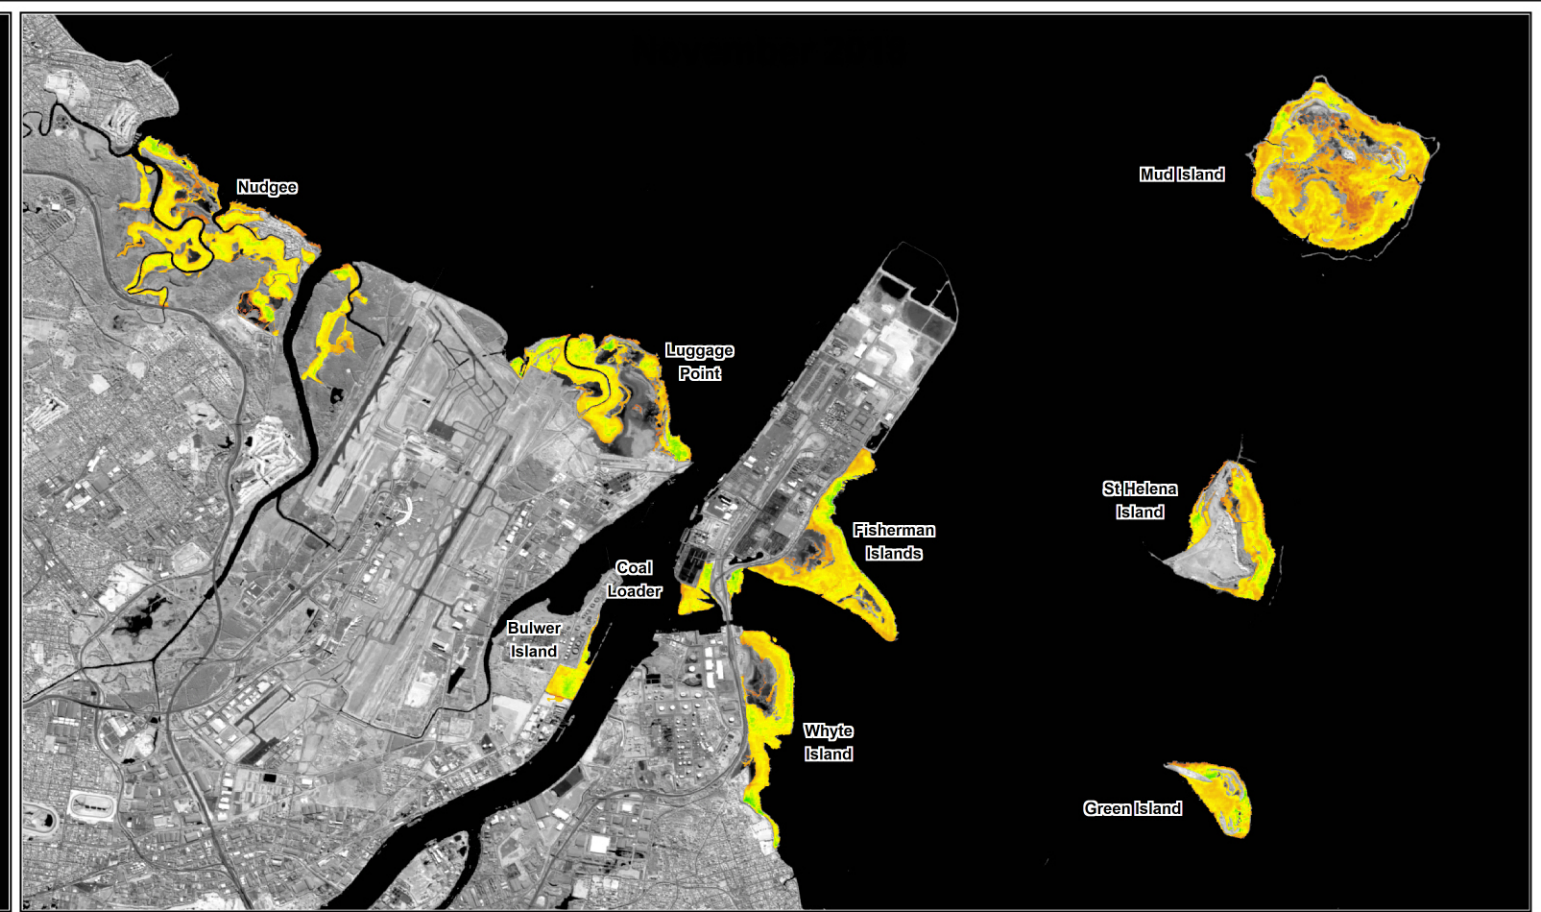
<p>Title:</p> <p>LAI at investigation sites in July 2018, November 2018, February 2019, and July 2019</p>		<p>Figure:</p> <p>3-7</p>	<p>Rev:</p> <p>A</p>
<p>BMT WBM endeavours to ensure that the information provided in this map is correct at the time of publication. BMT WBM does not warrant, guarantee or make representations regarding the currency and accuracy of information contained in this map.</p>		<p>Approx. Scale</p>	
<p>Filepath: \\BMT-BNE-FS01\drafting\B20259_I_BRH Port of Brisbane DLR\DRG\Mangrove_2018\ECO_010_190829_LAI_4_plot.WOR</p>

Temporal differences in LAI are mapped in Figure 3-7 and Appendix C. Like NDVI and SAVI, the magnitude of temporal change varied within locations. In particular, between July 2018 and February 2019 (Figure C-1) there an increase in LAI occurred along seaward and creek fringes while LAI tended to decline in central areas. Mud Island had the greatest reduction in LAI while Bulwer Island and Coal Loader both had an increase in LAI.

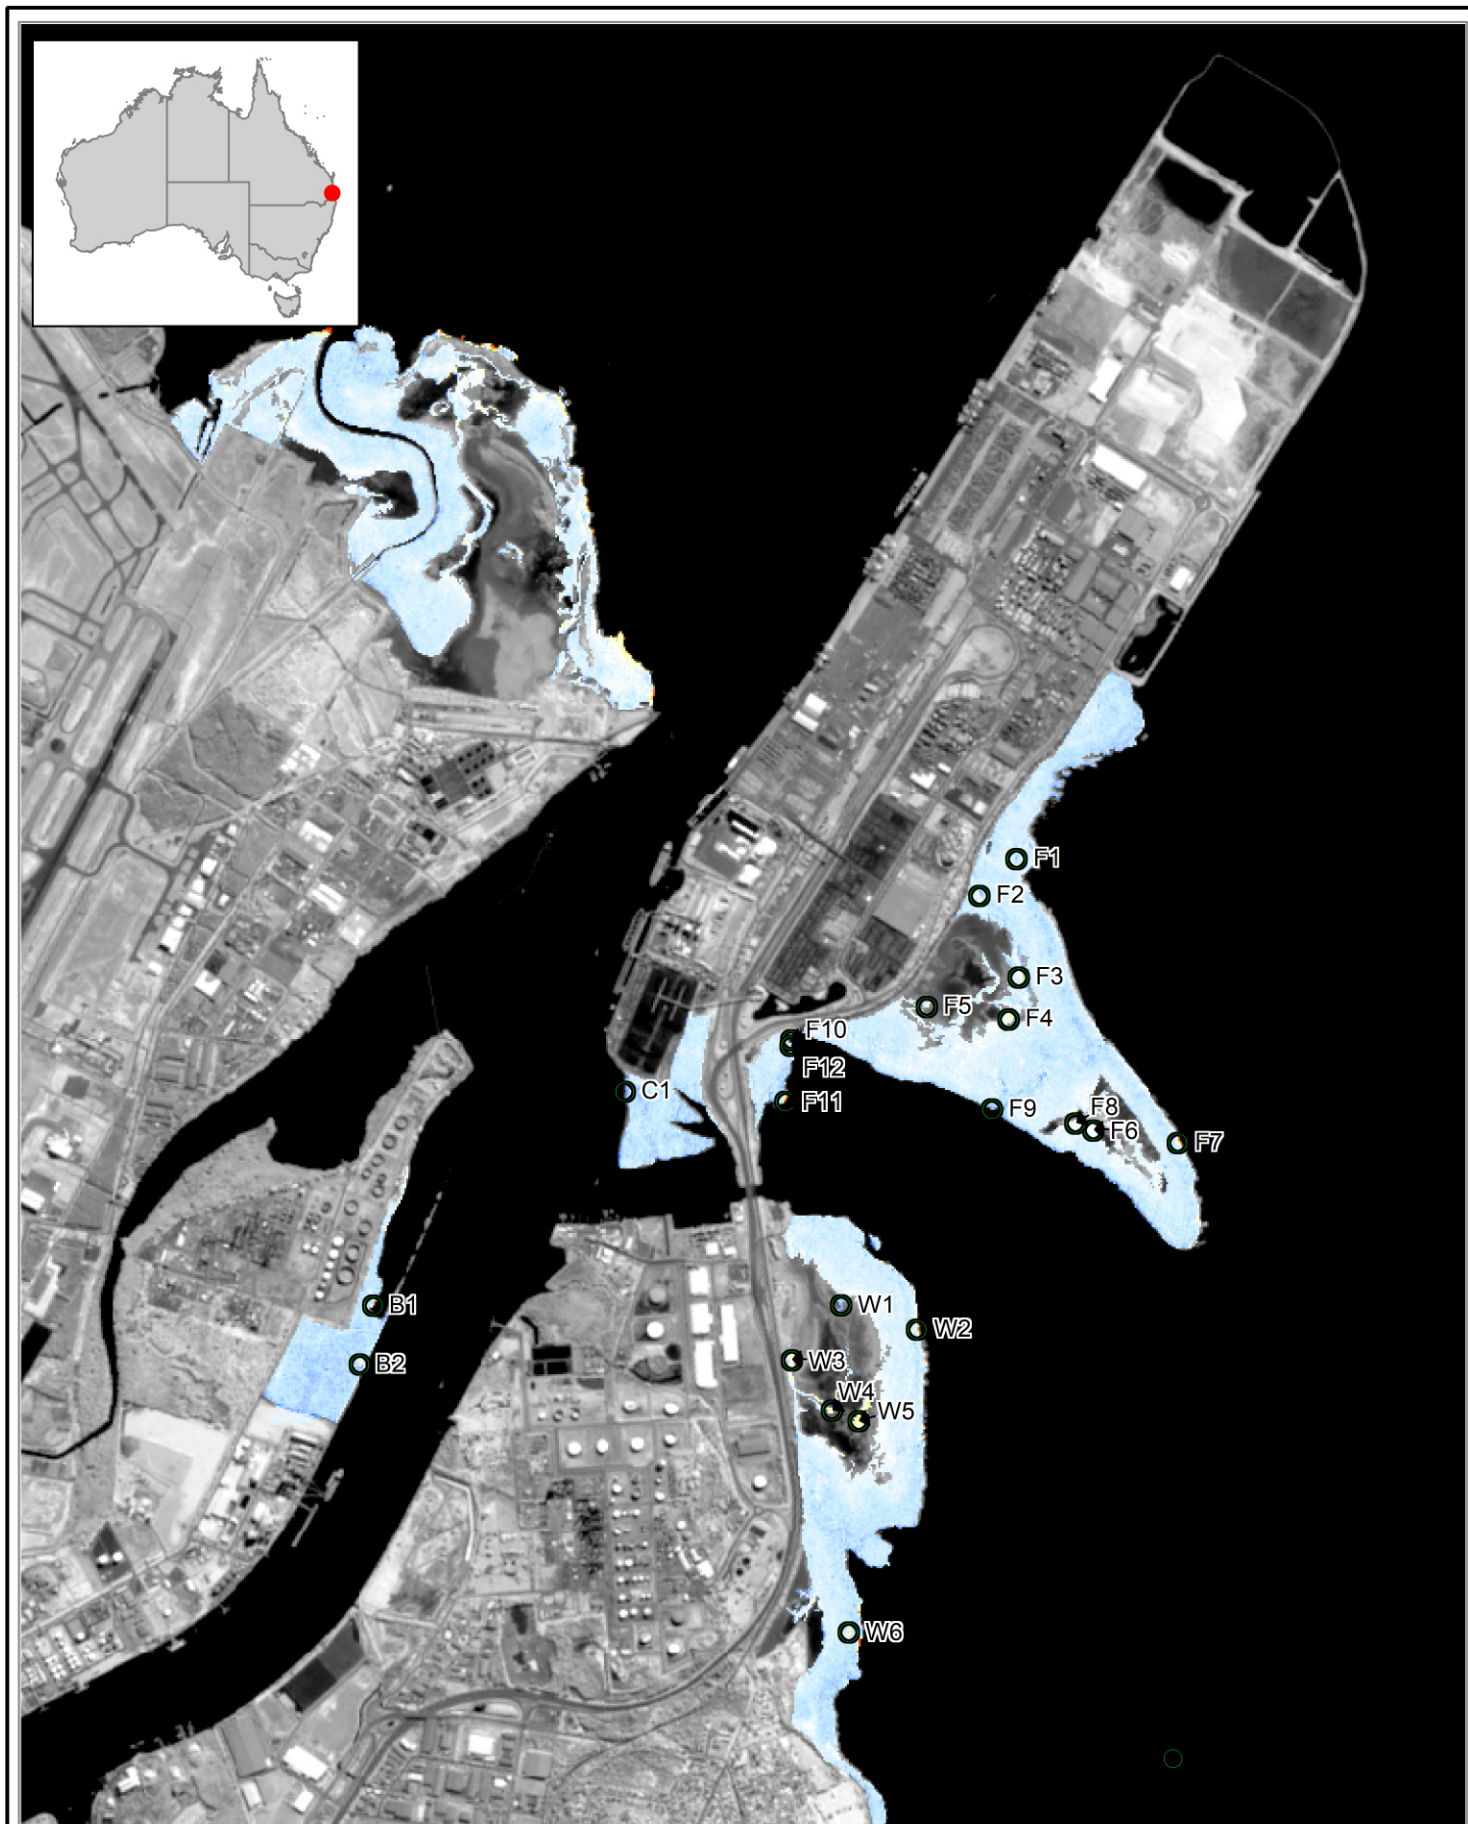
Figure:
3-8

Title:
NDVI field validation sites 2019

Ground-truthing was conducted on the 1st of August at 20 sites (Figure 3-8) where vegetation condition indices indicated a decline or improvement in mangrove condition. There was excellent agreement between remotely sensed data and site observations, as summarised in Table 3-1 (Fisherman Islands) and Table 3-2 (Whyte and Bulwer islands). Declines in mangrove condition were a response to tree-fall, die-back and canopy thinning. Improvements in mangrove condition were a response to seedling recruitment and new growth on mature trees.

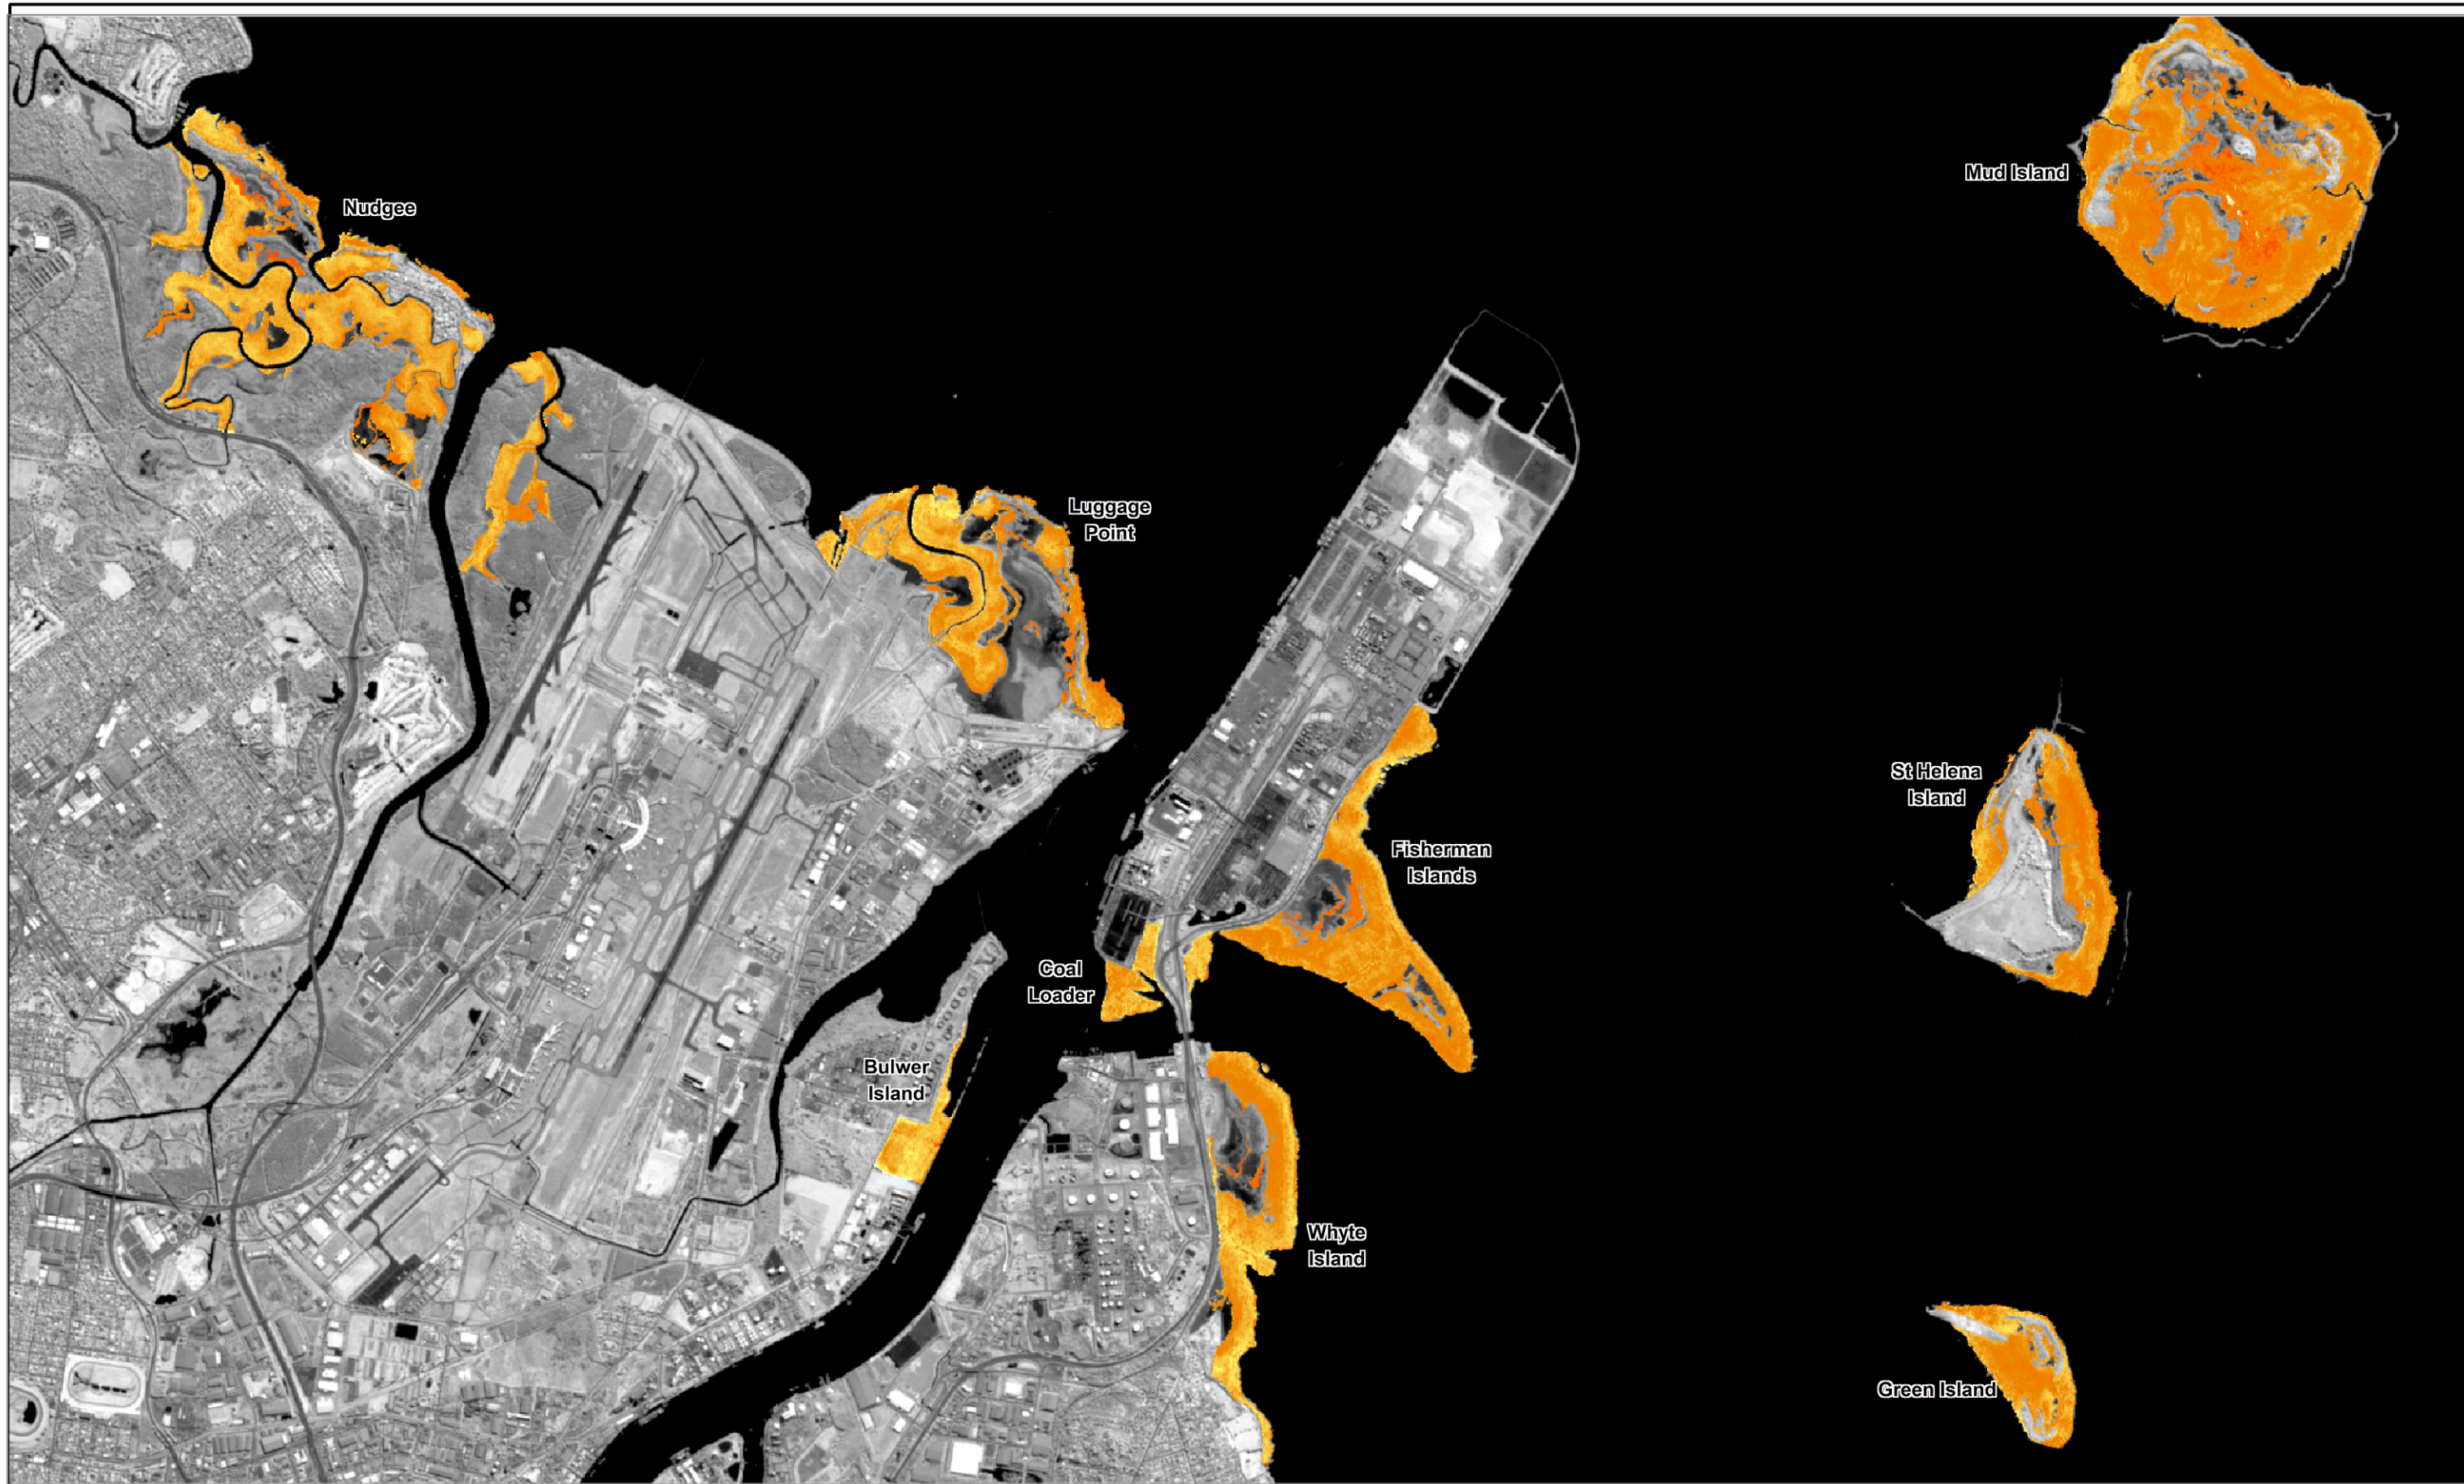
<p>LEGEND</p> <p>NDVI Change Score</p> <p>-1.5 0 1.5</p>	<p>Title:</p> <p>Changes in NDVI between July 2018 and Feburary 2019</p> <p><small>BMT WBM endeavours to ensure that the information provided in this map is correct at the time of publication. BMT WBM does not warrant, guarantee or make representations regarding the currency and accuracy of information contained in this map.</small></p> <div> <p>Approx. Scale</p> </div> <p>Filepath: I:\B23621.PoB Monitoring 2019-25\DRG\2019_Mangroves\ECO_002_190725_NDVI_change_July18-Feb19.WOR</p>		<p>Figure:</p> <p>A-1</p>	<p>Rev:</p> <p>A</p>

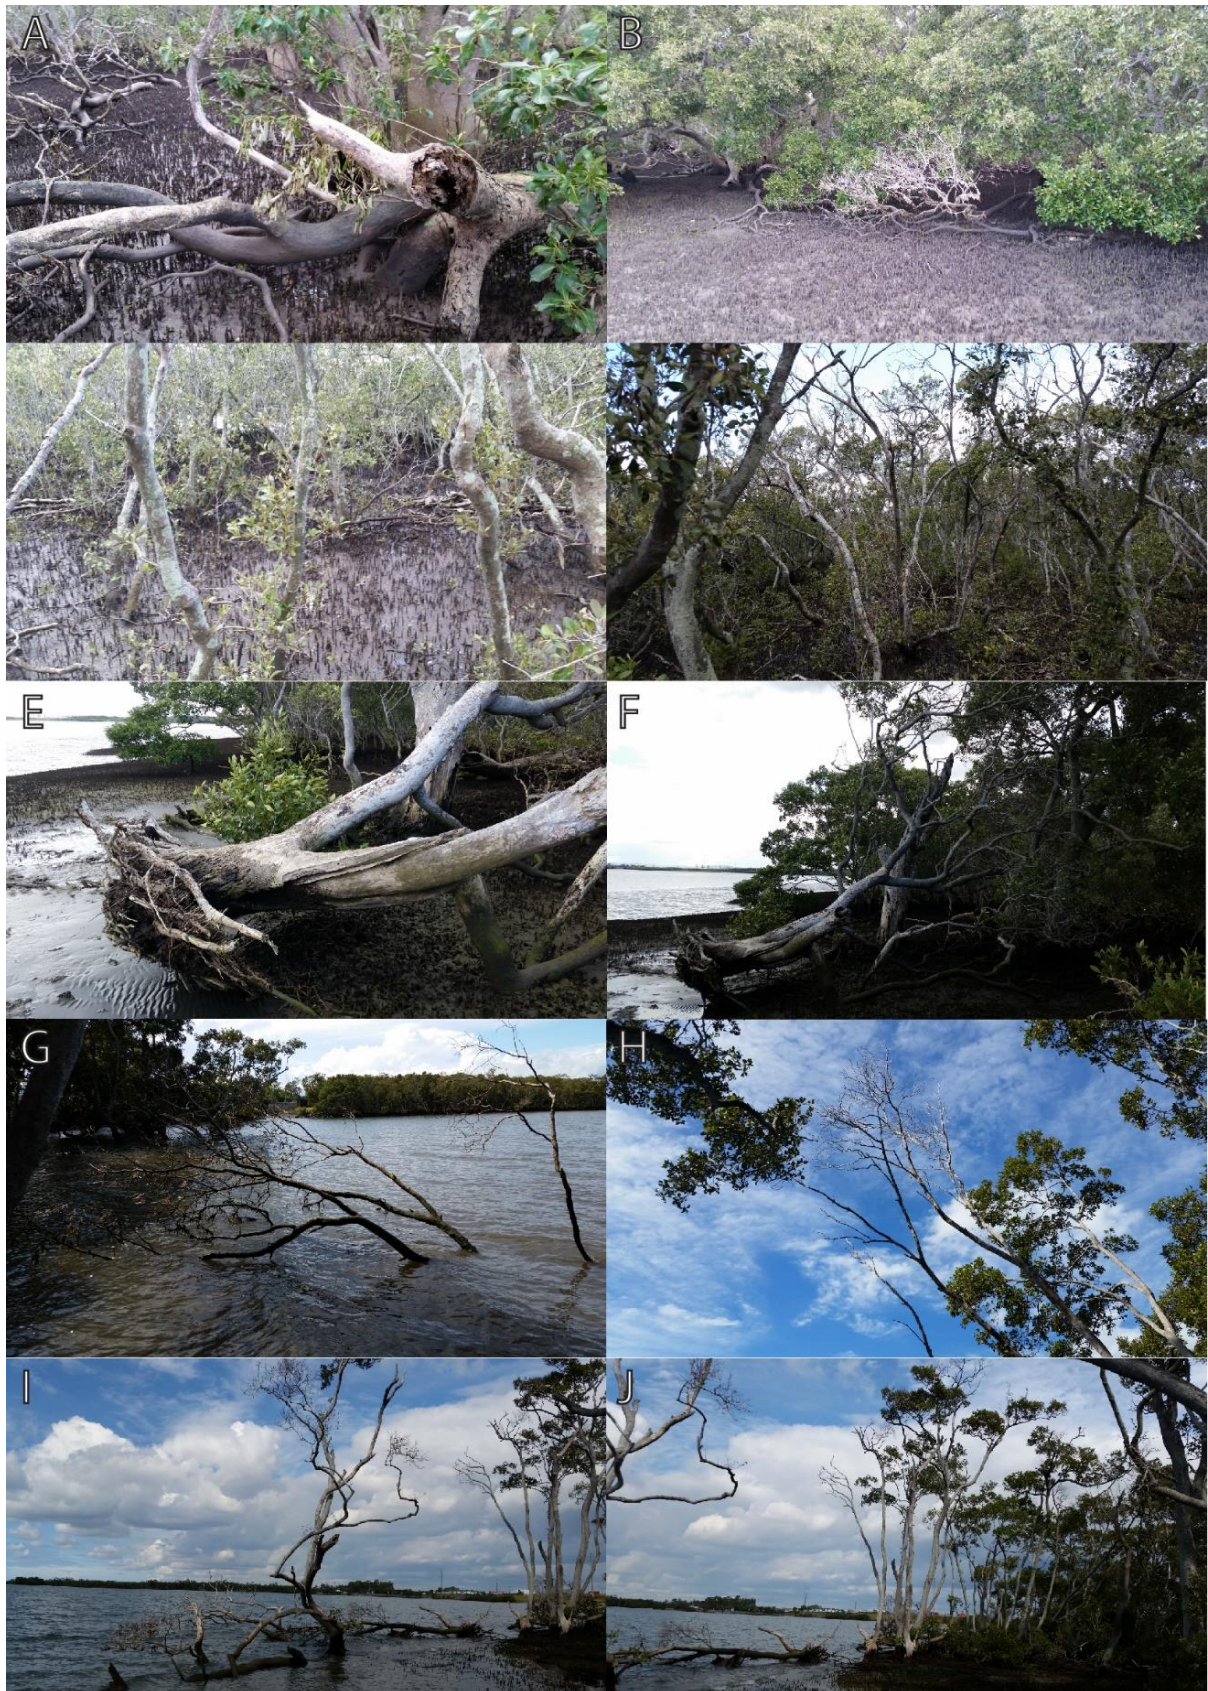
F8 is located near Fisherman Islands site 6. This area was in good condition in 2017-18 but declined in condition during 2018-19. Minor defoliation was observed in the upper and lower canopy, however new regrowth was also observed on several trees.

F10 is located on Boat Passage. This site displayed no clear trend in condition in the previous period but declined in condition over 2018 and 2019. The decline in condition was due to tree fall (three individuals) resulting from bank erosion.

F11 is located on Boat Passage. This site displayed no clear trend in condition in the previous period but declined in condition over 2018 and 2019. The decline in condition was due to tree fall. Numerous cable roots were present, indicating changes in sediment erosion and accretion processes.

Figure D-2 Ground-truthing site photos at: Fisherman Islands site 7 (A and B), site 8 (C and D), site 9 (E and F), site 10 (G and H) and site 11 (I and J).

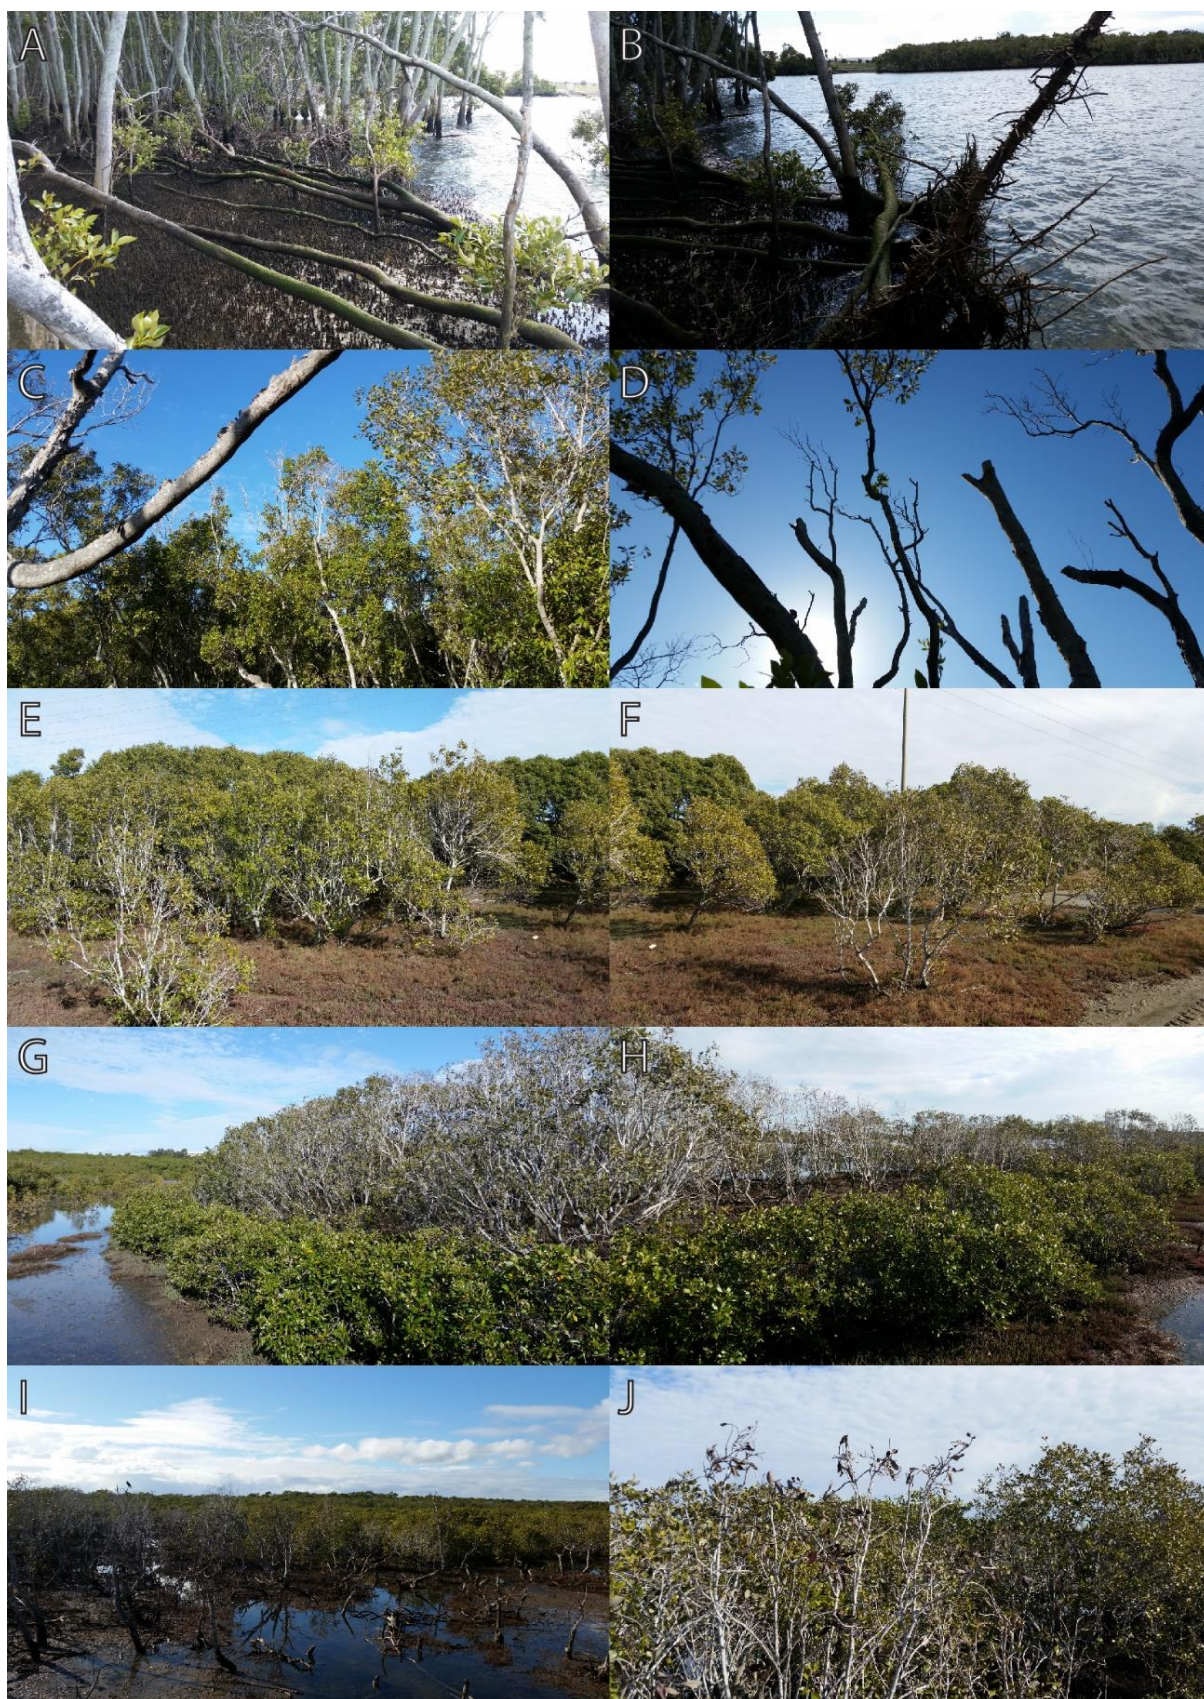
F12 is located on Boat Passage. This site displayed no clear trend in condition in the previous period but declined in condition over 2018 and 2019. The decline in condition was due to tree fall resulting from bank erosion.

W2 is located on the eastern fringe of Whyte Island. This site displayed no clear trend in condition in the previous period but declined in condition over 2018 and 2019. Mangroves in this area were in poor condition, manifested as leaf yellowing, canopy thinning, and tree death.

Whyte Island site 3 is located on the landward side of Whyte Island. Several old dead trees were present indicating historical die-back. Mangrove condition declined during 2018-19, a result of canopy defoliation.

W5 is located near W4, on the southern side of the claypan. Unlike trends in previous years, this site had a decrease in mangrove health in 2018-19. Minor canopy thinning and leaf-browning was observed at this site.

Figure D-3 Ground-truthing photos from: Fisherman Islands site 12 (A and B), Whyte Island site 2 (C and D), site 3 (E and F), site 4 (G and H) and site 5 (I and J).
