Port of Brisbane Mangrove Health Monitoring Program 2019 – Final Report

Reference: R.B23621.002.01.Mangrove_2019.docx
Date: February 2020
Confidential

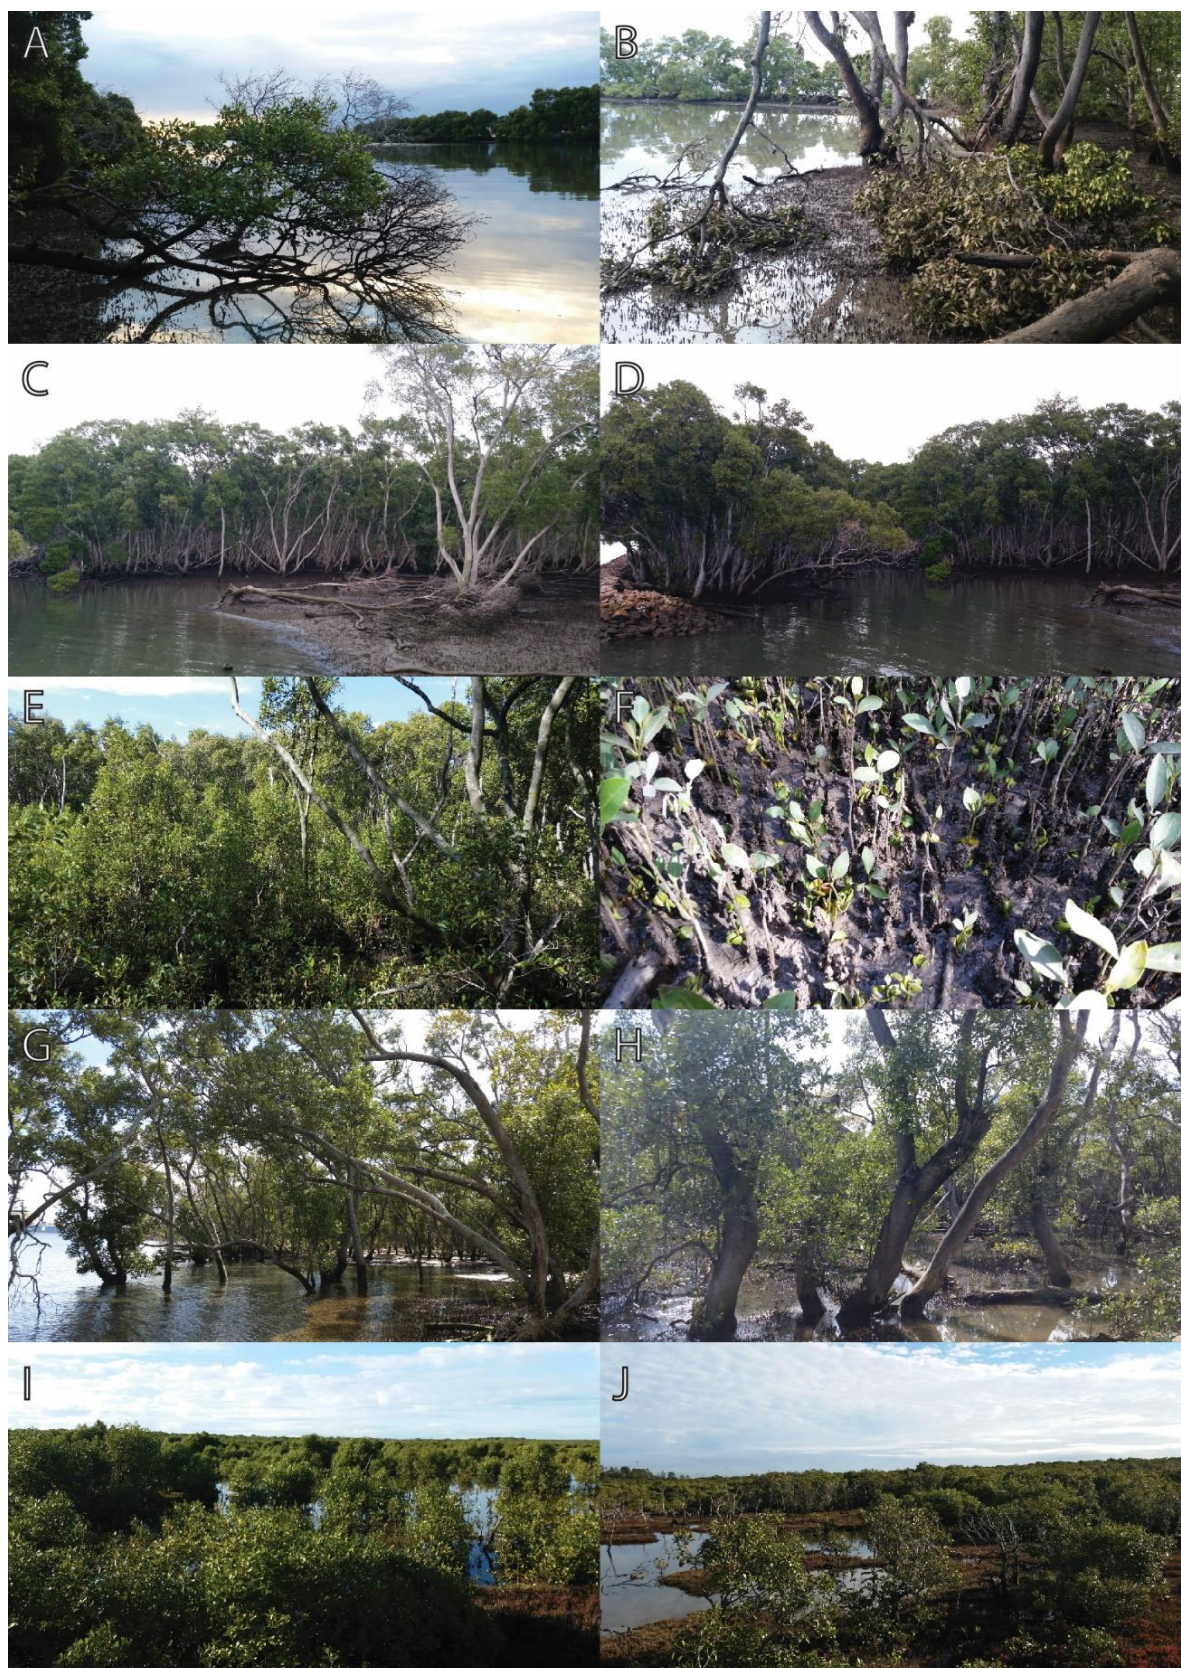
Site F1 is located on the northern end of Fisherman Islands. In previous years mangrove condition in this patch was in poor condition, but there was improvement over 2018-19. Ground-truthing identified mangrove seedling recruitment had occurred, resulting in a dense mat of seedlings across the site. In addition, established trees had new growth and there the presence of several saplings indicated that recruitment from the previous year was successful.

In the previous year, mangrove condition at this site was poor. There was a broad-scale improvement in vegetation condition in 2018-19 at the Coal Loader, especially along the seaward fringe. Ground-truthing indicated that the improvement in condition was mainly due to new growth on existing trees.

Whyte Island site 1 is located on the northern side of the central Whyte Island claypan. In previous years mangrove condition in this patch was in poor condition, but there was improvement over 2018-19. Ground-truthing identified that recovery of trees previously in poor condition, and seedling recruitment.

Bulwer Island site 1 and 2 were located on the seaward fringe of Bulwer Island and both had a decrease in mangrove condition, continuing trends observed in 2017-18. Newly fallen *Avicennia* were observed at site B1 along with some defoliating trees. Fallen and newly dying trees were also observed at site B2, and the presence of exposed cable roots suggest that the area was eroding.

Figure D-4 Ground-truthing from: Bulwer Island site 1 (A and B), site 2 (C and D), Fisherman Islands site 1 (E and F), Coal Loader (G and H) and Whyte Island site 1 (I and J).
