# Whyte Island Rehabilitation Program - Year 1 Assessment

PBPL  
000885  
005  
02

28 August 2024

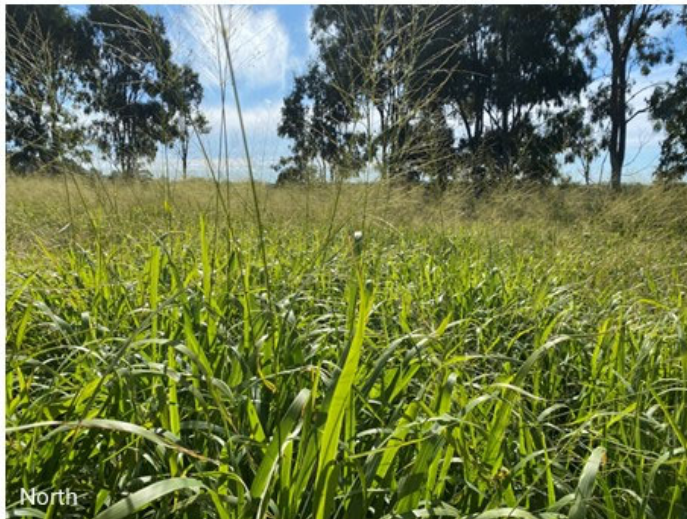
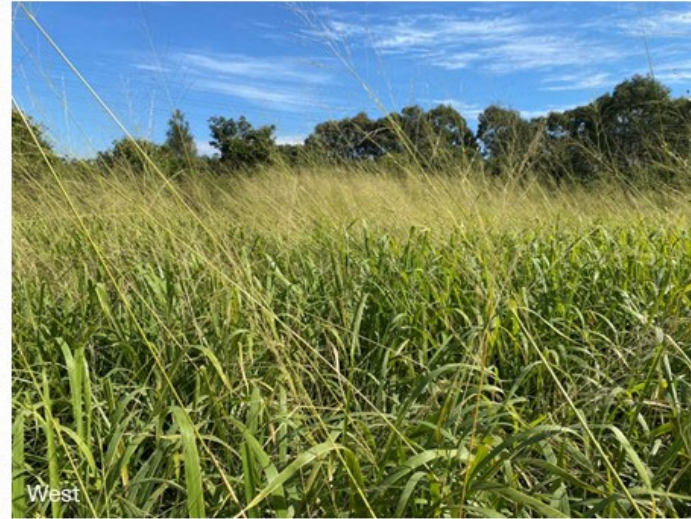
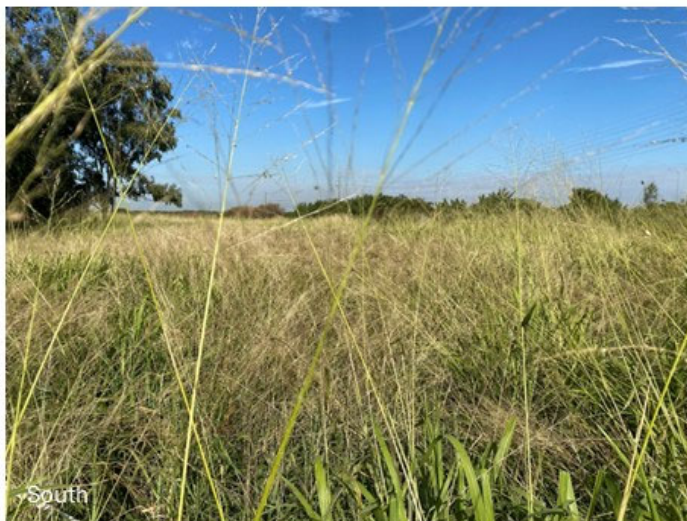
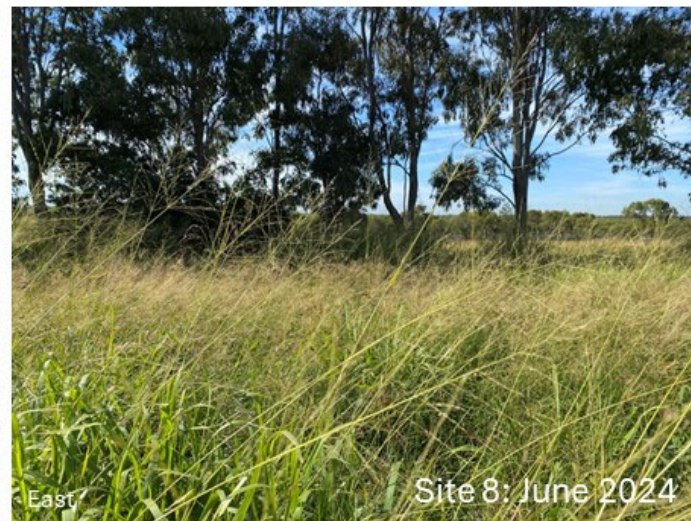
## A.8 Site 8

Vegetation attributes at site 8 were scored against 'best on offer' RE 12.3.11 *Eucalyptus tereticornis* open forest in coastal areas of south-east Queensland. Site 8 is predominantly cleared with an average BioCondition Score of 0.07 (7% of Benchmark Condition) which is considered to be very poor ecological condition. The low native tree cover/richness, lack of shrub species, no evidence of woody recruitment and low native grass and forb species richness contribute to its poor condition. Weed dominance and the lack of litter, woody debris and large trees also contributes to its overall low habitat value. Rehabilitation measures focusing on planting, weed control and installation of logs, mulch and nest boxes would improve its overall habitat condition.

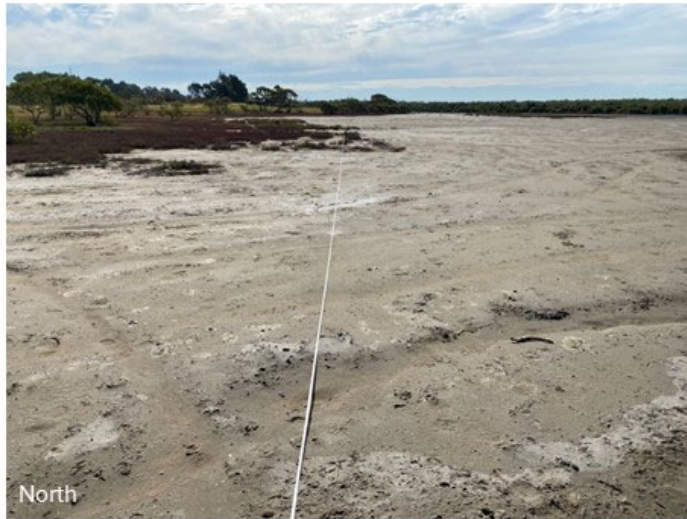
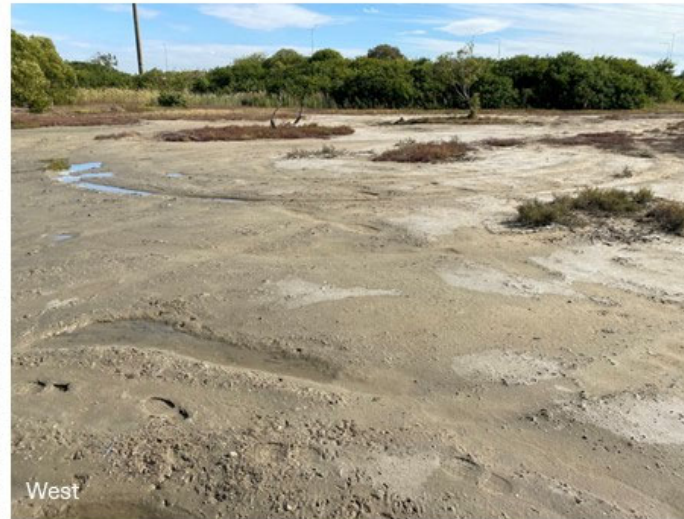
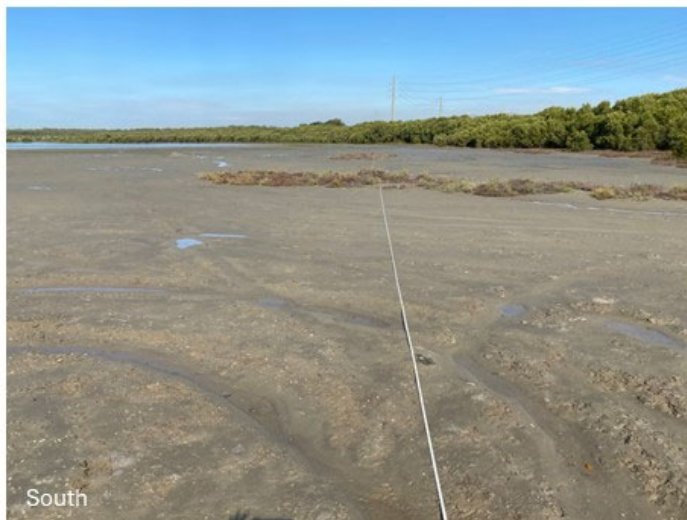
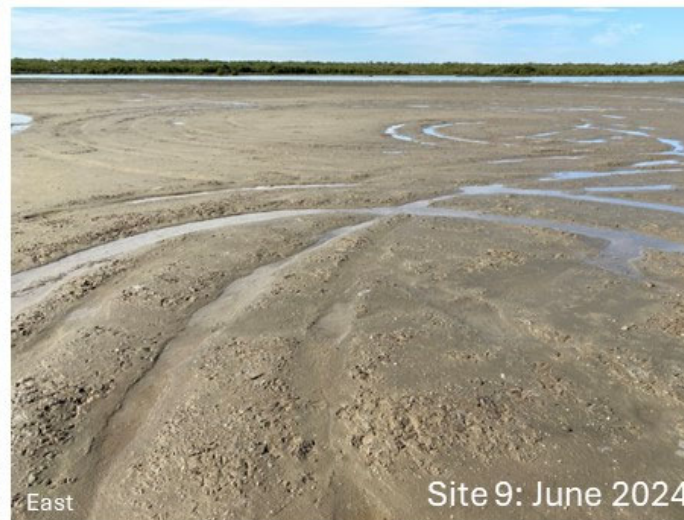
A.9 Site 9

Site 9 measured an average BioCondition Score of 0.92 (92% of Benchmark Condition). The site supports remnant saltmarsh in very good condition when scored against 'best on offer' RE 12.3.20 samphire forbland communities in south-east Queensland. Although the site supports high vegetation cover it is impacted by recreational vehicles. Preventing vehicle access to saltmarsh habitat could improve vegetation cover and overall habitat condition particularly for disturbance-sensitive waders.

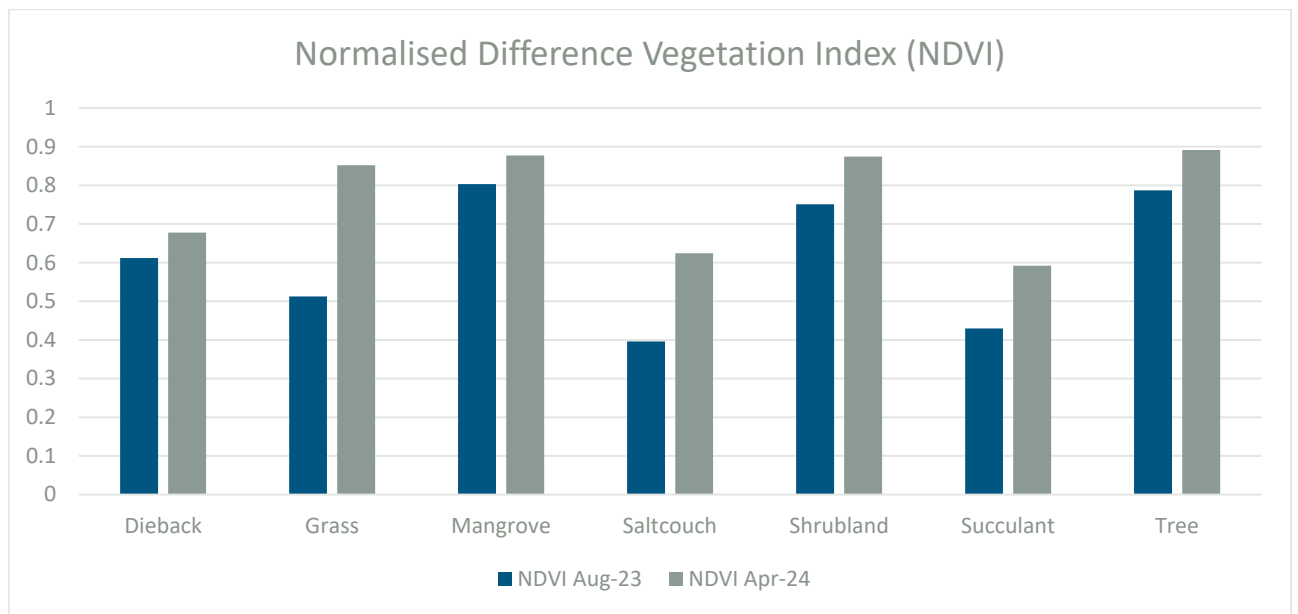
The geo-median vegetation health indices, including NDVI, EVI, and SAVI, exhibit consistent patterns across all vegetation classes as shown in Figures 5.1 to 5.3. Large green leafy vegetation covers, such as mangroves, shrublands, and tree vegetation, display healthy NDVI values ranging from 0.7 to 0.9 between August 13, 2023, and April 9, 2024, indicating good vegetation health. Saltmarsh species, including succulents and saltcouch, exhibit naturally lower NDVI values ranging from 0.4 to 0.6 compared to larger or medium-sized vegetation covers. Succulent species are more resilient to stress in August due to their ability to store large amounts of water, while saltcouch shows minor stress during the dry season. As expected, grasslands are in good condition during the wet season but experience dieback in the dry season. Grasslands show the highest variance among all vegetation cover classes.

Figure G.1 The overall Normalised Difference Vegetation Index (NDVI) across vegetation categories

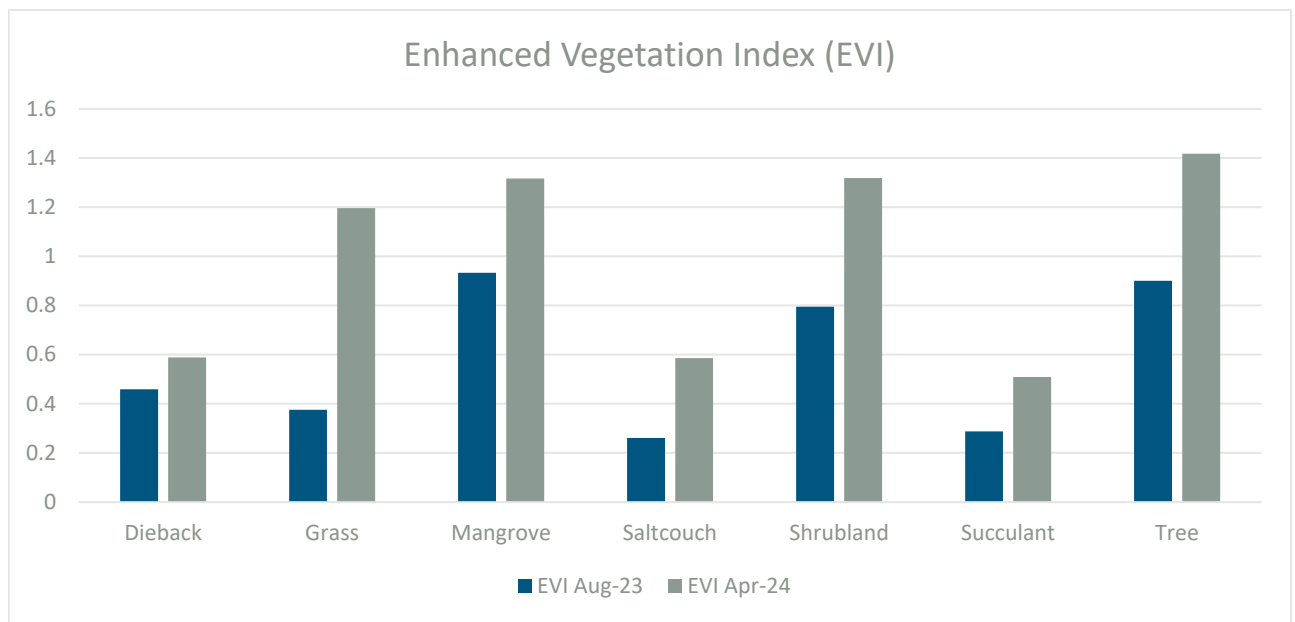
Figure G.2 The overall Enhanced Vegetation Index (EVI) across all vegetation categories

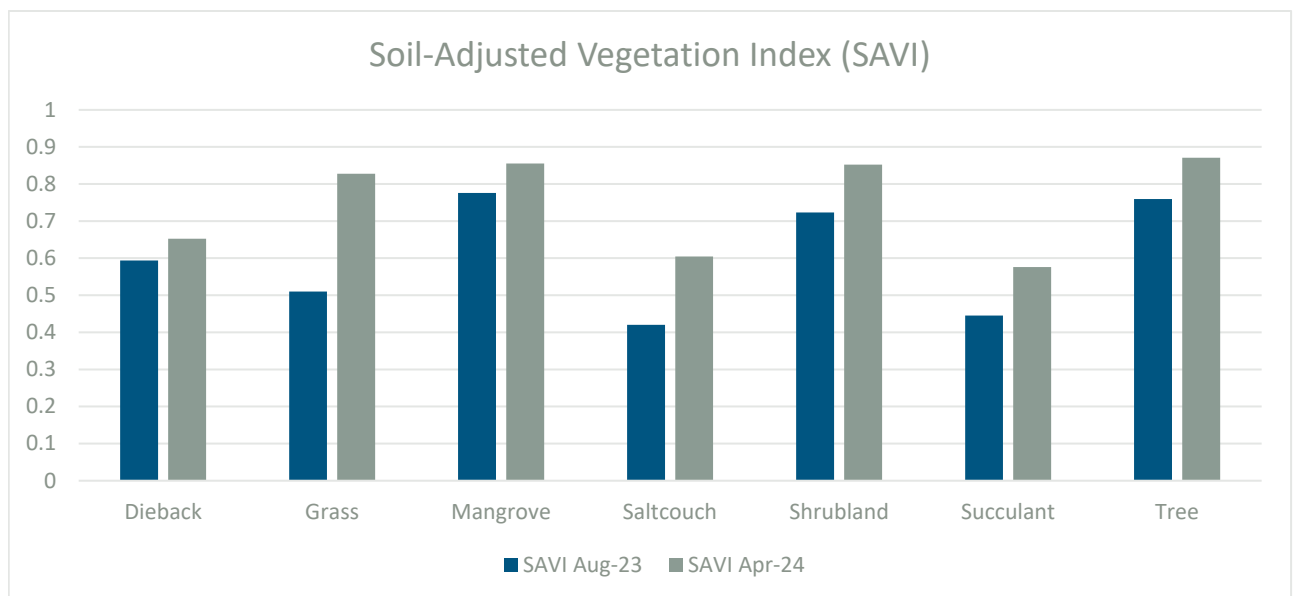
Figure G.3 The overall Soil-Adjusted Vegetation Index (SAVI) across all vegetation categories

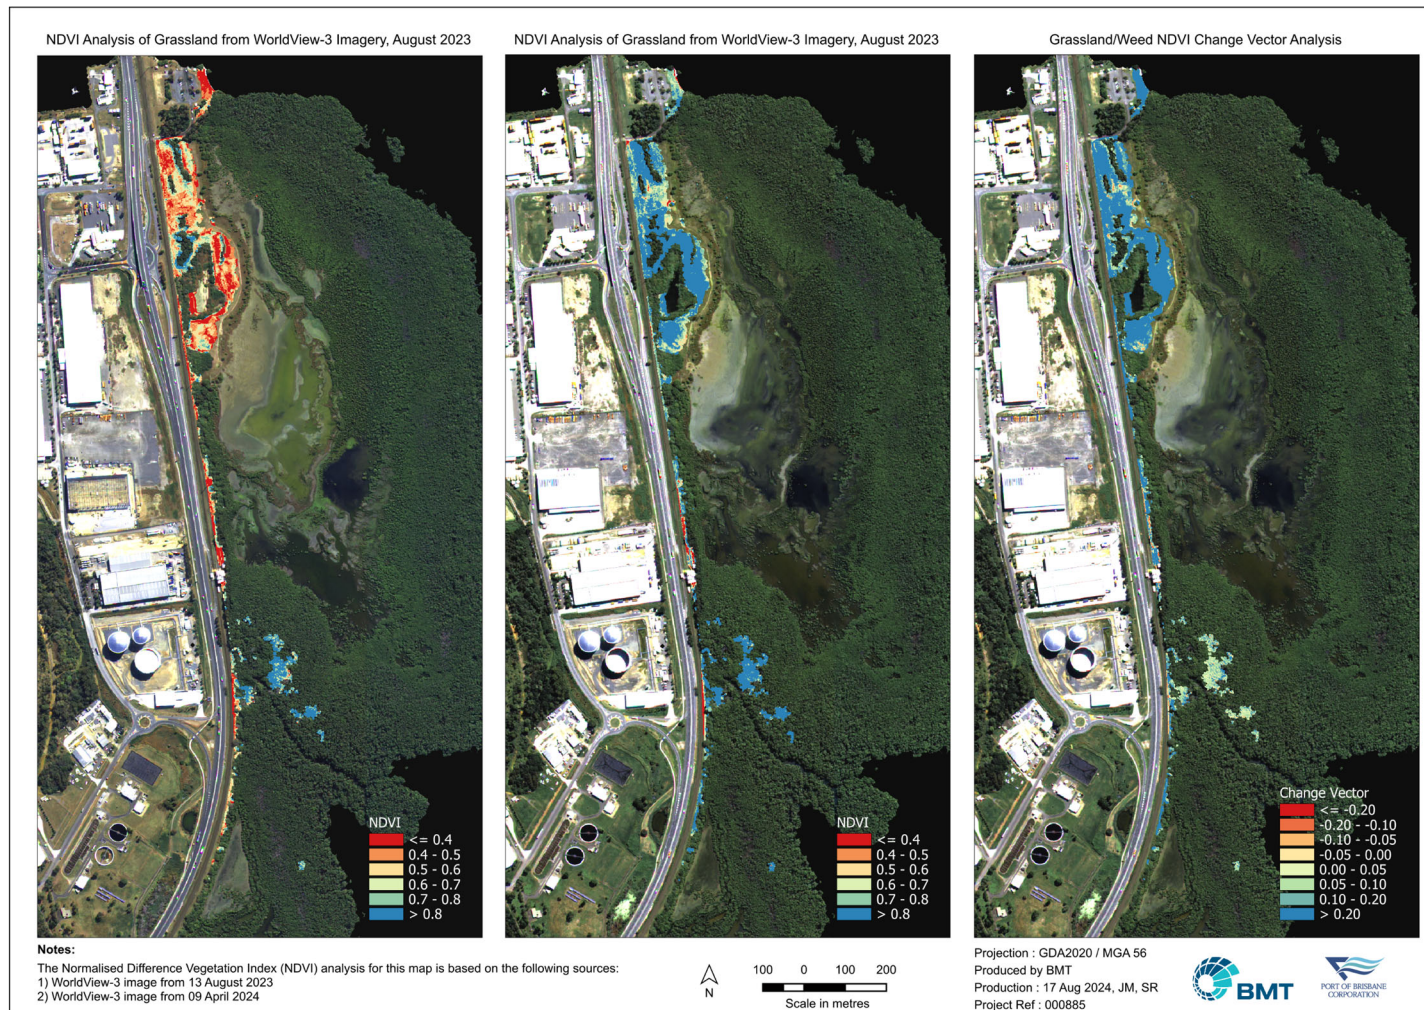
The NDVI analysis results for grassland/weed vegetation cover in August 2023 and April 2024, along with their CVA, are presented in Figure 5.4. The dry season result (August 2023, image on the left) indicated that most of this class dried out ( $NDVI \leq 0.4$ ) during the dry months, except in areas benefiting from shade or available water sources. In contrast, the wet season results (April 2024, image in the middle) showed that the vegetation returned to full health ( $NDVI > 0.8$ ) in most areas, except those bordering saltcouch species, likely due to higher salt levels. Nevertheless, these areas still showed good health recovery. The CVA results (right image) indicated a good overall recovery, with only minor locations where the grassland/weed vegetation did not recover well.

Figure G.4 Normalised Difference Vegetation Index (NDVI) and Change Vector Analysis for Grassland/Weed Areas

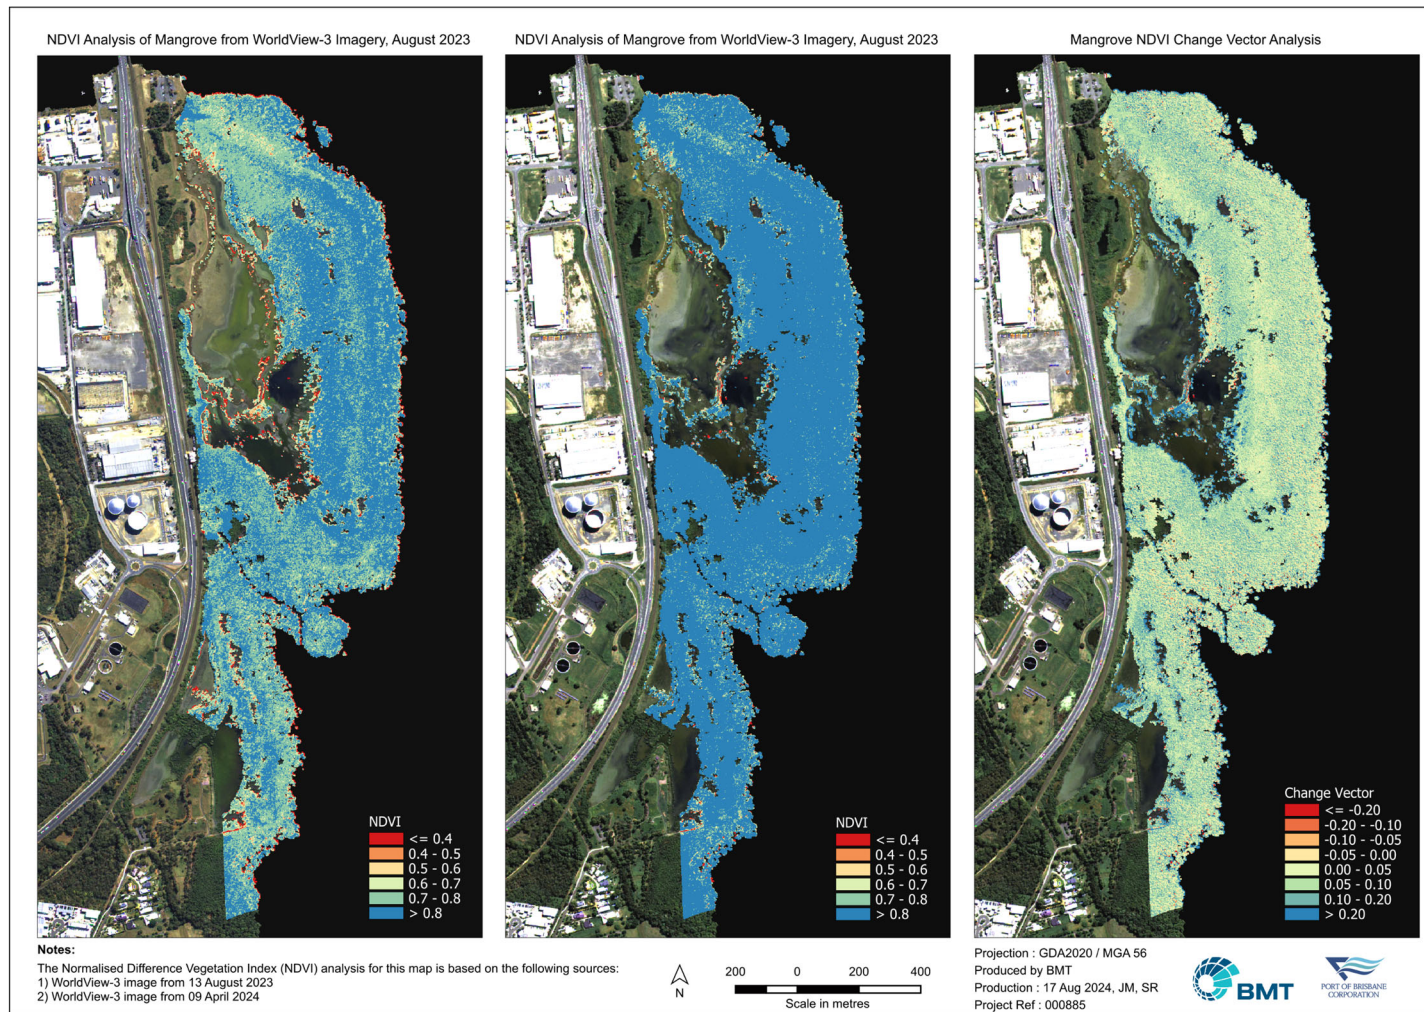
The NDVI analysis results for mangrove vegetation cover in August 2023 and April 2024, along with their CVA, are presented in Figure 5.5. The dry season results (August 2023, image on the left) indicated that the majority of mangroves had excellent and good health indicators ( $\text{NDVI} > 0.7$ ). However, a significant portion also showed moderate health ( $0.5 < \text{NDVI} < 0.7$ ), particularly in the northern part of the mangrove area. Poor health indicators ( $\text{NDVI} \leq 0.4$ ) were mostly observed on the fringes, especially in the claypan/mudflat areas where the trees were relatively smaller, as well as in dieback areas, possibly due to already stressed or dying mangroves, or smaller juvenile mangroves. The wet season results (April 2024, image in the middle) showed that the majority of the mangrove cover exhibited excellent health ( $\text{NDVI} > 0.7$ ), with a significant portion also displaying moderate recovery ( $0.5 < \text{NDVI} < 0.7$ ). The CVA results (right image) revealed 'red spots' scattered across the mangrove cover, where the rate of change ranged equal to smaller than  $-0.2$ . These areas could indicate early signs of stress, suggesting that certain sections of the mangrove ecosystem may be experiencing environmental pressures or other factors affecting their health.

Figure G.5 Normalised Difference Vegetation Index (NDVI) and Change Vector Analysis for Mangrove Areas

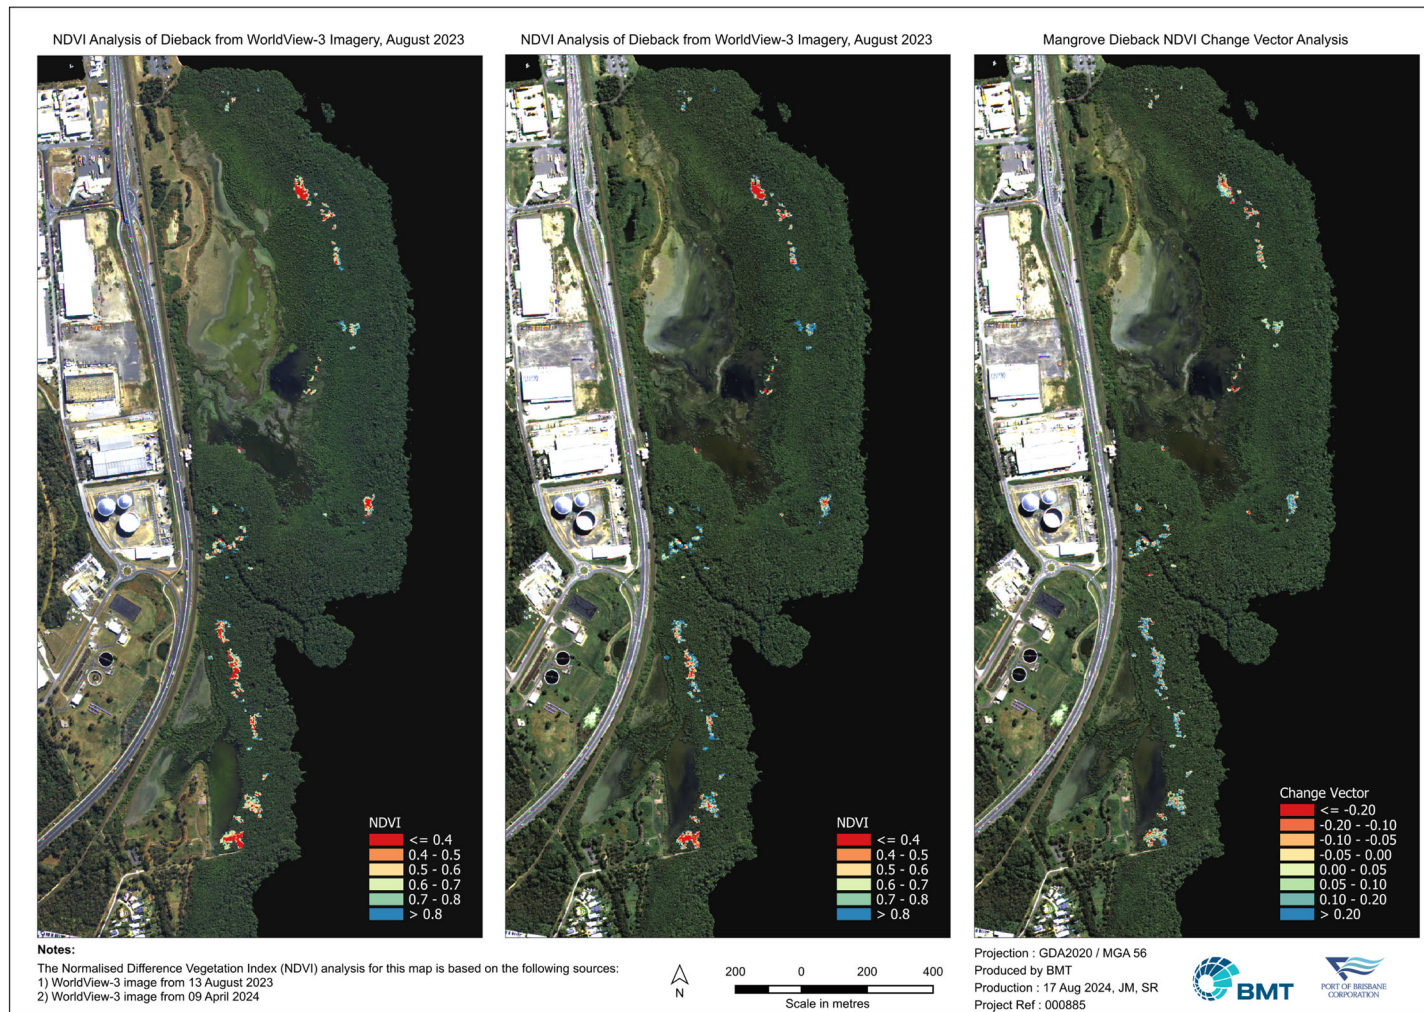
Figure G.6 Normalised Difference Vegetation Index (NDVI) and Change Vector Analysis for Mangrove Dieback Areas

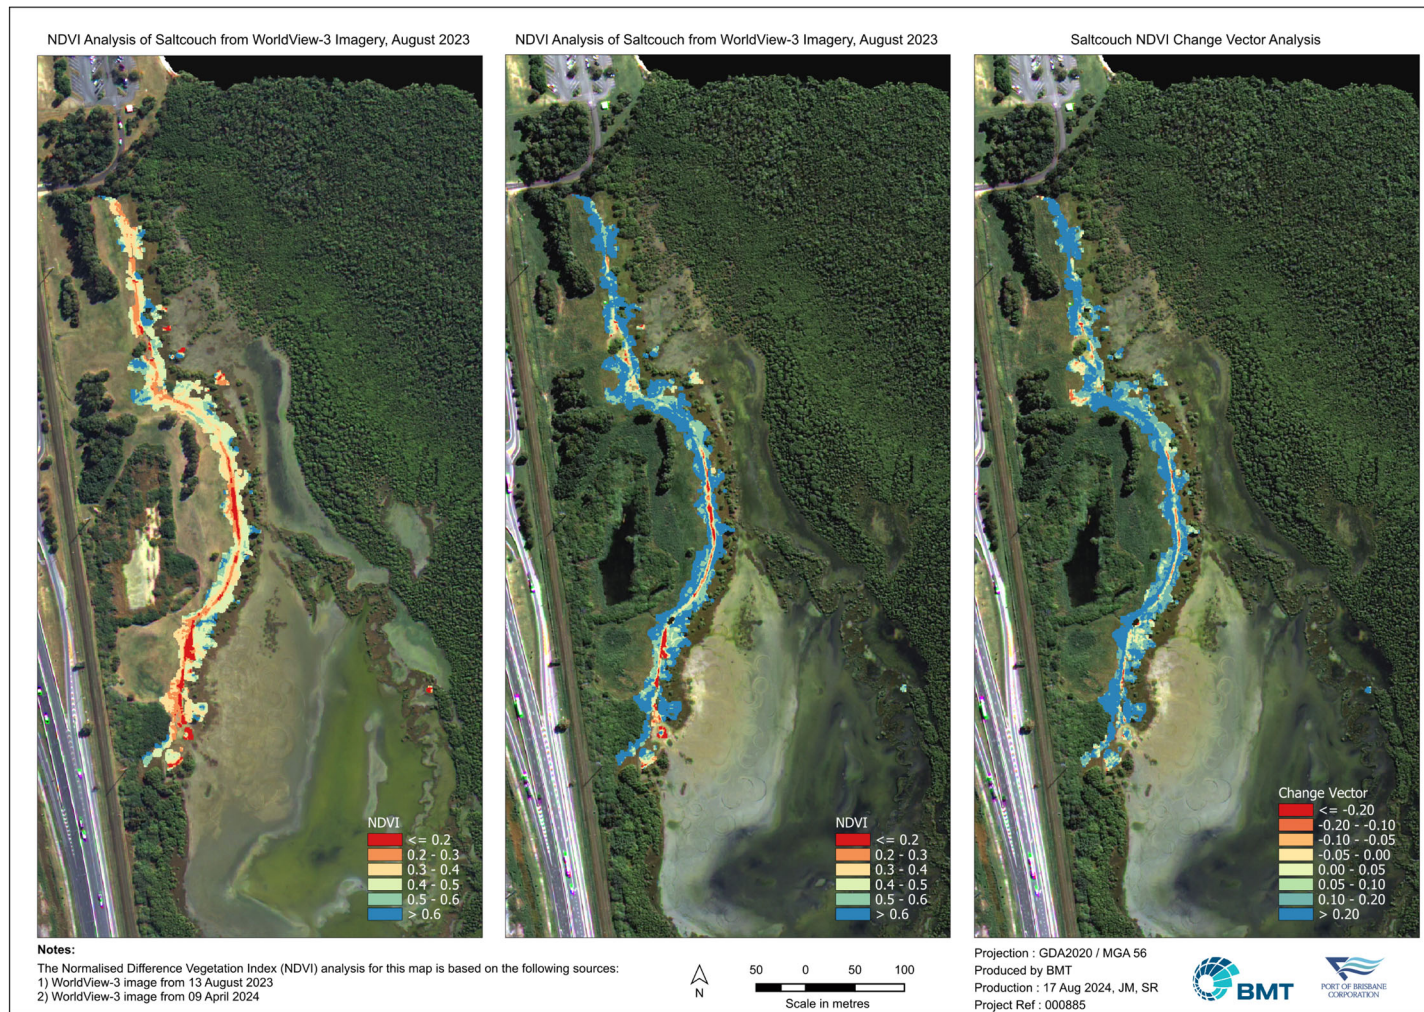
The NDVI analysis results for saltcouch cover in August 2023 and April 2024, along with their CVA, are presented in Figure 5.7. The dry season results (August 2023, image on the left) indicated that the majority of these areas exhibited moderate health status ( $\text{NDVI} > 0.4$ ) with poor to no vegetation activity ( $\text{NDVI} < 0.3$ ) near disturbed areas which were less dense and degraded. Similar to the grassland class, the majority of the vegetation had revived during the wet season (April 2024, image in the middle). The red areas likely represent disturbed areas or regions that did not recover. The CVA results (right image) revealed blue areas on the map, where the rate of change was equal to or greater than  $0.2$ , indicating regrowth or recovery in those regions. Additionally, there were small areas of negative change, where the rate of change was less than  $-0.1$ , indicating poor recovery.

Figure G.7 Normalised Difference Vegetation Index (NDVI) and Change Vector Analysis for Saltcouch Areas

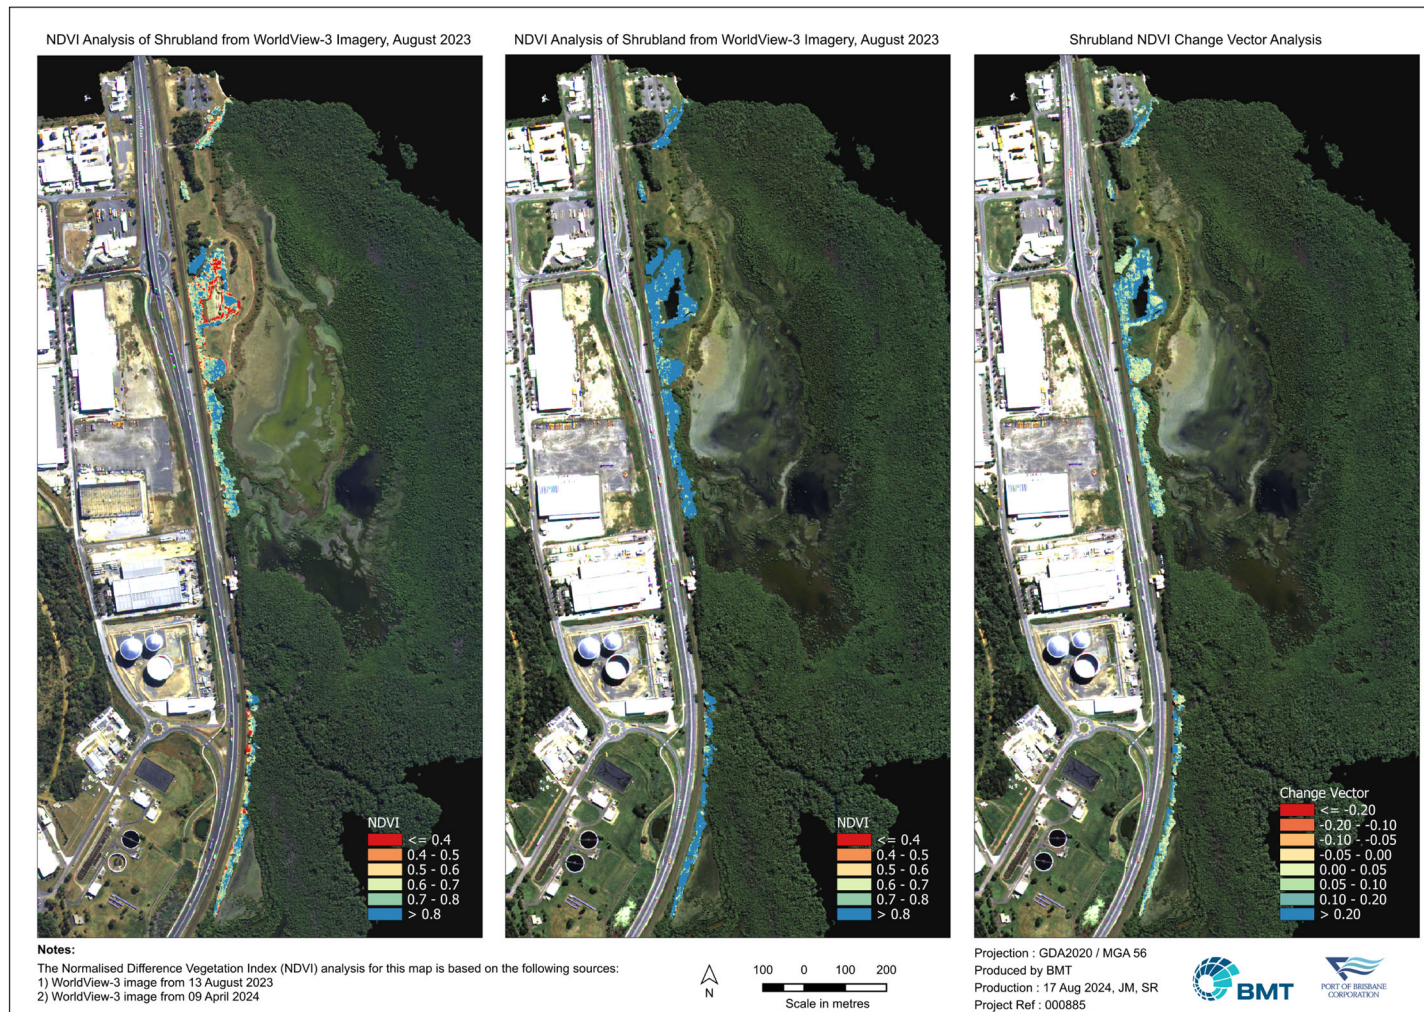
Figure G.8 Normalised Difference Vegetation Index (NDVI) and Change Vector Analysis for Shrubland Areas

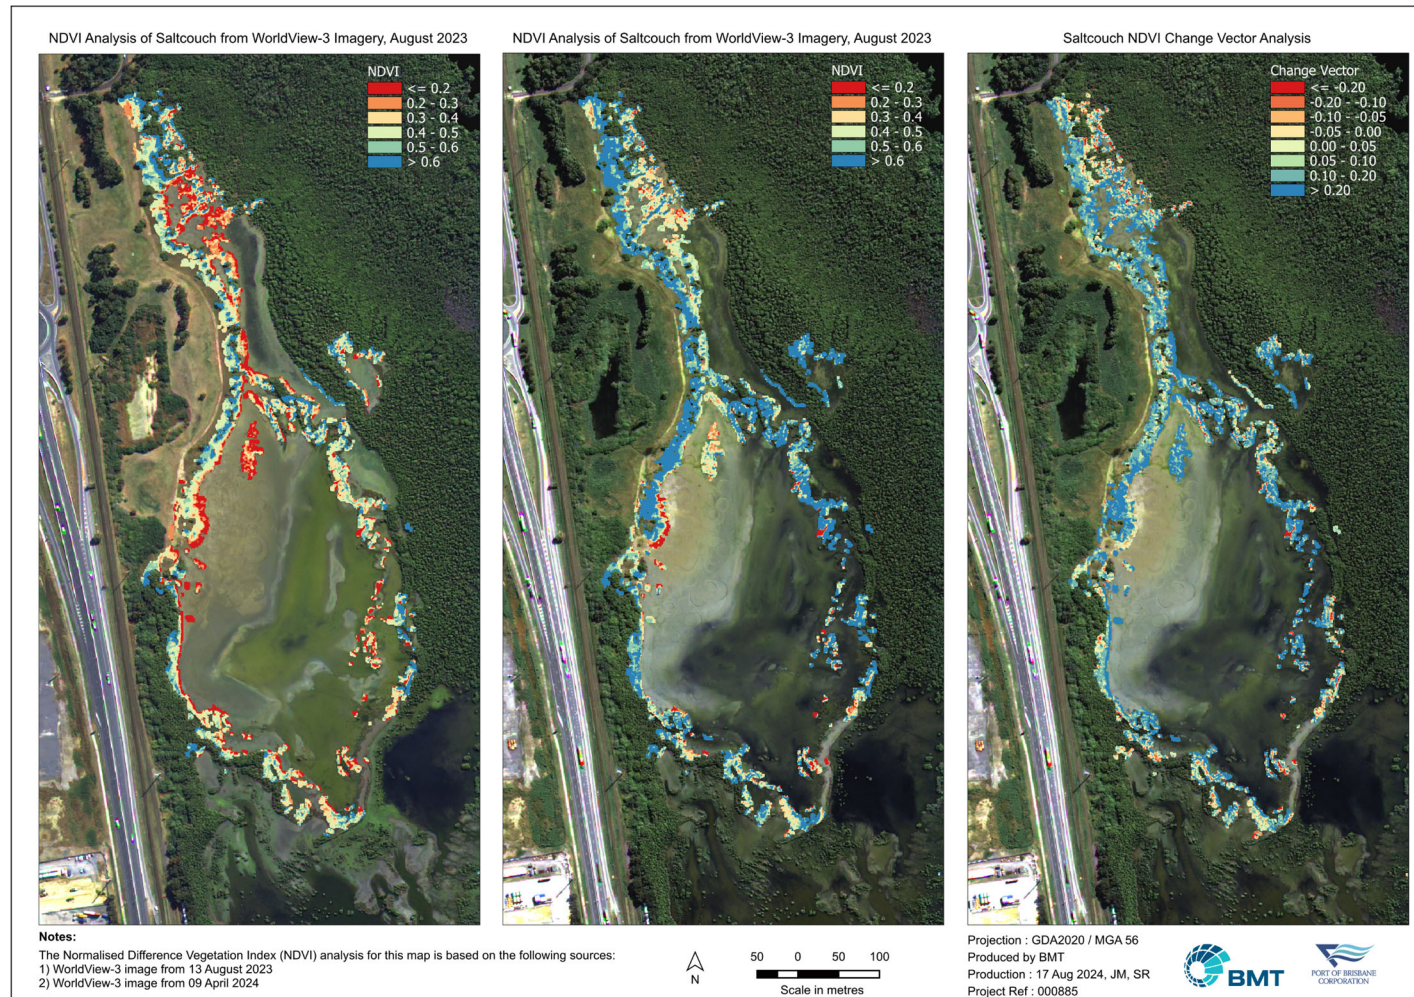
The NDVI analysis results for succulent cover in August 2023 and April 2024, along with their CVA, are presented in Figure 5.9. The dry season results (August 2023, image on the left) indicated signs of stress ( $\text{NDVI} \leq 0.2$ ), particularly near the fringes of the claypan/mudflats areas, while some areas showed excellent condition ( $\text{NDVI} > 0.6$ ). During the wet season (April 2024, image in the middle), these areas appeared to recover, achieving good to excellent health ( $\text{NDVI} > 0.4$ ). However, some areas still showed poor status ( $\text{NDVI} < 0.3$ ), particularly adjacent to the wetland. The CVA results (right image) for this class were mostly positive, indicating overall resilience, but the northern and southern regions showed some negative change, suggesting these areas might be stressed.

Figure G.9 Normalised Difference Vegetation Index (NDVI) and Change Vector Analysis for Succulent Areas

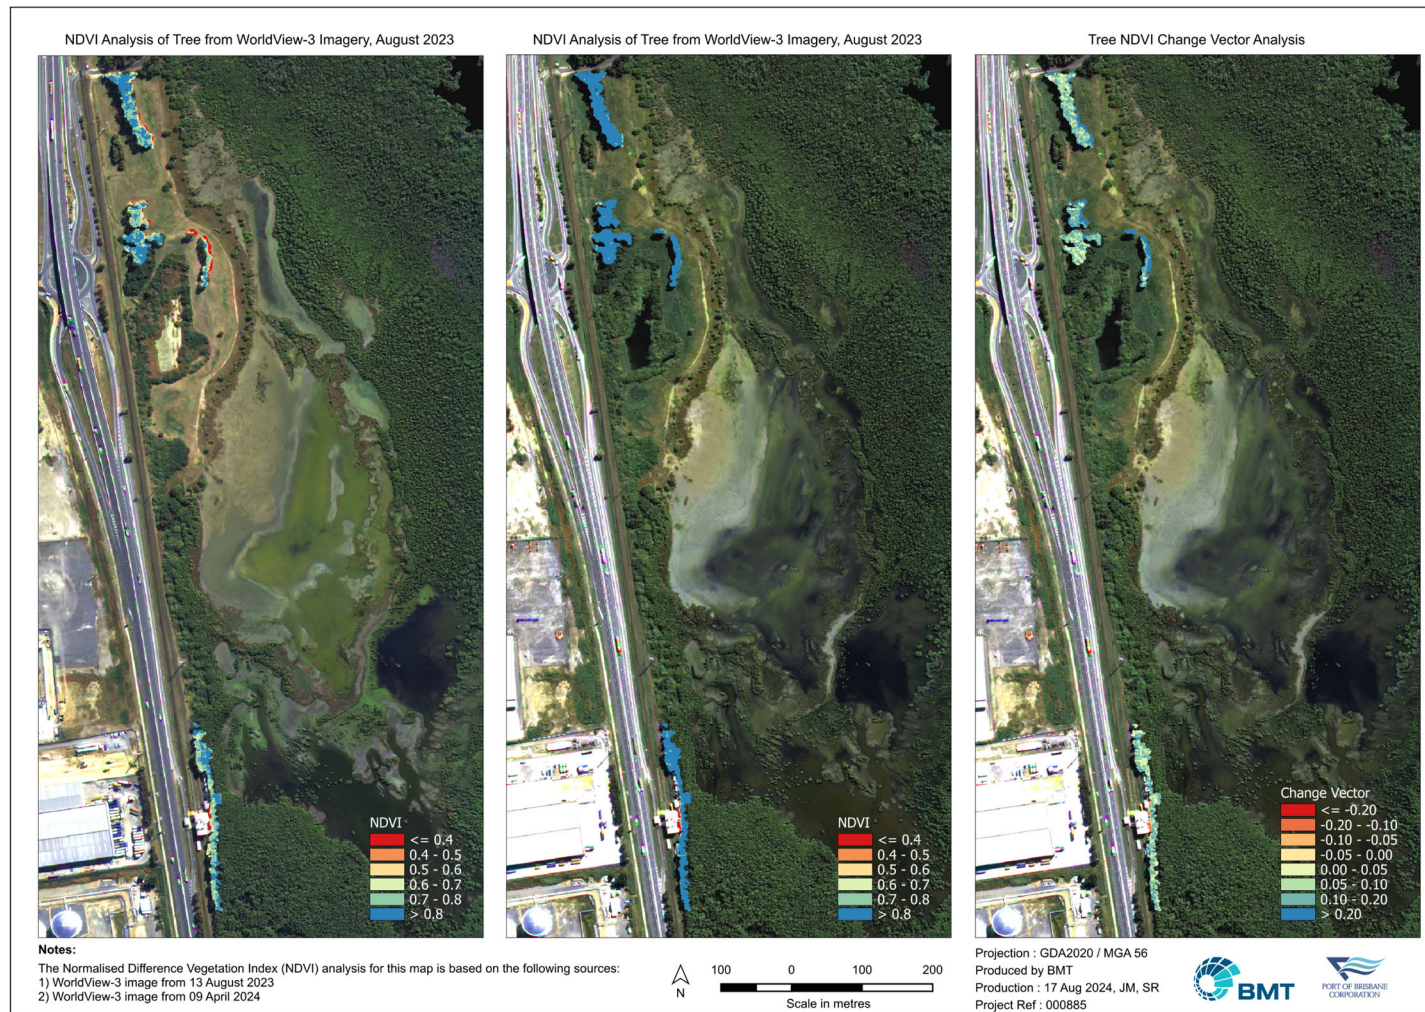
Finally, the NDVI analysis results for tree vegetation cover in August 2023 and April 2024, along with their CVA, are presented in Figure 5.10. The dry season results (August 2023, image on the left) indicated that the majority of these areas exhibited good to excellent health status ( $\text{NDVI} > 0.7$ ). However, there was poor to no vegetation activity ( $\text{NDVI} \leq 0.4$ ) in the north and east of the seasonal wetland, as well as near the left side of the infrastructure in the south. During the wet season (April 2024, image in the middle), these areas showed increased activity and achieved excellent health indicators ( $\text{NDVI} > 0.8$ ). However, the poor area near the east side of the infrastructure did not show any signs of improvement. The CVA results (right image) for this class were mostly positive, indicating overall resilience.

Figure G.10 Normalised Difference Vegetation Index (NDVI) and Change Vector Analysis for Tree Areas
